GDC Project No. GF-2078

Subject: Summary of Observations
Sidewalk Removal by City of Pasadena
497 S. Lake Avenue, Pasadena, California 91101

GF-2078
Summary of Observations
497 S. Lake Avenue, Pasadena, California

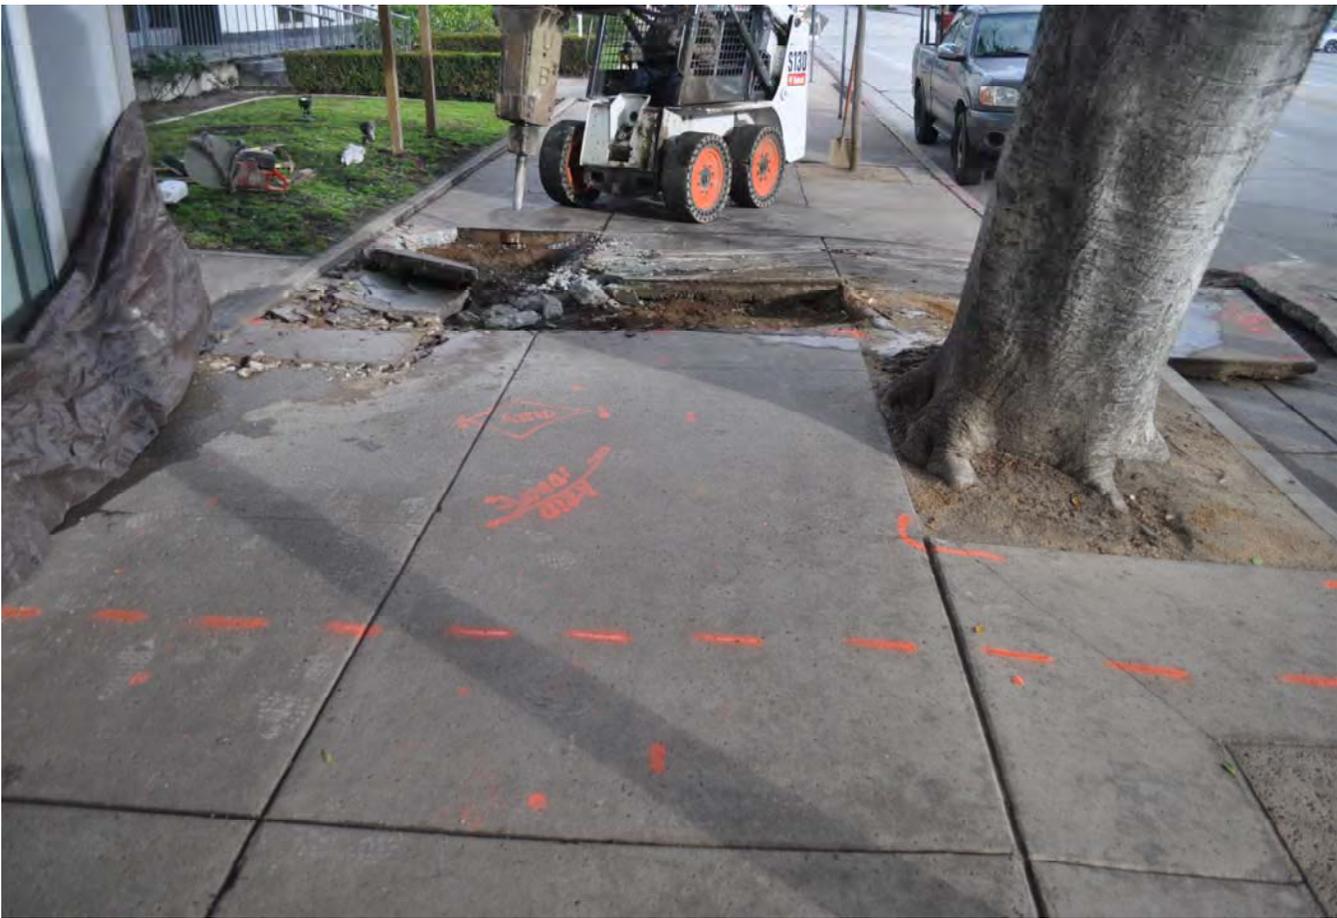
Photo 1

The sidewalk was demolished with a Bobcat jackhammer and the removal exposed numerous roots beneath the sidewalk adjacent to the subject building (Photos 1 - 6). Some roots are over 6 inches in diameter. A section of the sidewalk adjacent to the northeast corner of building was not demolished because there is a survey point that is likely for the property line (Photo 7).

Sidewalk removal began about 9.5 feet north of the subject building (Photos 1 - 3) and extended to the south (Photos 4, 6) a total distance of about 82 feet, 8 feet south of the south end of the building (Photo 5). The 9 feet 10-inch wide sidewalk sections were removed, with two wider sections of sidewalk removed south of the north tree planter and south of the southernmost tree planter. The sidewalk varied in thickness, but typically about 4 to 5 inches and there was no apparent steel reinforcement.

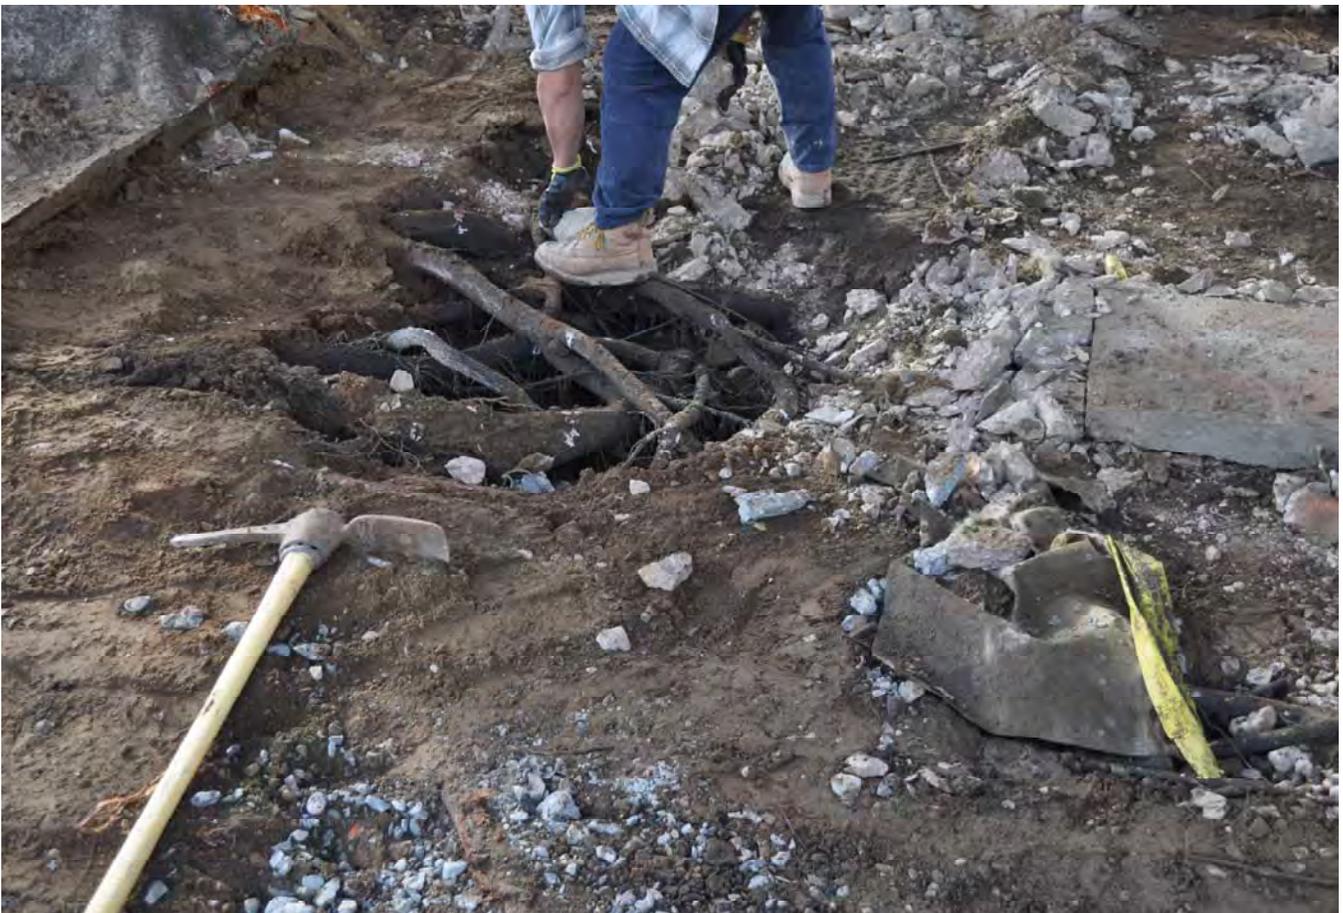
Photo 8

Several large roots were encountered at a roughly 4 x 6-foot depression adjacent to the northernmost tree (Photos 8 - 10). The depression was about 1-foot deep and 4 feet east of the building perimeter. At this location, some roots are over 6 inches in diameter (Photo 11). The

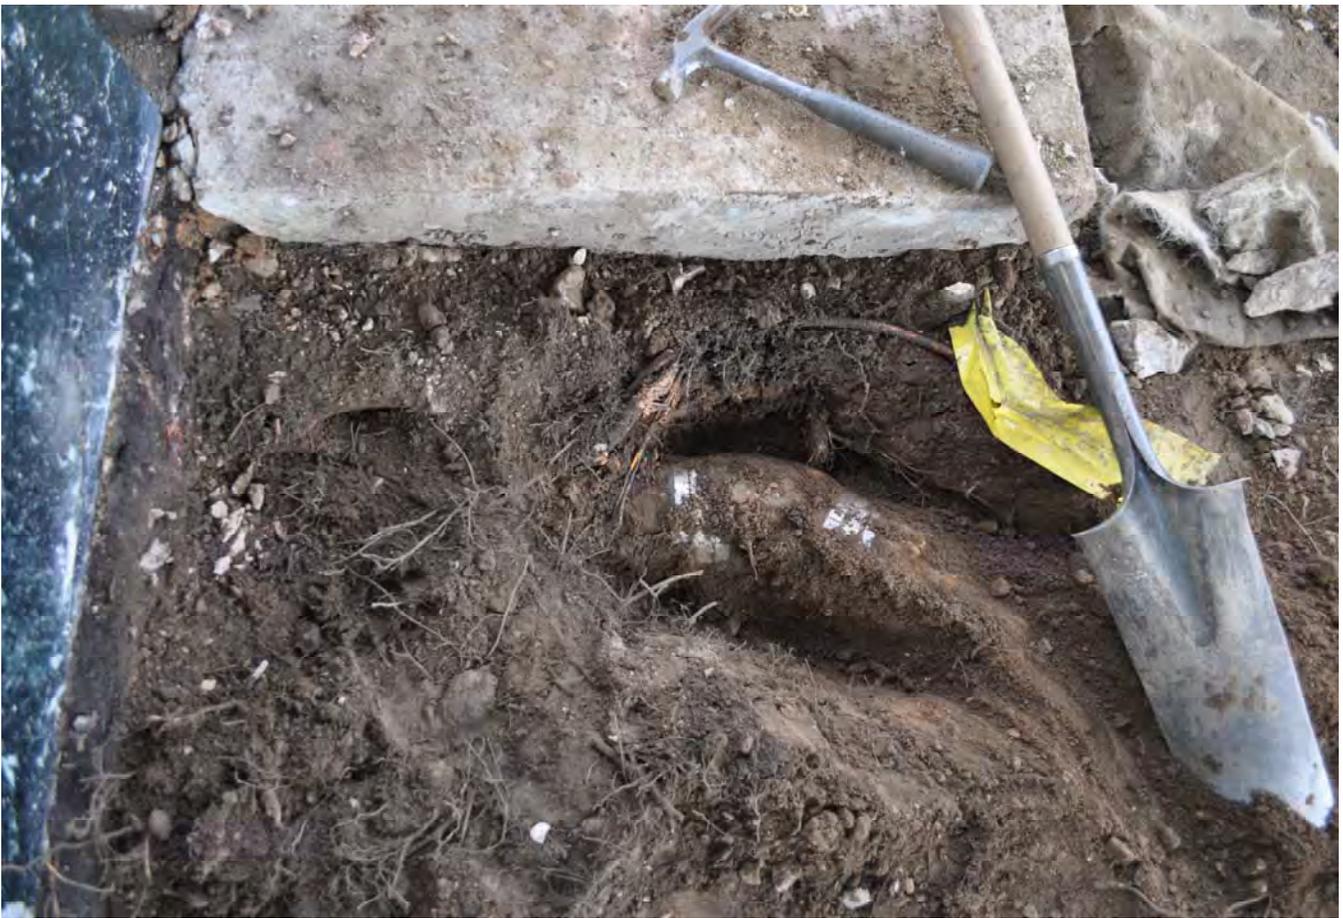
Photo 13

At the northeast building corner, just below the sidewalk, is 4-inch cast iron drain line that extended out of the building (Photos 12 – 14). The line had a cast iron elbow directing the pipe to the southeast toward the street. The pipe extended out several feet where it connected with a 4-inch plastic pipe (Photo 15). There was a roughly 2-foot section of the plastic pipe that was broken adjacent to the depression (Photos 16, 17). Roots were observed growing inside this portion of the drain line. The cast iron pipe was opened up at the elbow and was found to be completely filled with roots (Photos 18 - 26). We observed a ½-inch wide root (Photos 27 – 29) and numerous smaller roots that completely filled the pipe and continue into the cast iron pipe and into the building.

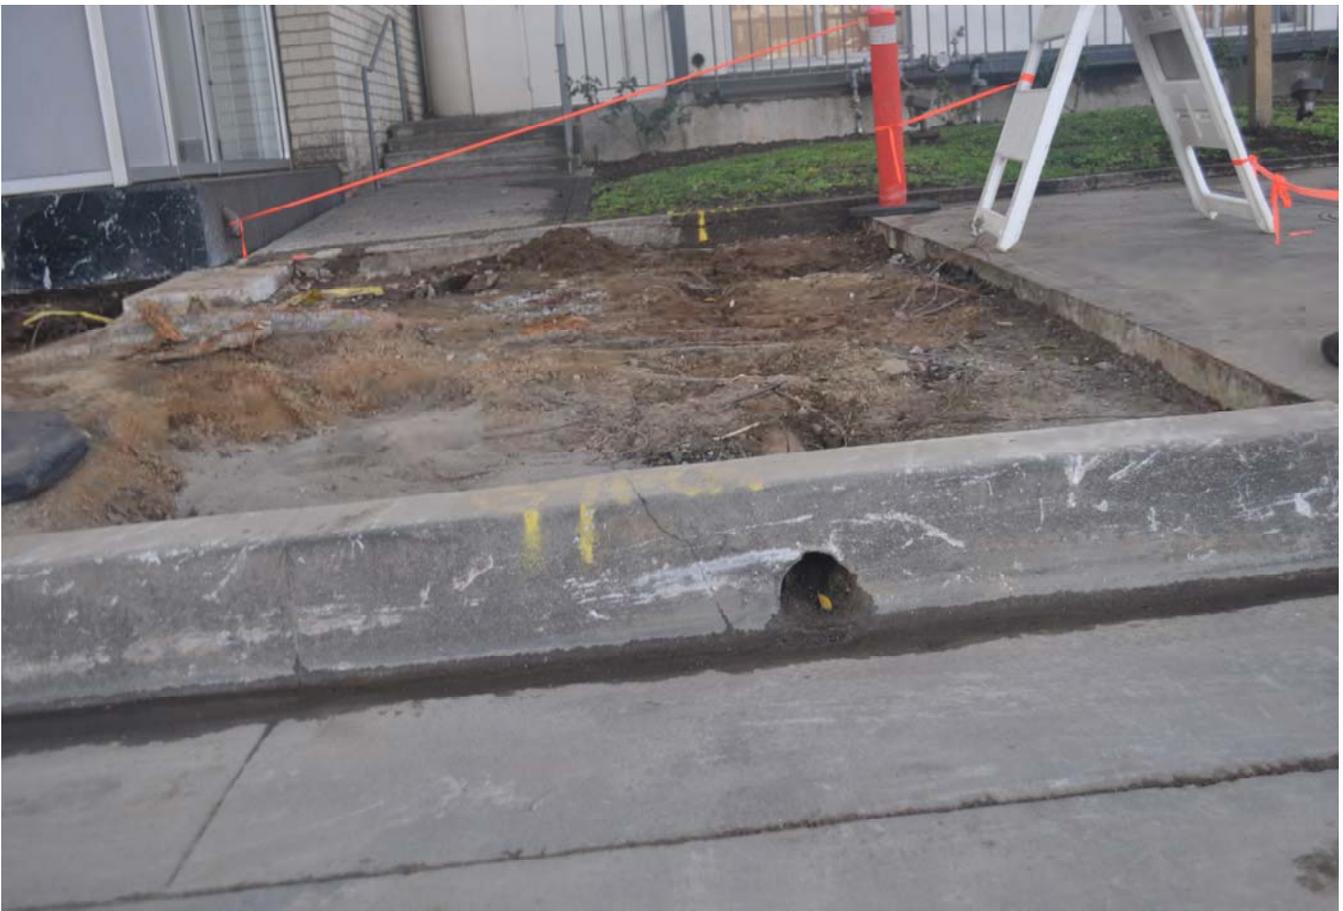
Photo 30

North of the depression are two easterly trending drain lines that appear to be for the vacated neighboring building to the north (Photo 30). About 7 feet north of the subject building is a cast iron line that was observed to be broken near the street and with roots growing in the pipe (Photos 31, 32). The outlet at the street is completely blocked (Photo 33). At about 4.5 feet north of the subject building is a plastic drain line that is damaged at one location where we observed standing water (Photos 34, 35). The curb outlet for this pipe is completely blocked (Photo 36). There are two roots about 1 to over 1.5-inches in diameter that trend along this pipe and go to the west under a landscaping curb (Photo 37).

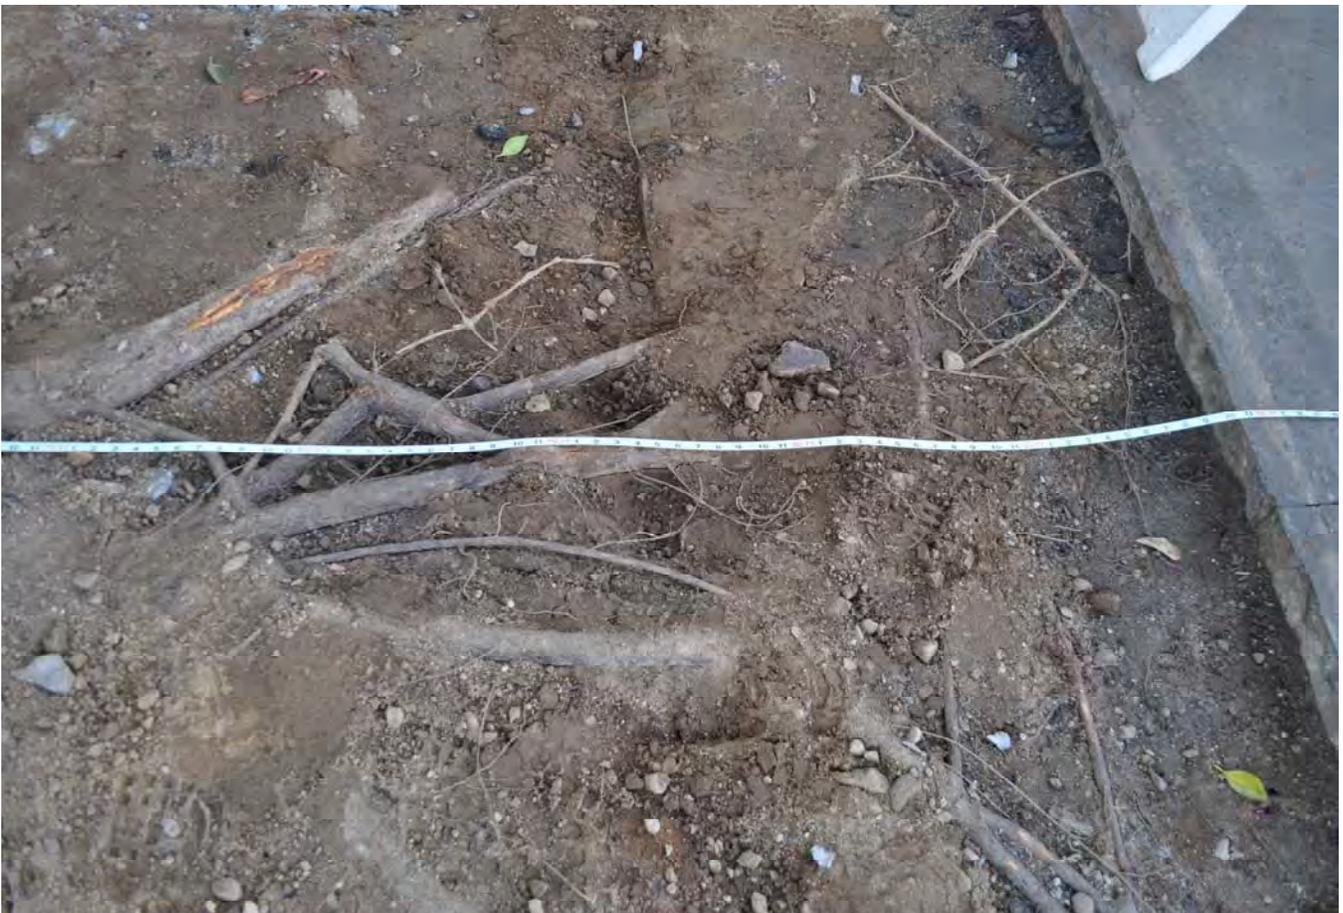
Photo 38

A large mass of roots at the ground surface fan out northward of the north tree (Photo 38). Another large mass of roots fan out to the southwest toward the north portion of the building (Photo 39). These surface roots, directly beneath the sidewalk extend all the way toward the building.

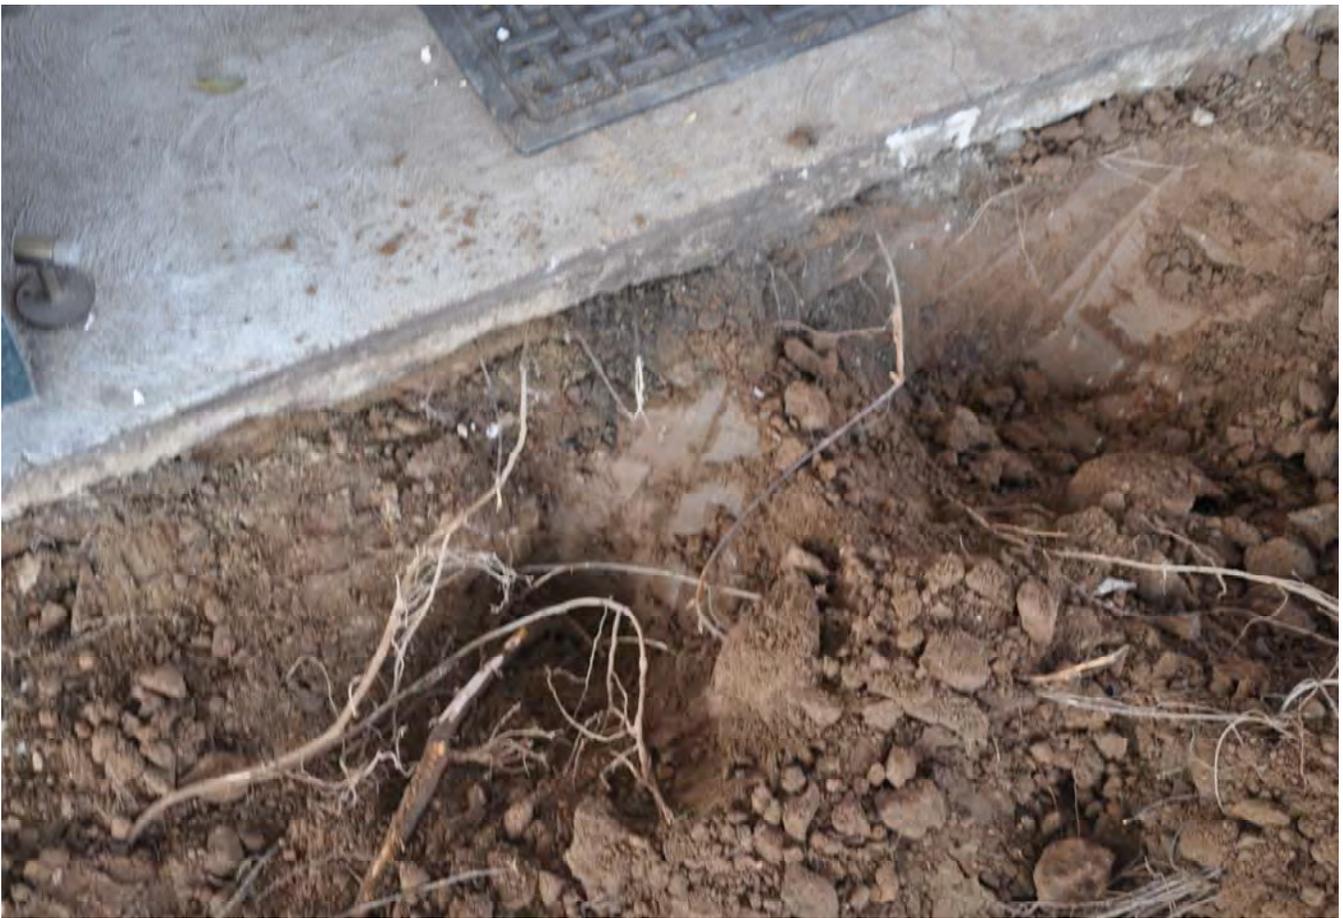
Photo 41

The general contractor had the Bobcat Jackhammer operator disturb the ground surface adjacent to the north front entrance a total depth of about 1 foot and a linear distance of about 7 feet (Photos 40, 41). We hand excavated deeper and along the disturbed ground to expose the slab edge and open up the disturbed ground (Photo 42). This work exposed a ¾-inch root and smaller roots going under the adjacent slab (Photos 43, 44). This slab appeared to be about 3½ inches thick and our metal detector did not indicate the presence of metal reinforcement (Photo 45). The general contractor did not want to excavate any further because he said that there is a gas line in the vicinity of this portion of the building.

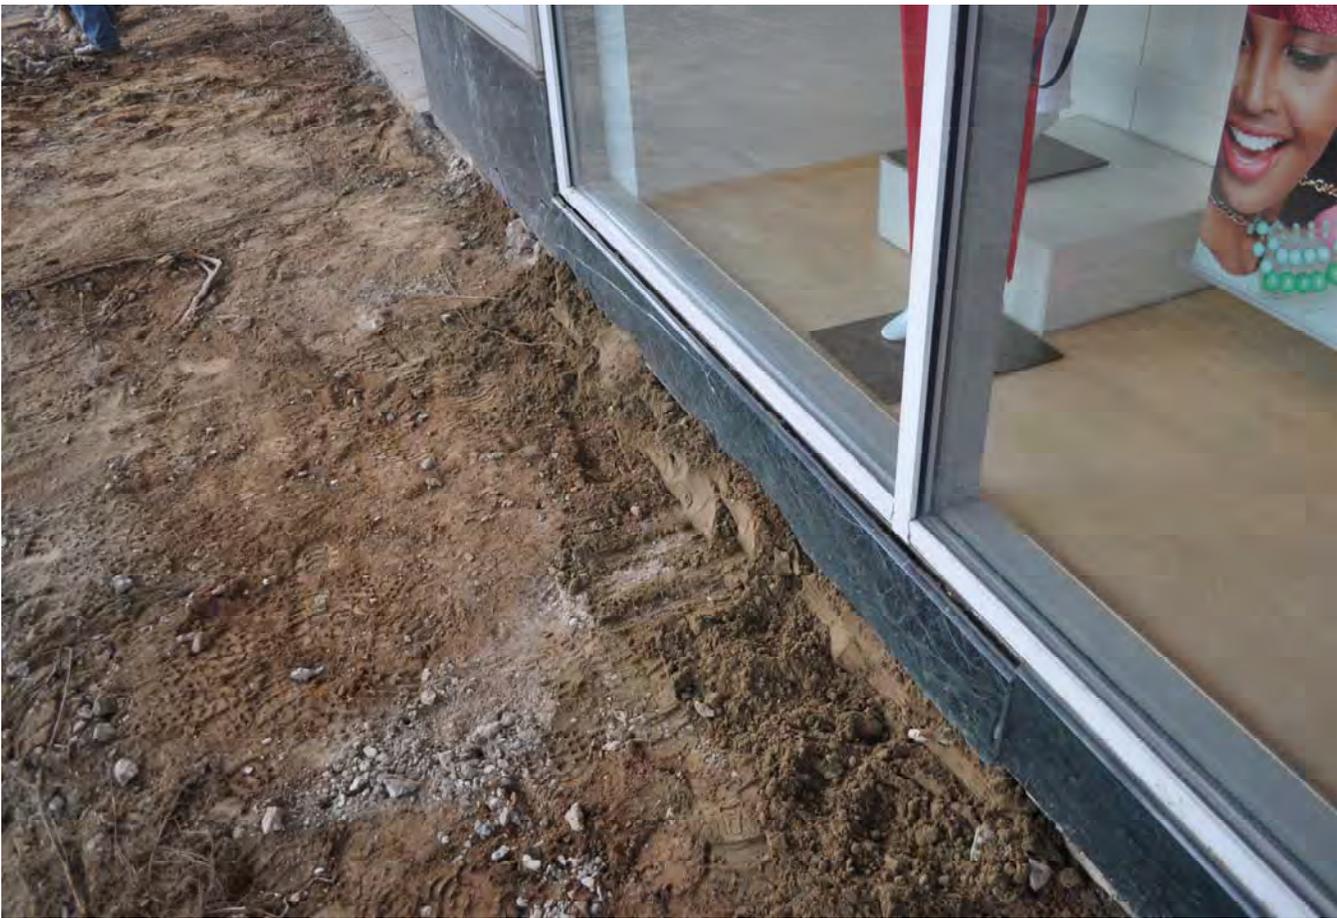
Photo 47

A significant number of surface roots were directly beneath the sidewalk between the middle and south trees (Photo 46). Removal of the sidewalk in between the south and middle trees resulted in detachment of a section of the marble facing (Photos 47, 48). Removal of the sidewalk showed that the sidewalk butted up against the cracked wall facing (Photos 49, 50) that was observed during our original site visit (Photos 51, 52). This confirmed that the growth of the south tree root mass most likely caused the compression damage to the sidewalk and likely pushed the

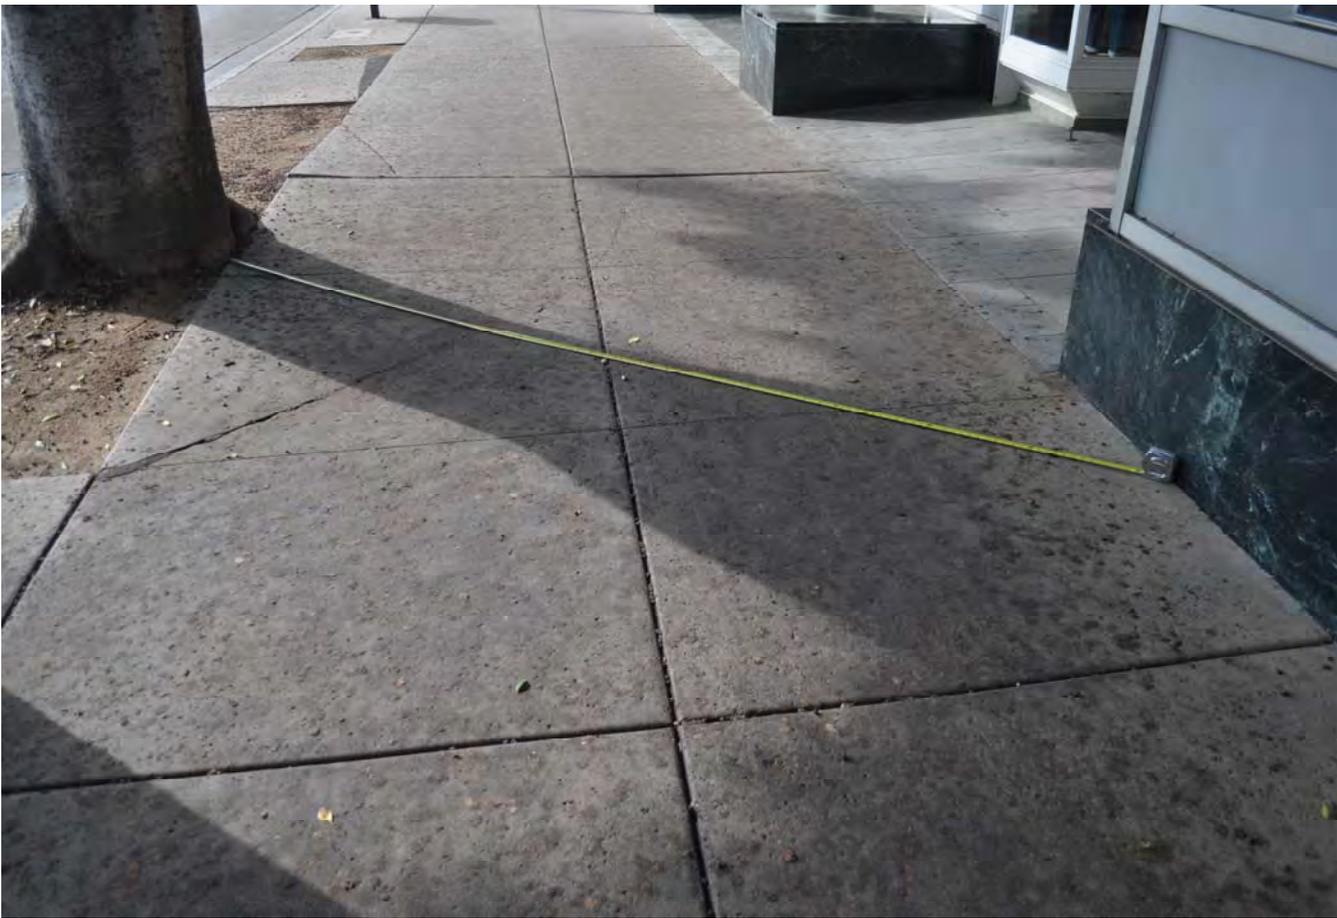
Photo 53

sidewalk northwestward and into the building facing (Photo 53). This may have been exacerbated by the growth of roots directly beneath this portion of the sidewalk (Photo 54).

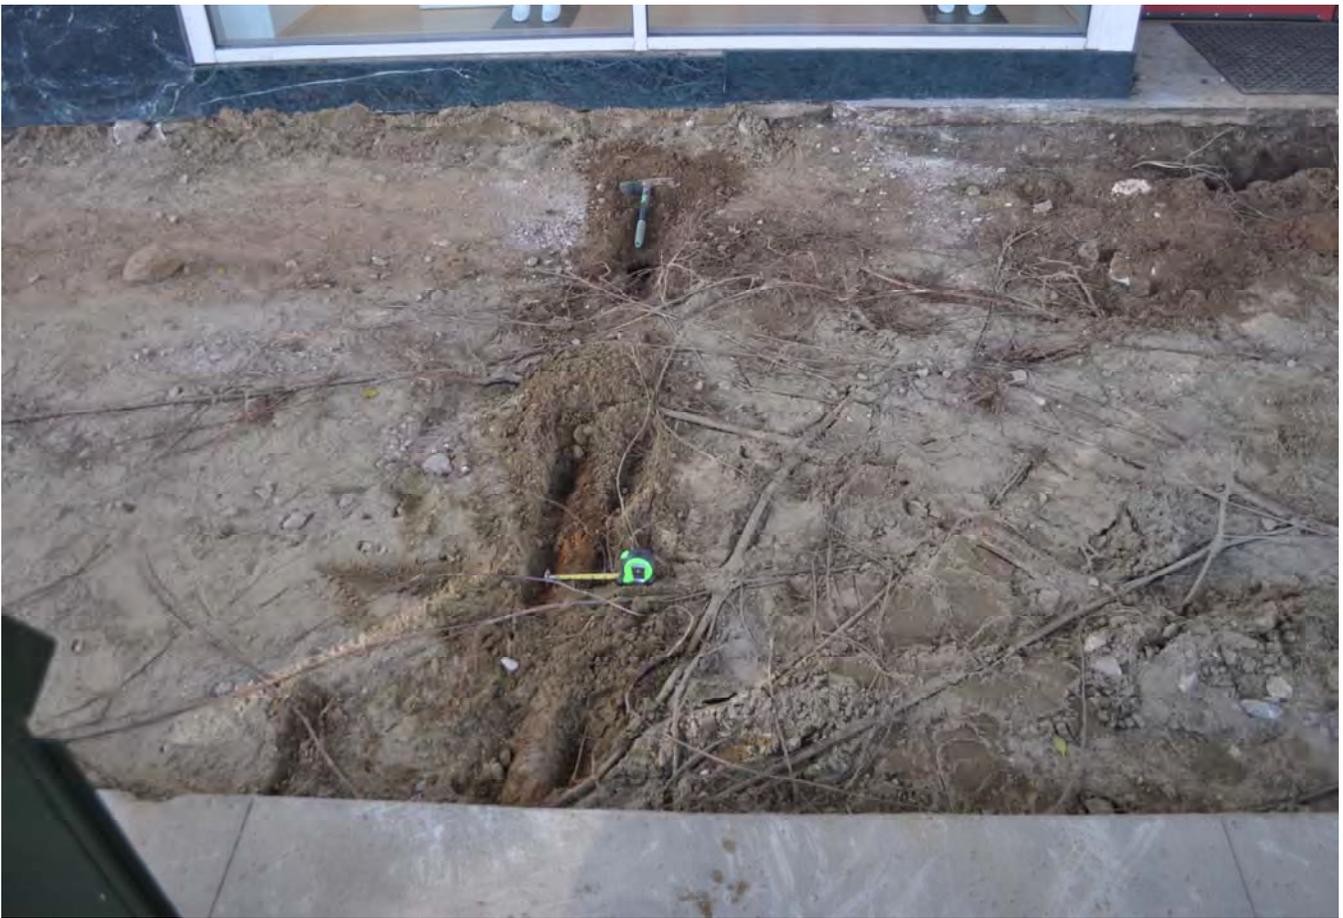
Photo 55

About 10 feet north of the south tree, a linear 3.5-inch diameter iron drain line extends from the building toward the street (Photo 55). The outlet for this pipe is complete blocked with debris/soil (Photo 56). A section of this pipe was broken and roots were visible inside (Photo 57). There is no indication that this drain line is connected.

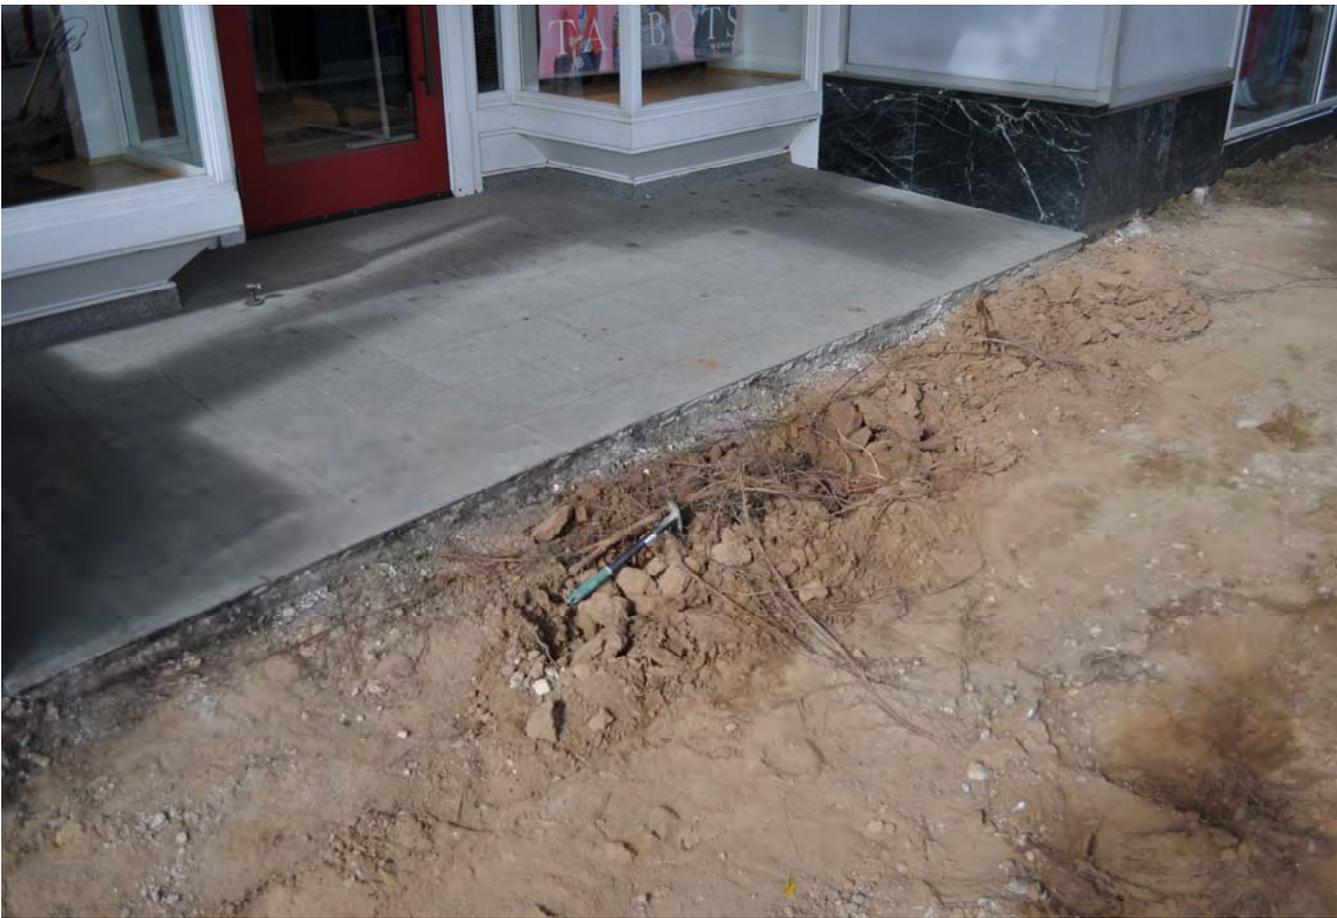
Photo 59

The general contractor disturbed the ground surface adjacent to the front entrance slab of the south building entrance (Photos 58, 59). The disturbance was about 0.5 to 1 foot deep and about 12 feet long. We hand excavated deeper and exposed a root about 5 to 6 inches in diameter about 4 feet south of the north end of the entrance slab (Photos 60 - 65). Several smaller roots splayed off the larger root (Photo 66). Mr. Kenny Graham, City of Pasadena Forestry Supervisor, had a couple of City personnel excavate around these roots and dig slightly deeper (Photos 67 - 69). It was discovered that the 5 to 6-inch thick root turns down into the ground and it is not known where it goes (Photo 70). The small roots were observed to have grown into the slab/footing edge of the entrance slab and then turned away. It was discovered that the entrance slab edge/footing is at least 14 inches deep at this location (Photo 71), with an apparent separate pour of 5-inch thick slab/tile installation on top. Our metal detector indicated the presence of metal reinforcement in this slab, possibly rebar.

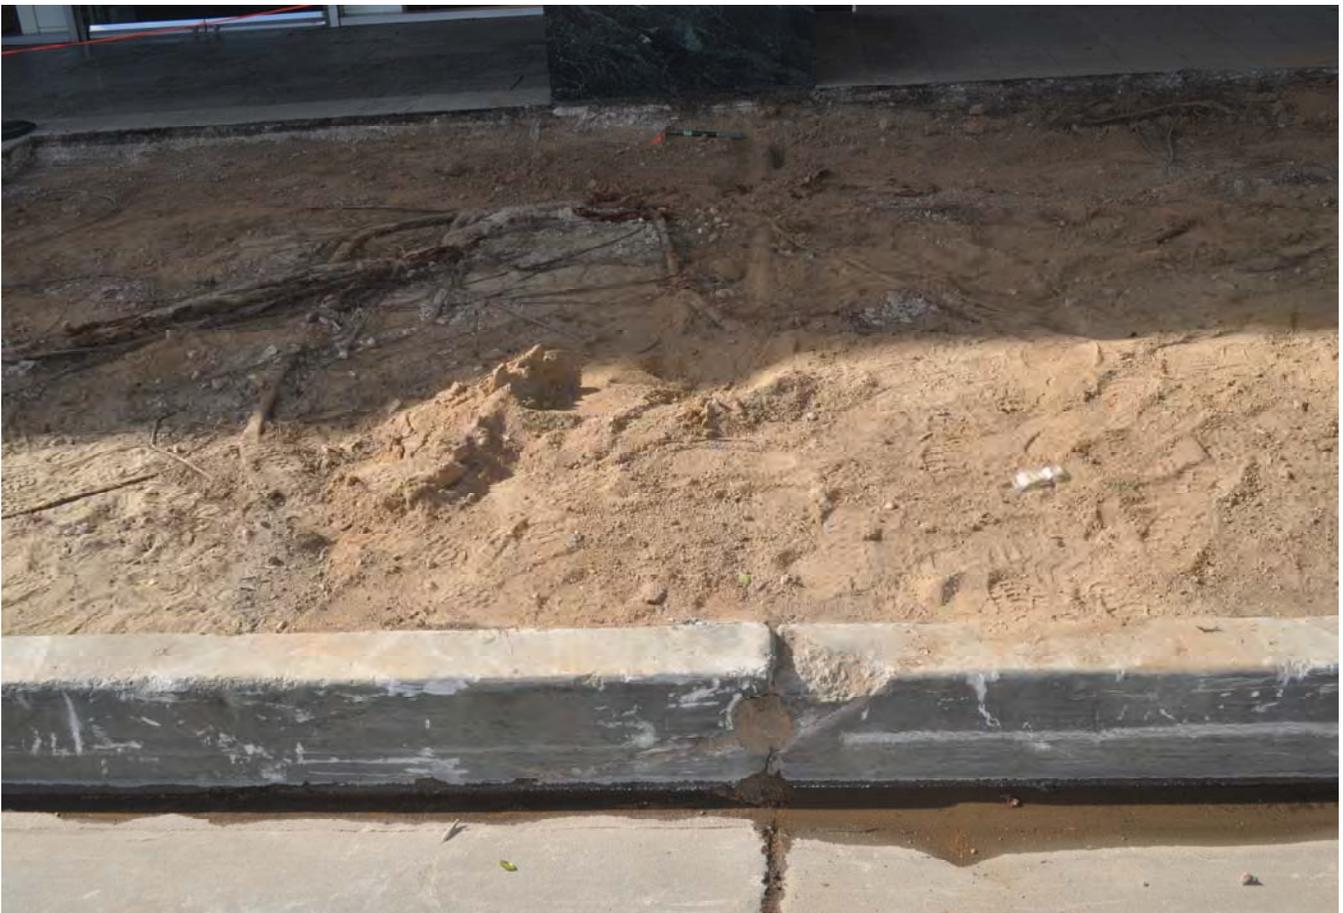
Photo 72

About 10 inches south of the south entrance slab is a 4-inch diameter cast iron drain line that trends east to an outlet at the street (Photo 72). The outlet is completely filled with soil (Photo 73). Near the building the pipe was found to be abandoned and filled with soil (Photo 74).

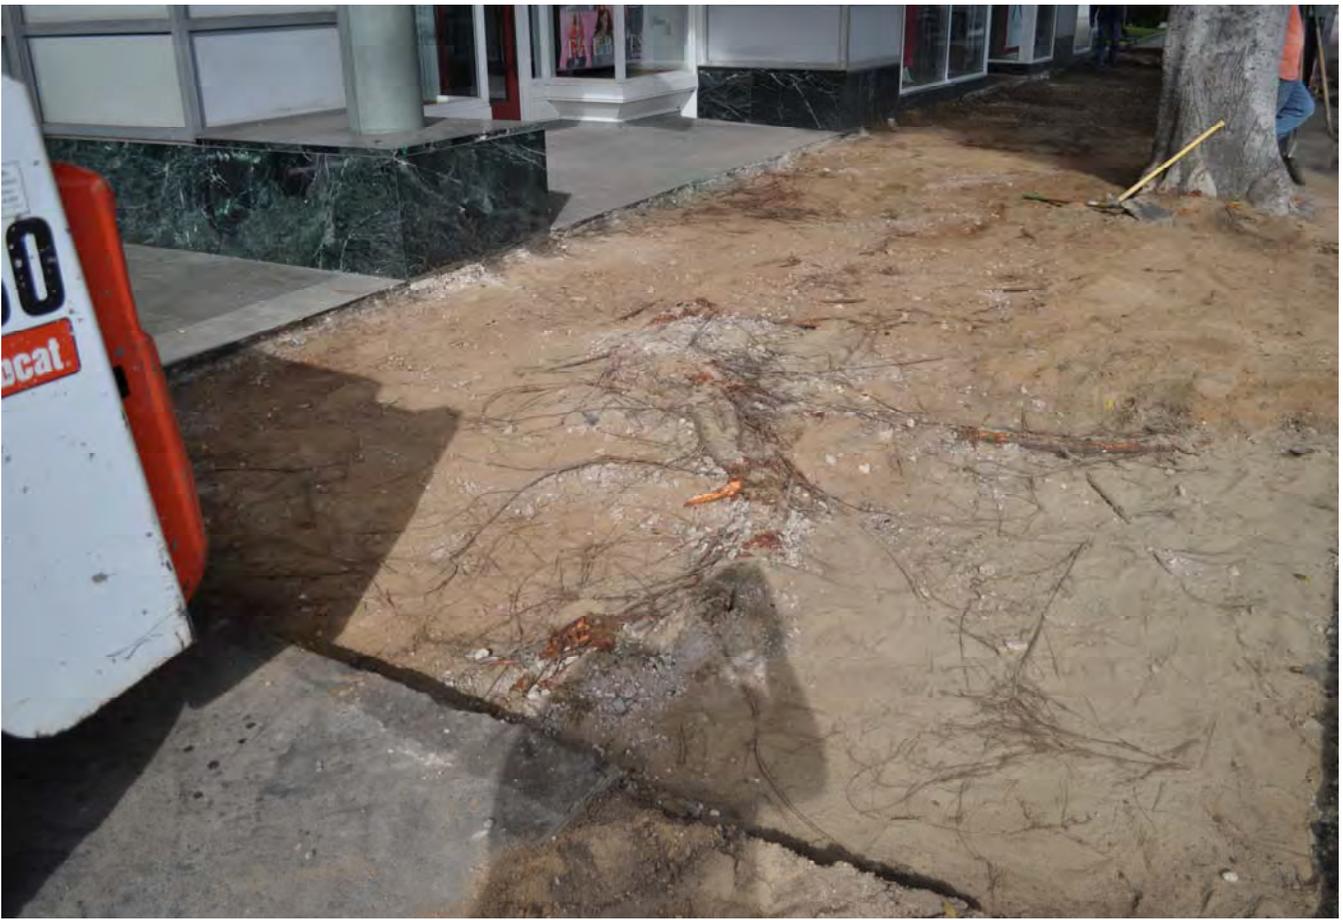
Photo 75

Beneath the south end of the sidewalk removal (Photo 75), large root(s), typically 4 to 4.5 inches in diameter extended to the south from an area between the south building entrance slab and the south tree (Photos 76 – 78). This tree root system extends at least 21 feet from the tree and continues beneath the remaining sidewalk with a root diameter of about 3 inches (Photo 79).

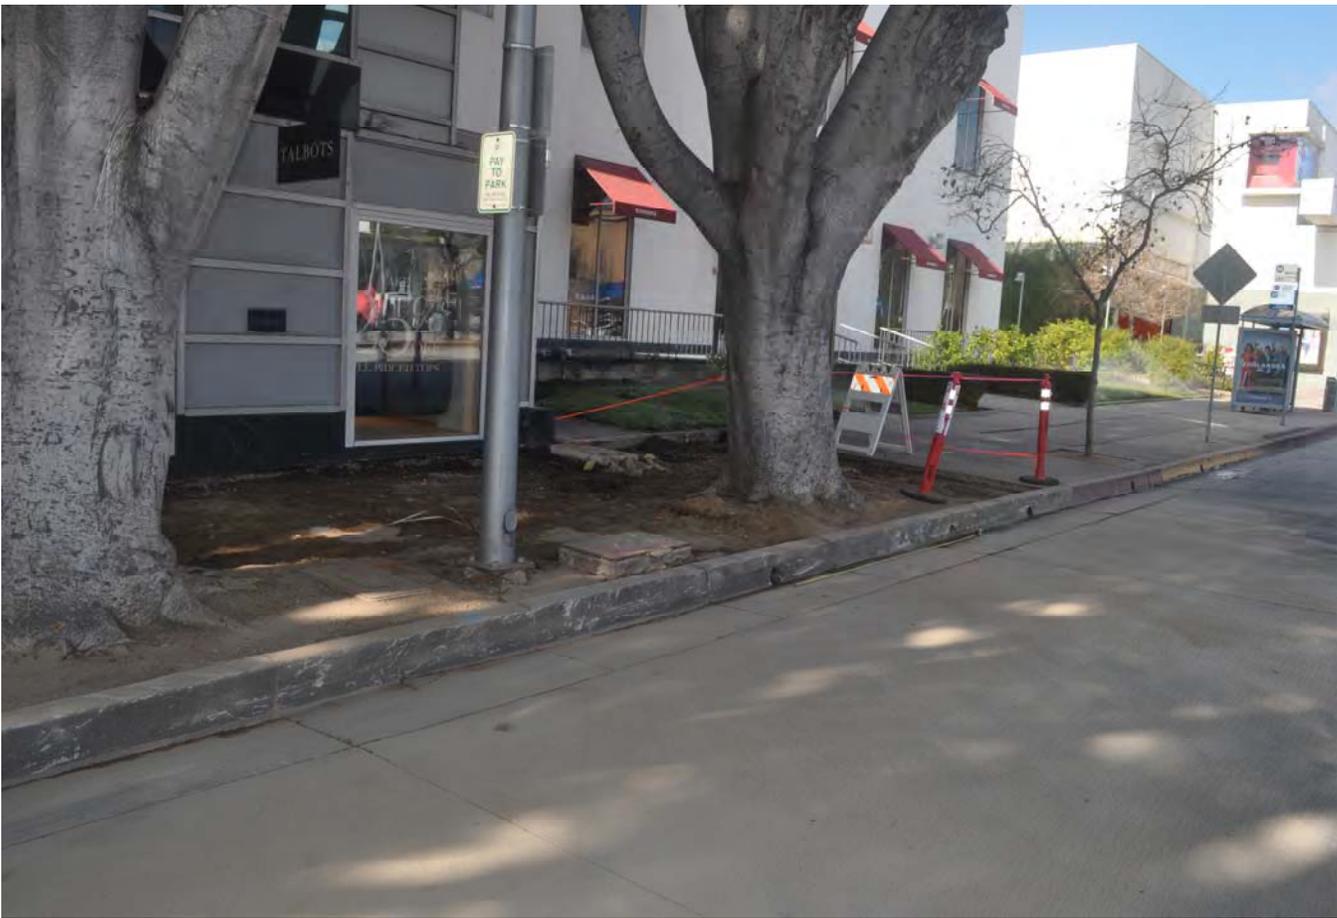
Photo 81

The trees and roots adjacent to the curb and street are massive (Photos 80 - 83) and the curbs have apparent long-term heave from continued growth of the three ficus trees (Photos 84 and 85).

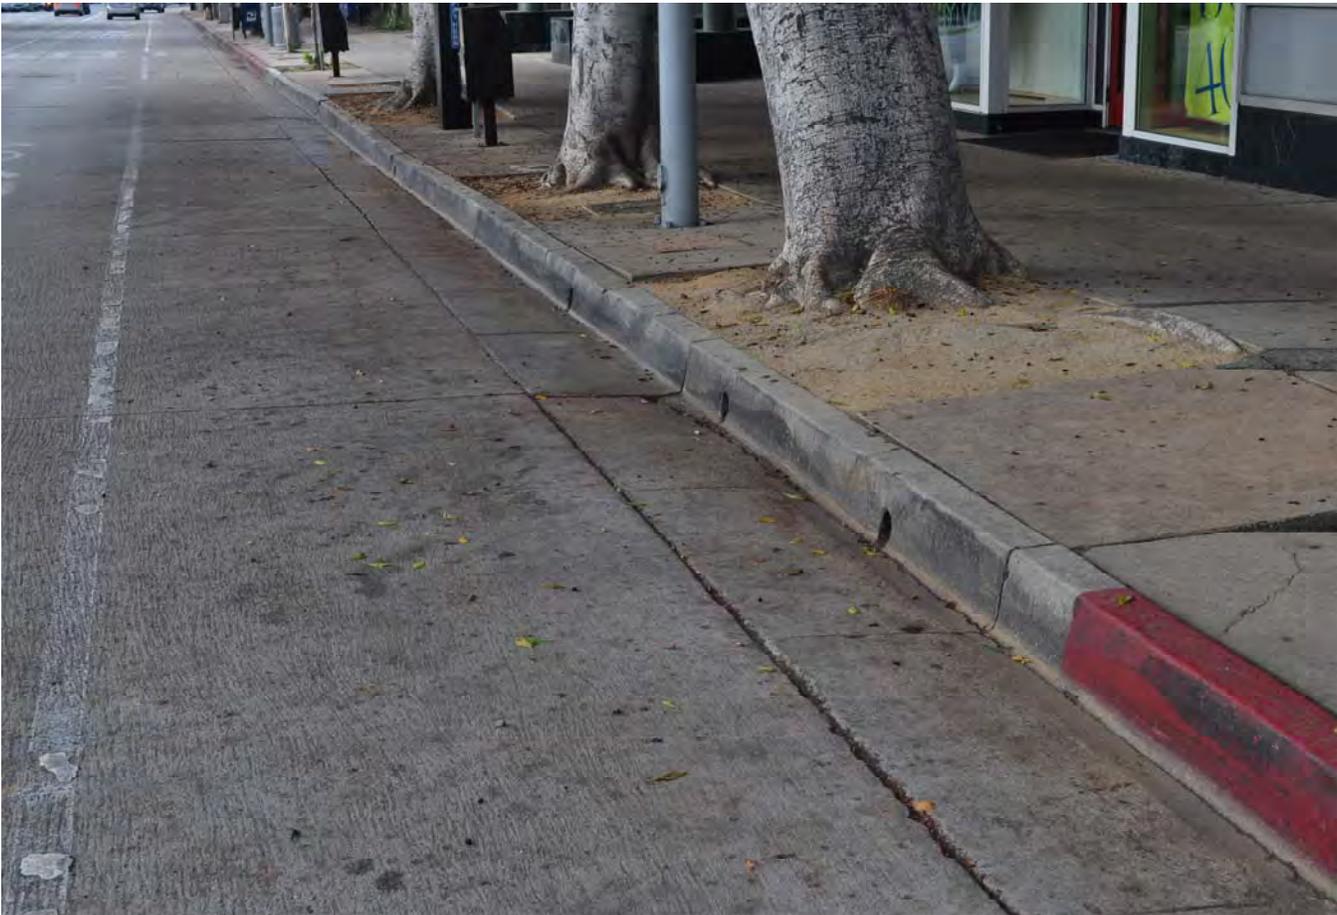
Photo 85

- Apparent uplift of the curb adjacent to the subject trees indicates that the tree roots are growing beneath and heaving the curb and under the street. Ongoing uplift of the curb and heave of the sidewalk will likely continue to result in distress in front of the building.
- Based on these findings, it is our opinion that if the trees are not removed the subject tree roots will continue to grow beneath the subject building, the sidewalk and the street. Ongoing growth of the tree roots will continue to damage these structures and will continue to harm the drain lines of the building and neighboring property.
