Re: Application for Tree Removal and/or Permit to Remove Trees at 497-511 South Lake Avenue

Purpose of this Report: To evaluate existing damages to the structure and the extent of damages resulting from three overgrown ficus trees adjacent to the property.

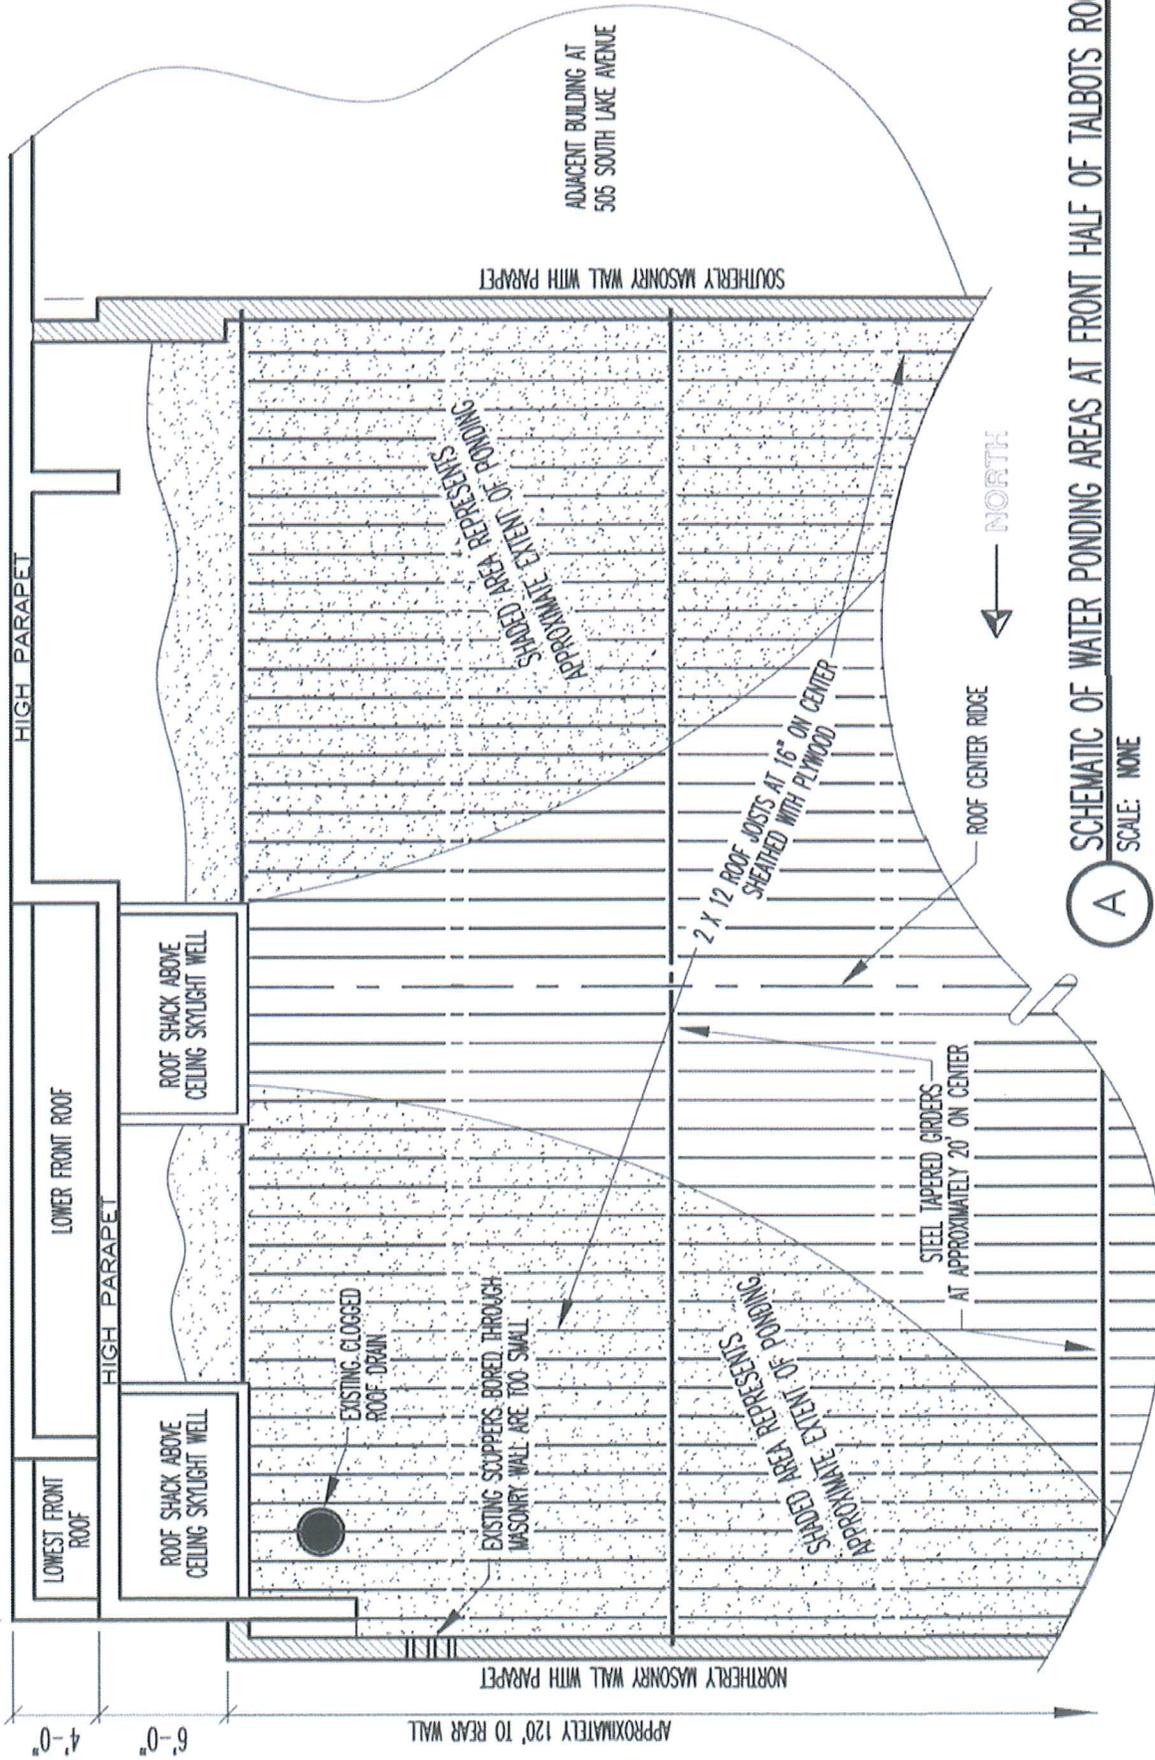
A SCHEMATIC OF WATER PONDING AREAS AT FRONT HALF OF TALBOTS ROOF
SCALE: NONE

Based upon observed parapet heights, we estimate that, at the very least, 1'-6" of water will pond at the buildings two front corners before it begins to run over the central high point of the roof (Figure 12).

- Because the roof drainage is blocked and water ponds on the roof. It is our opinion that at least at the two front corners of the Talbots building, there exists a danger of roof collapse during roof water ponding events as these cause serious bending overstress of the 2x12 roof joists below.

At the very least tree limbs should be cut back, clear and away, from the front of the building so that no branches overhang the roof. To prevent further sidewalk and building damages, tree removal will be required.

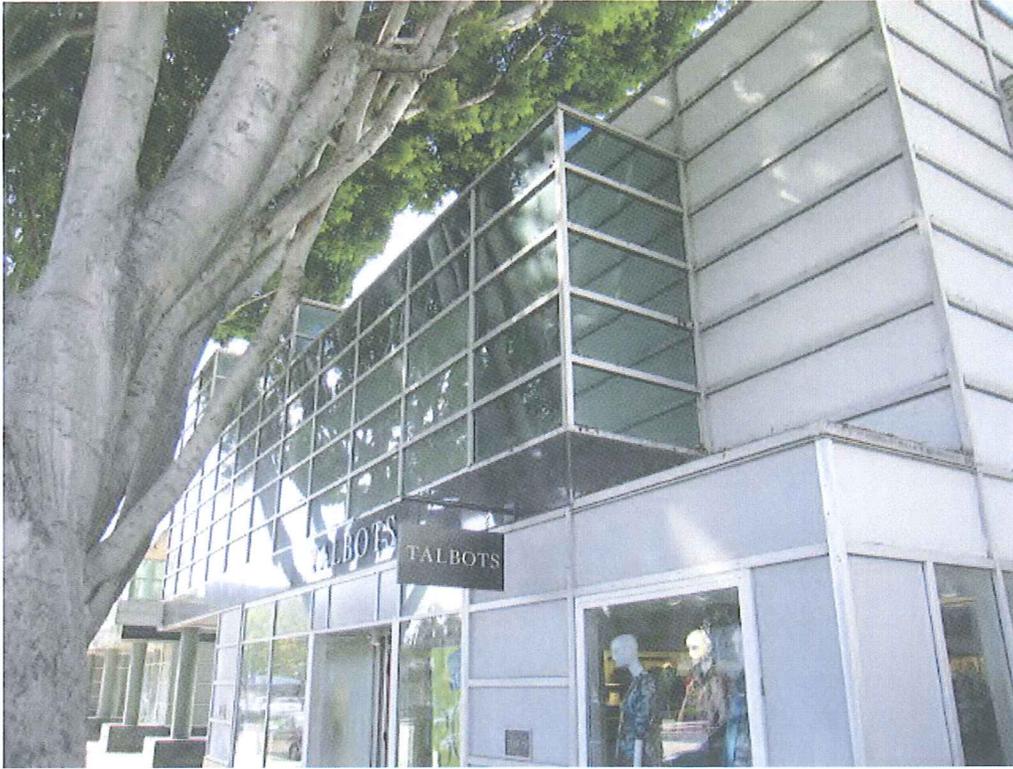
Photo 3

At the front entry area of the building are two small, lower roofs above the storefront aluminum and glass structure (Photos 3, 24 & 25). These have their own parapets and become filled with tree debris. The upper small roof drains back onto the main roof through a scupper (Photos 26 & 27), which when clogged by the debris will cause it to reservoir approximately a foot of water.

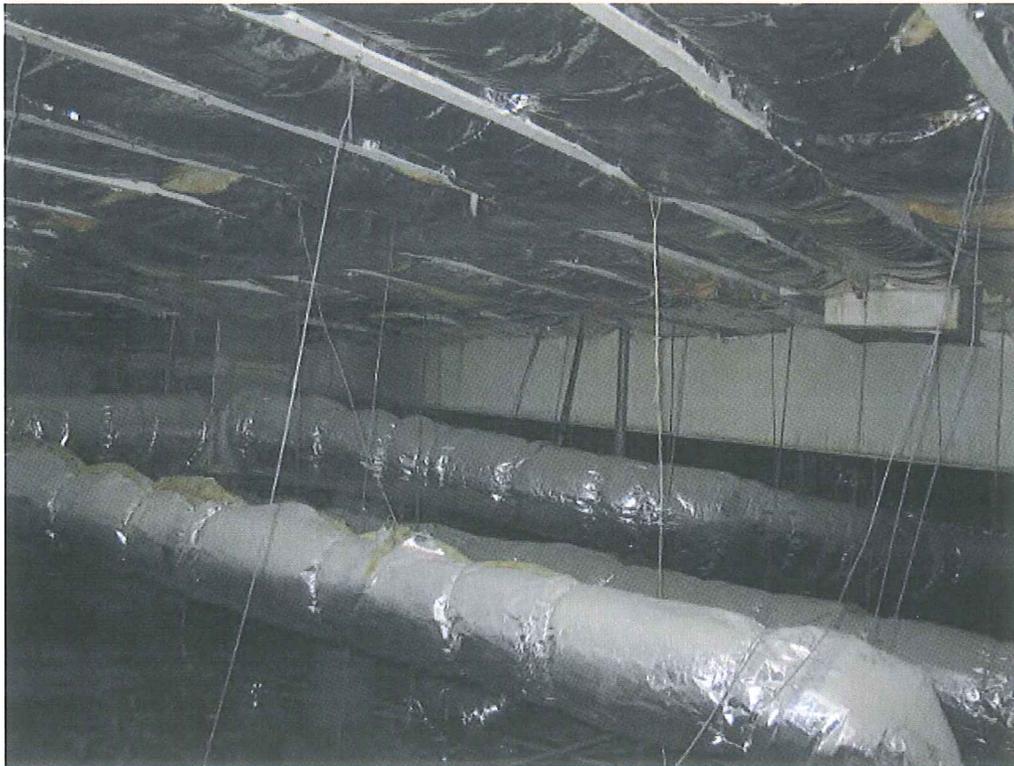
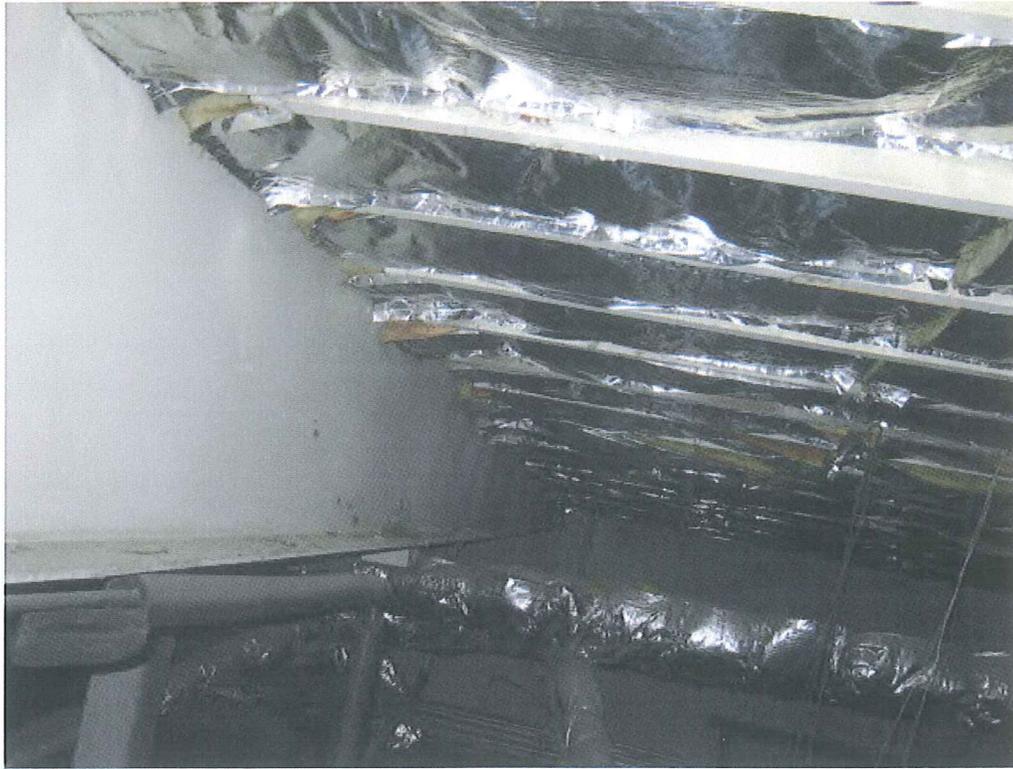
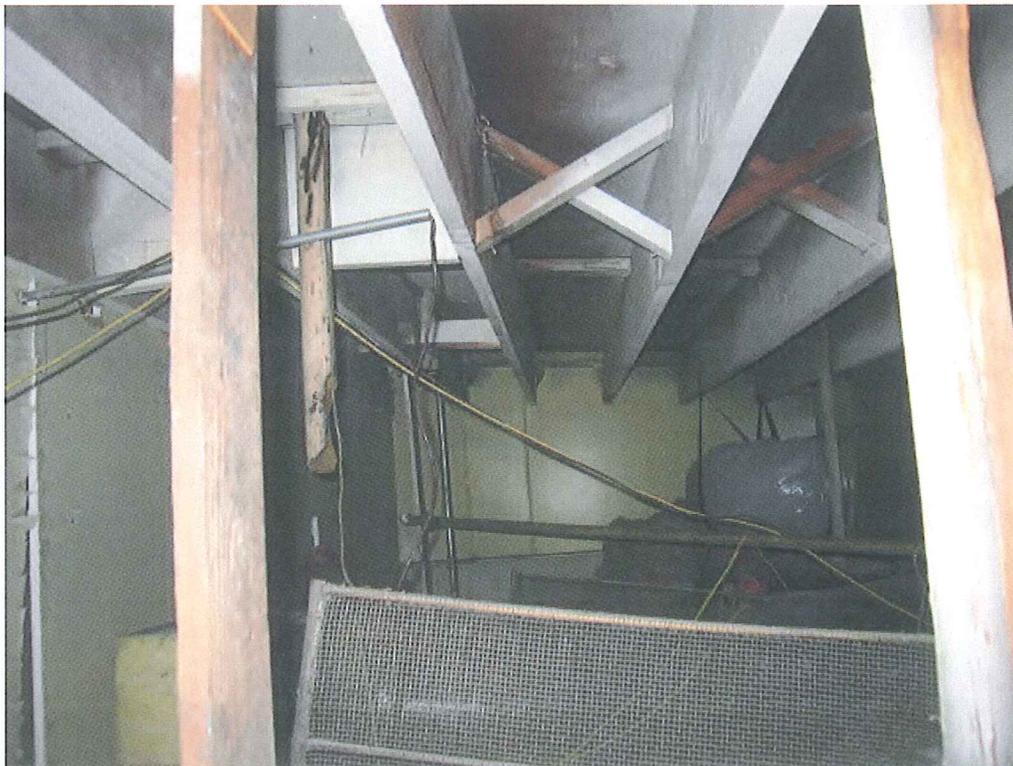
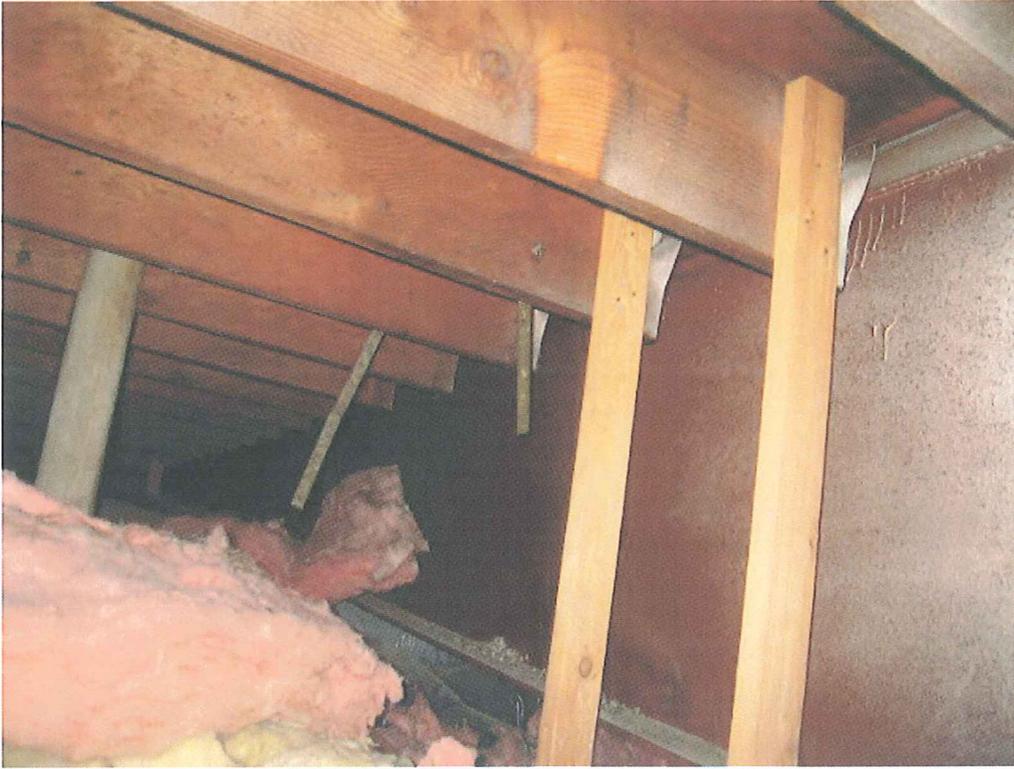
The roof structural system was observed from within the attic (Photos 8, 9, 10 & 11). Access was limited to a small area above the rear of the building due to fire separations as seen to the left in (Photo 10).

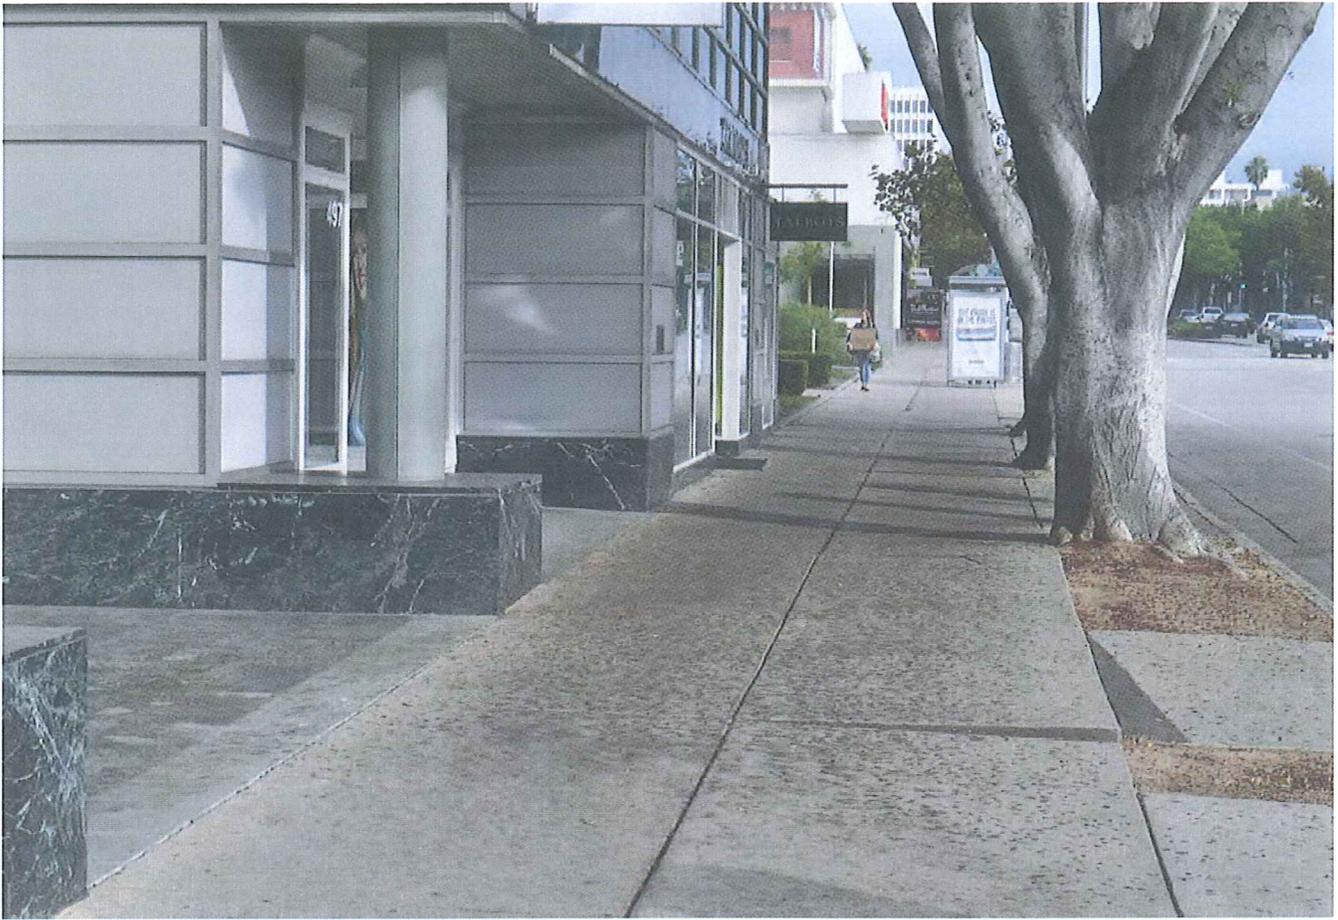
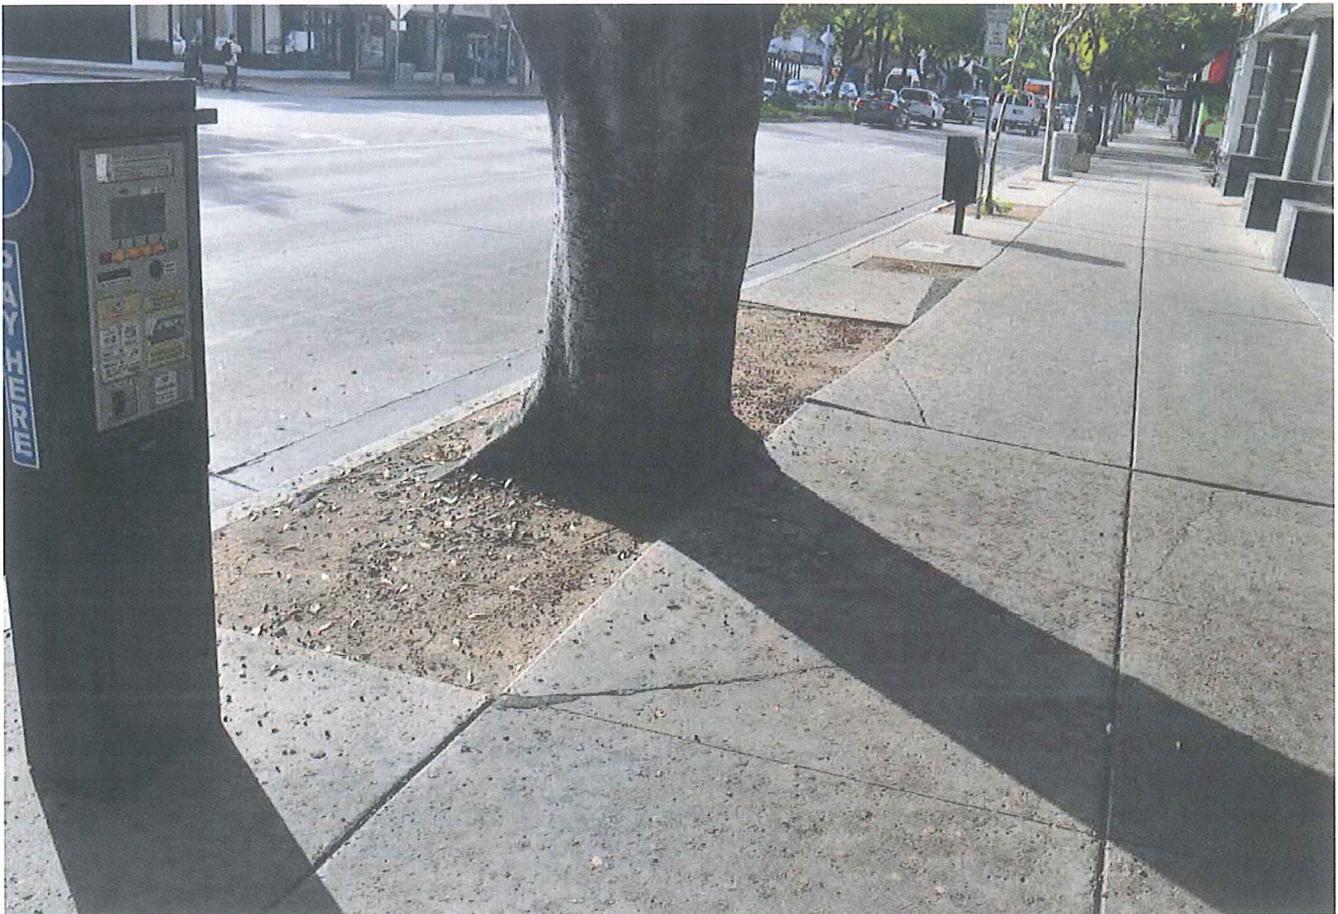
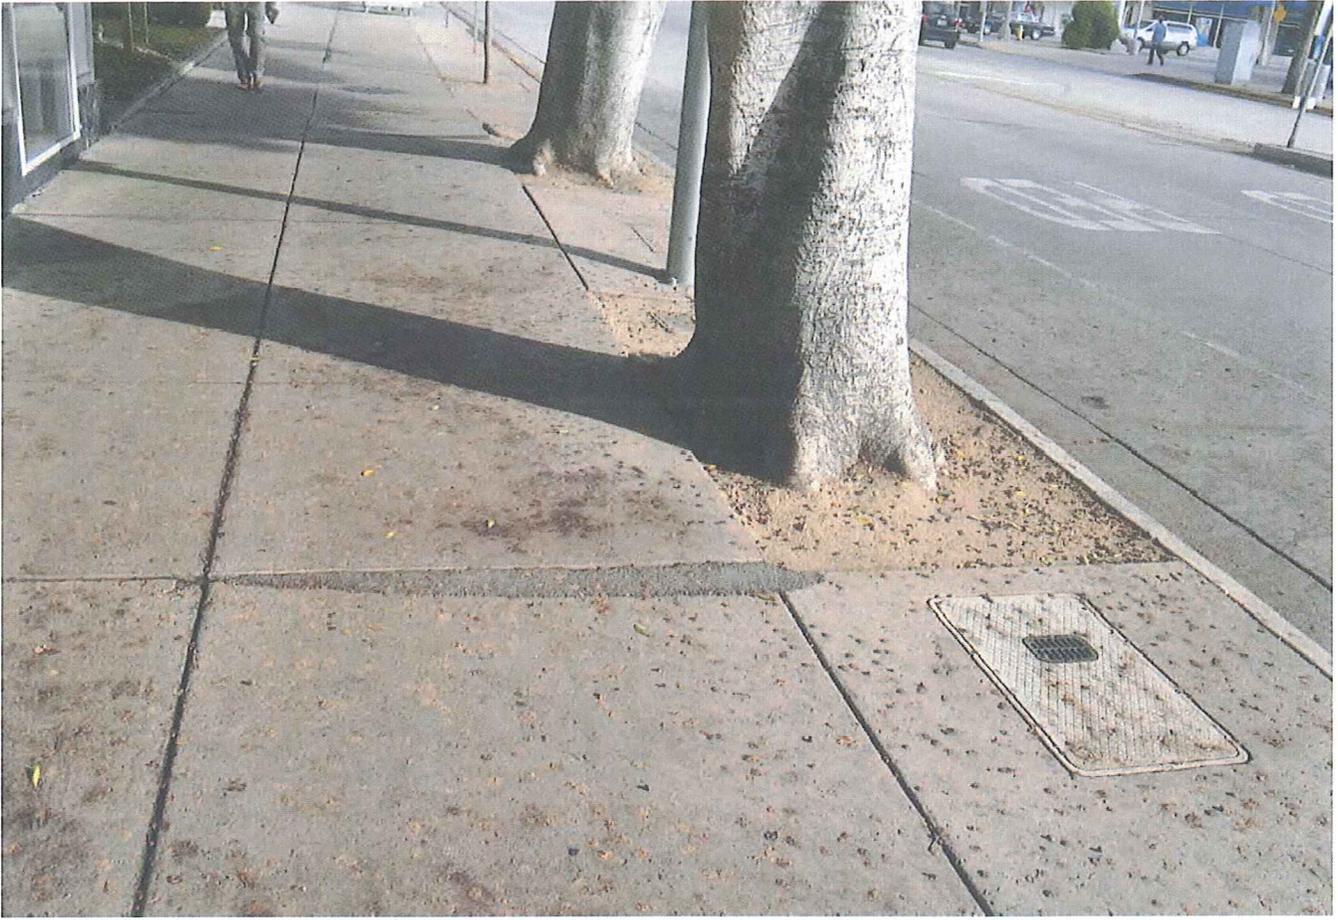
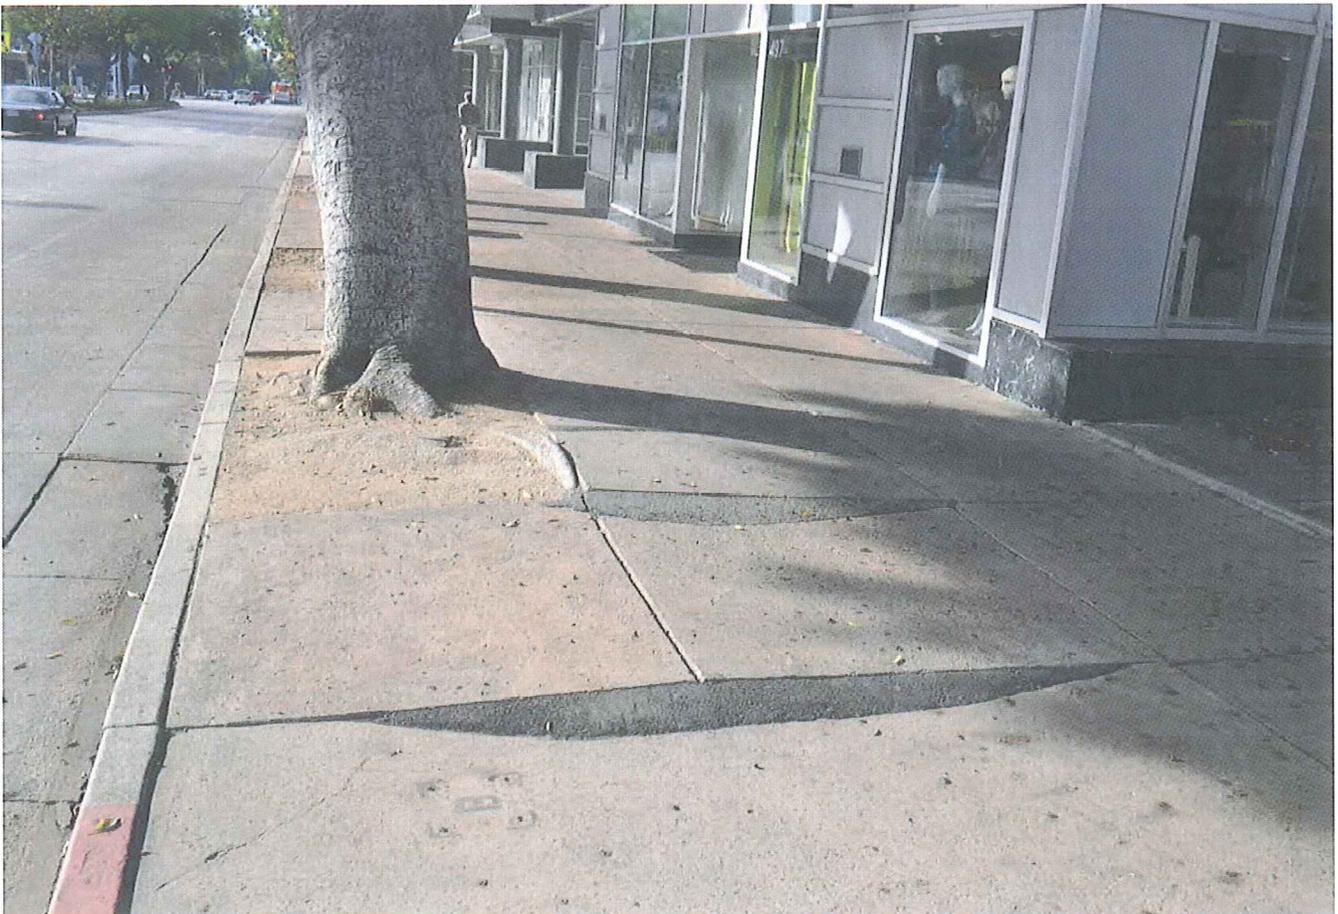
The front sidewalk concrete is heaved up and fractured by large tree roots (Photos 30 through 33). The crack locations and damage pattern are associated with growth of the subject tree roots. This action is destroying the sidewalk and causing raised edges and out of level surfaces resulting in a pedestrian trip hazard. The vertical offsets in the sidewalk have been patched at several locations, in an apparent attempt to reduce the trip hazard associated with the offsets (Photos 34, 35 & 36). Some of the vertical offsets are up to 2 inches.

- The tree roots have caused significant uplift and crack damages to the sidewalk and possibly damage to the concrete slab in front of the north entrance.

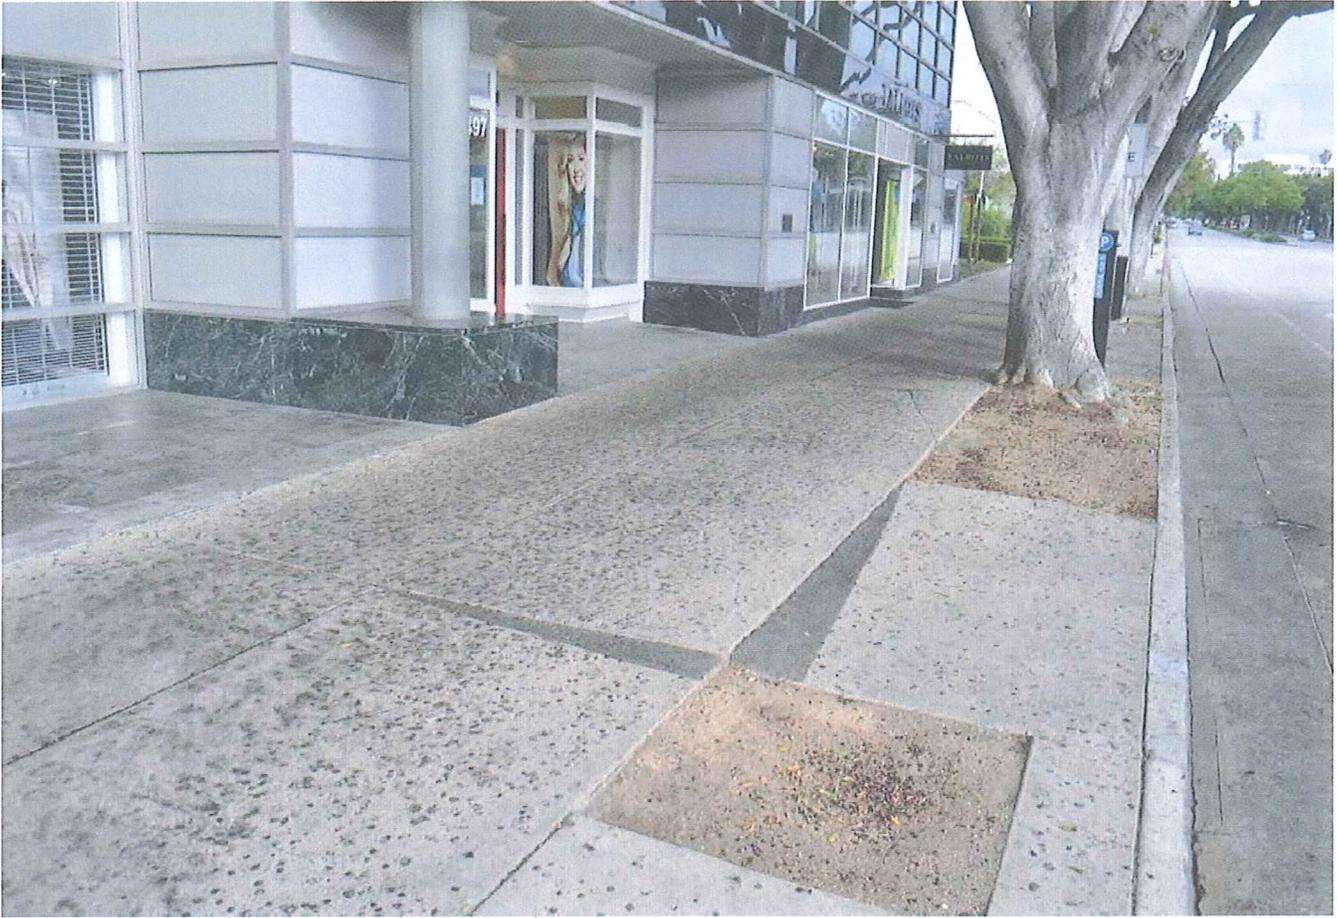
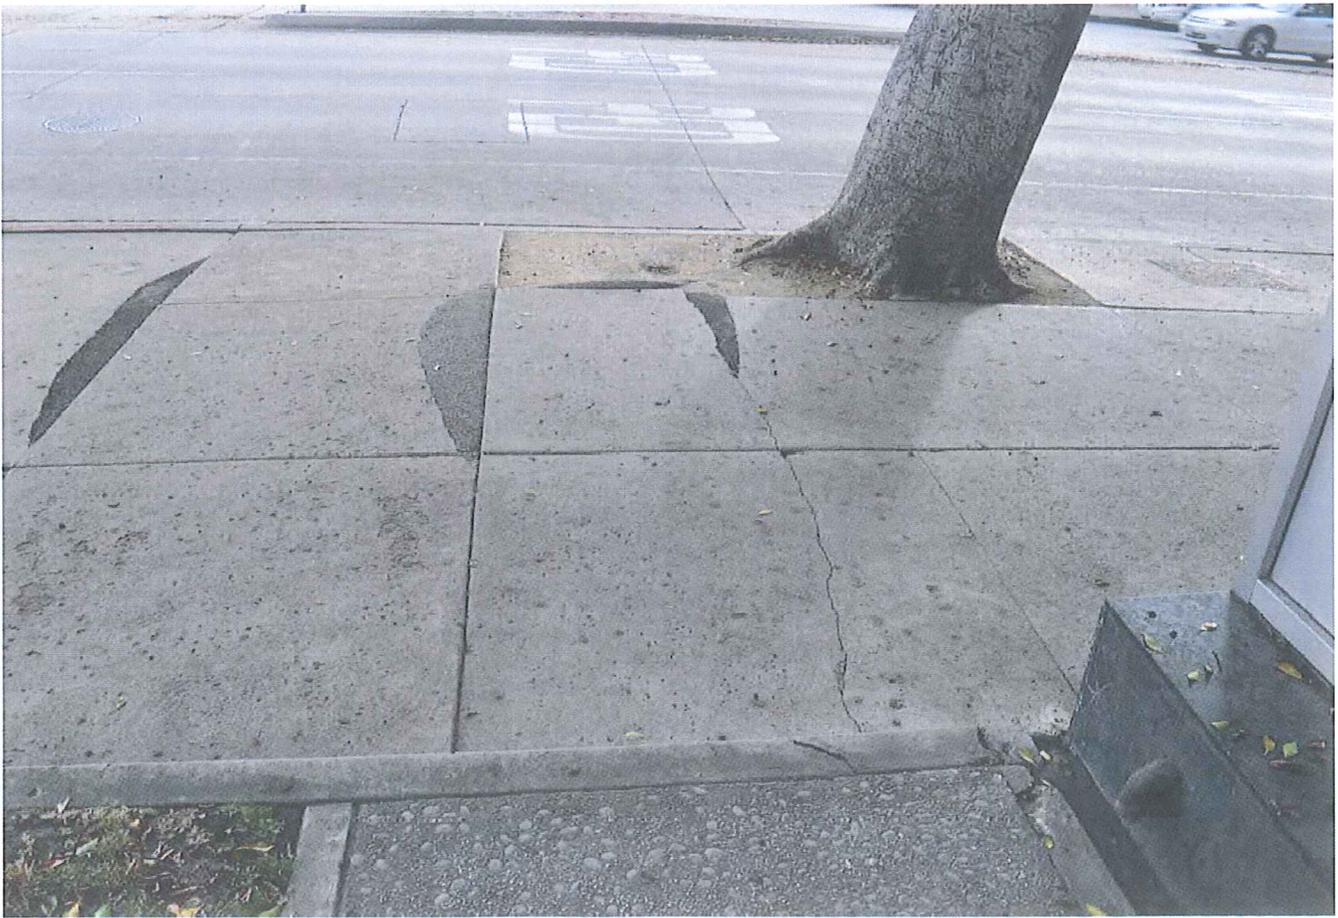
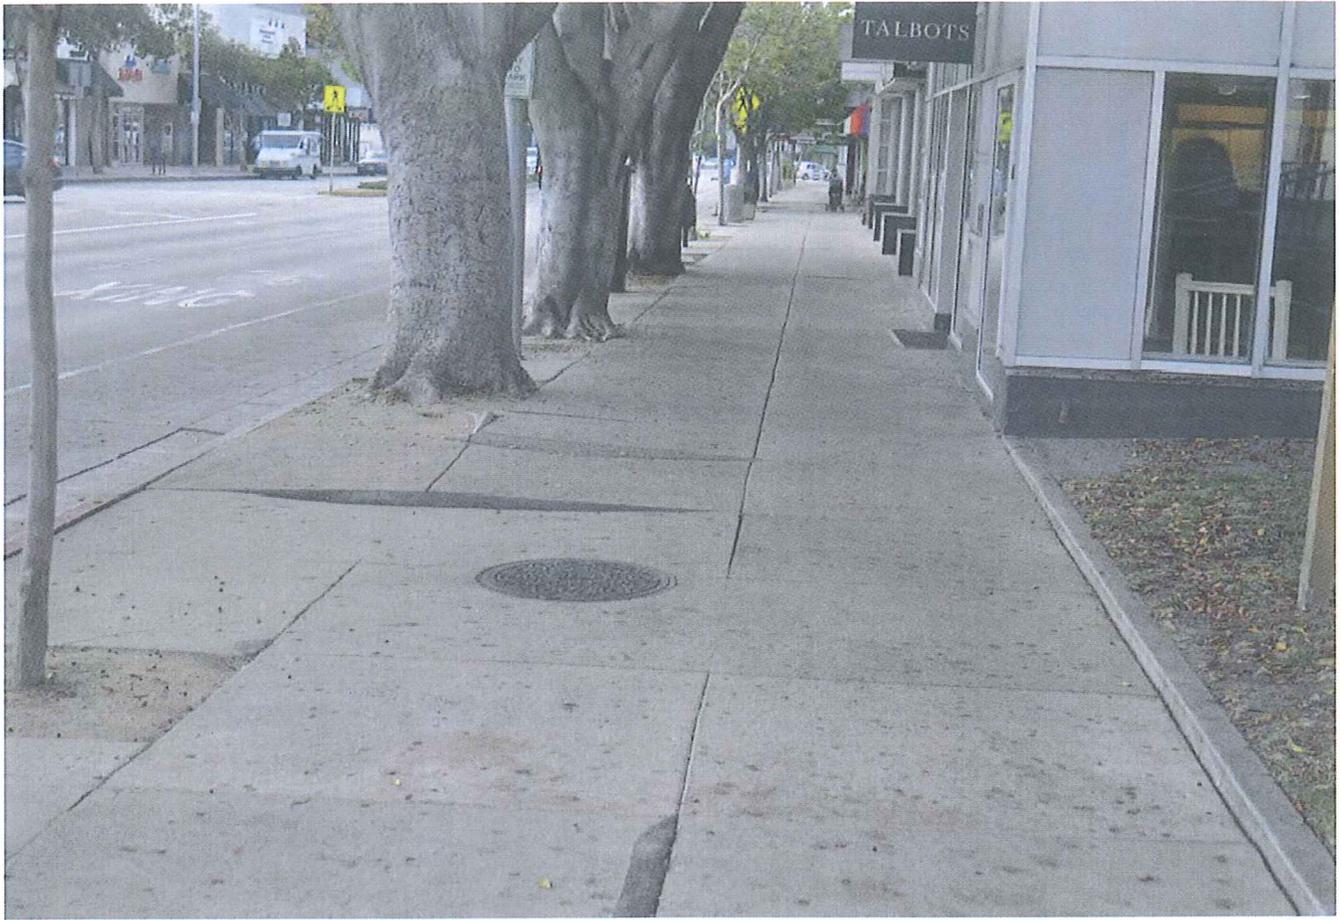
- Tree root uplift of the sidewalk has resulted in distress and crack damage to the architectural serpentine stone finish near the south entrance.
- The uplift and sidewalk panel offsets create an unsafe condition for pedestrians and retail patrons.

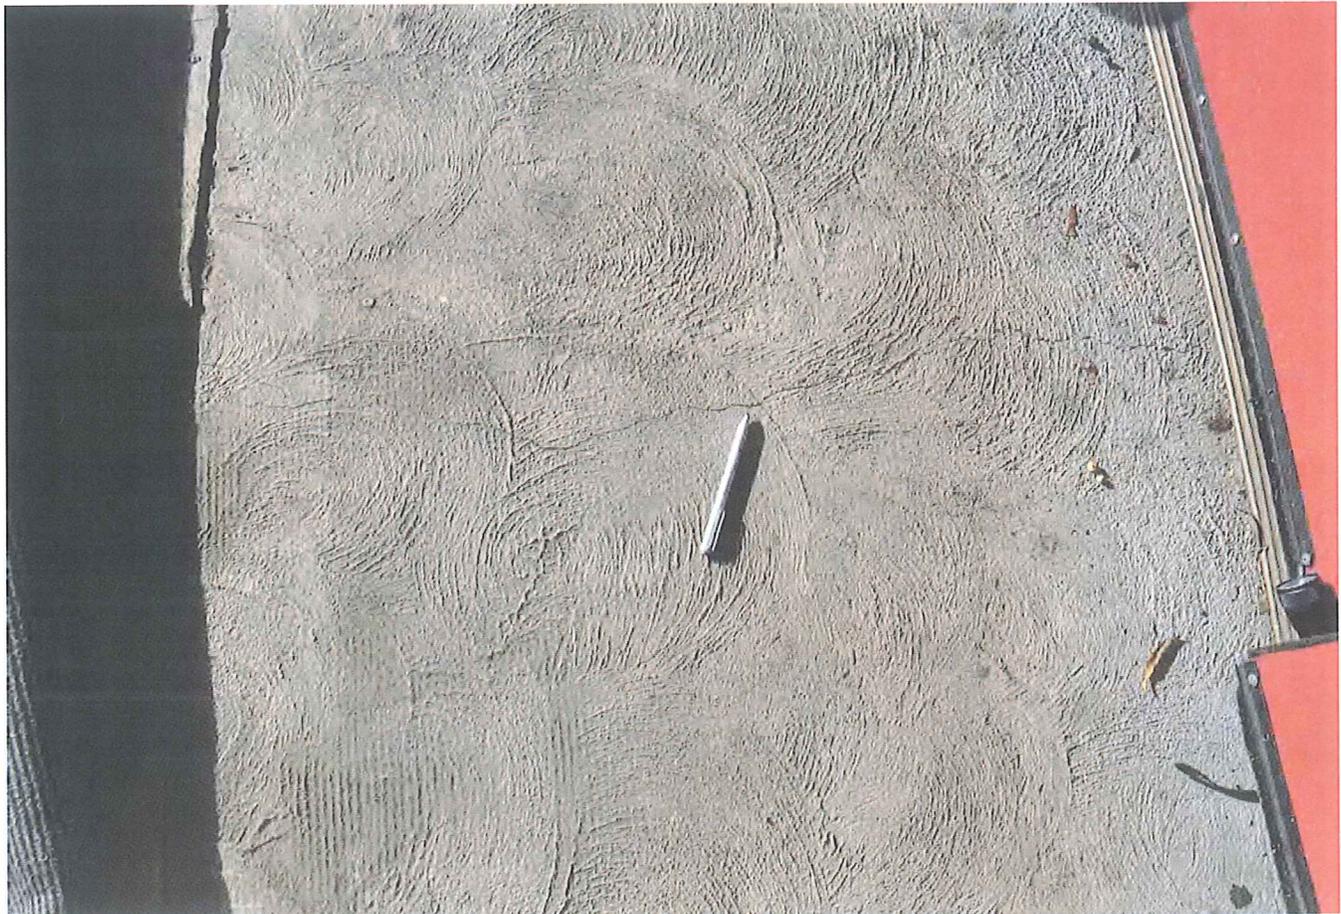
Photo 37

At the north store entrance, we observed a west-trending 1/64-inch wide crack in the concrete slab that is a separate pour of concrete from the sidewalk (Photo 37). This crack has some worn edges indicating that it has likely been present for some time. This crack is consistent with being a concrete shrinkage crack that developed during original concrete curing. However, it cannot be ruled out that this crack is caused or worsened by tree root growth under the slab.

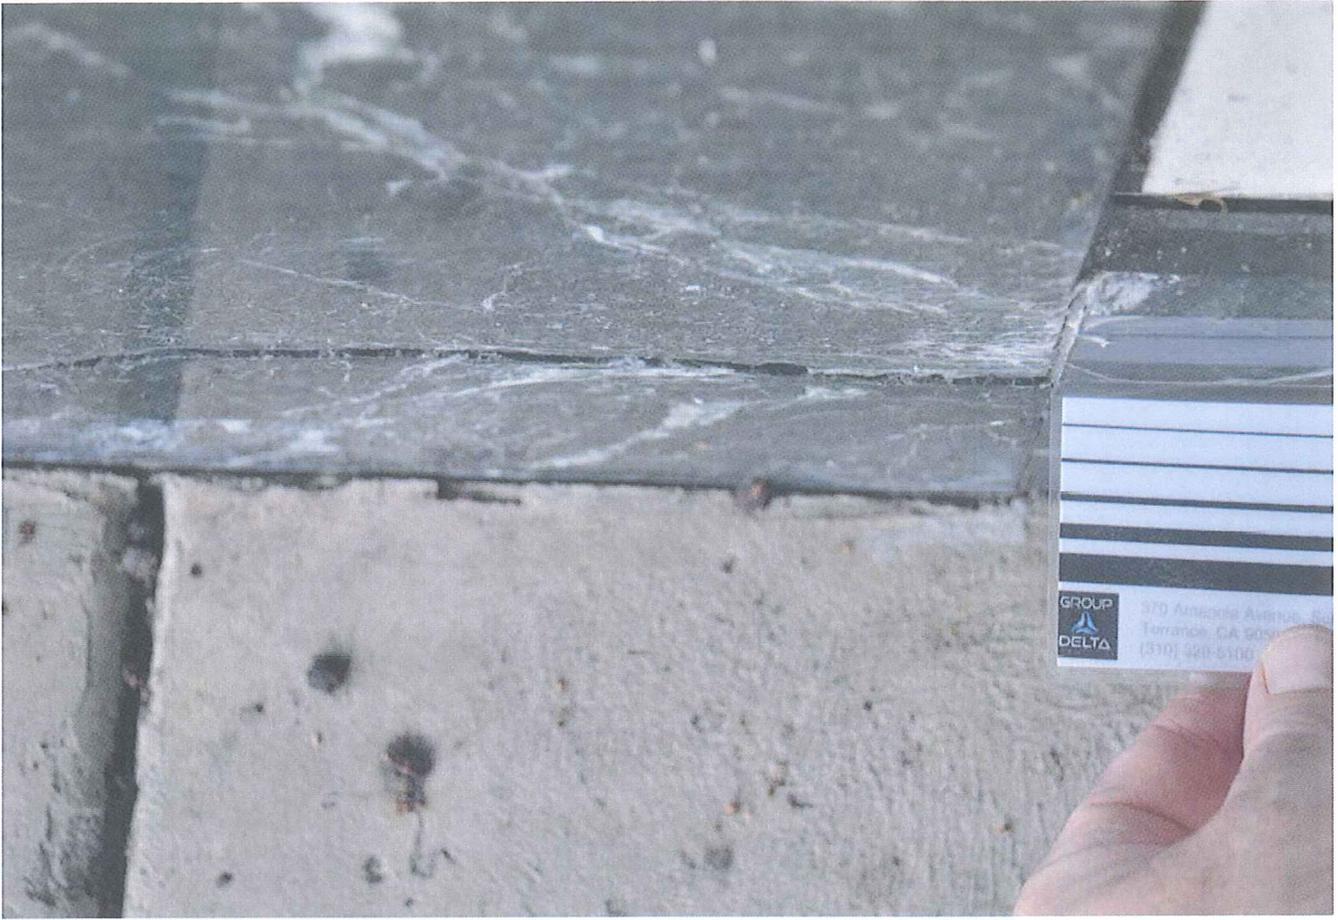
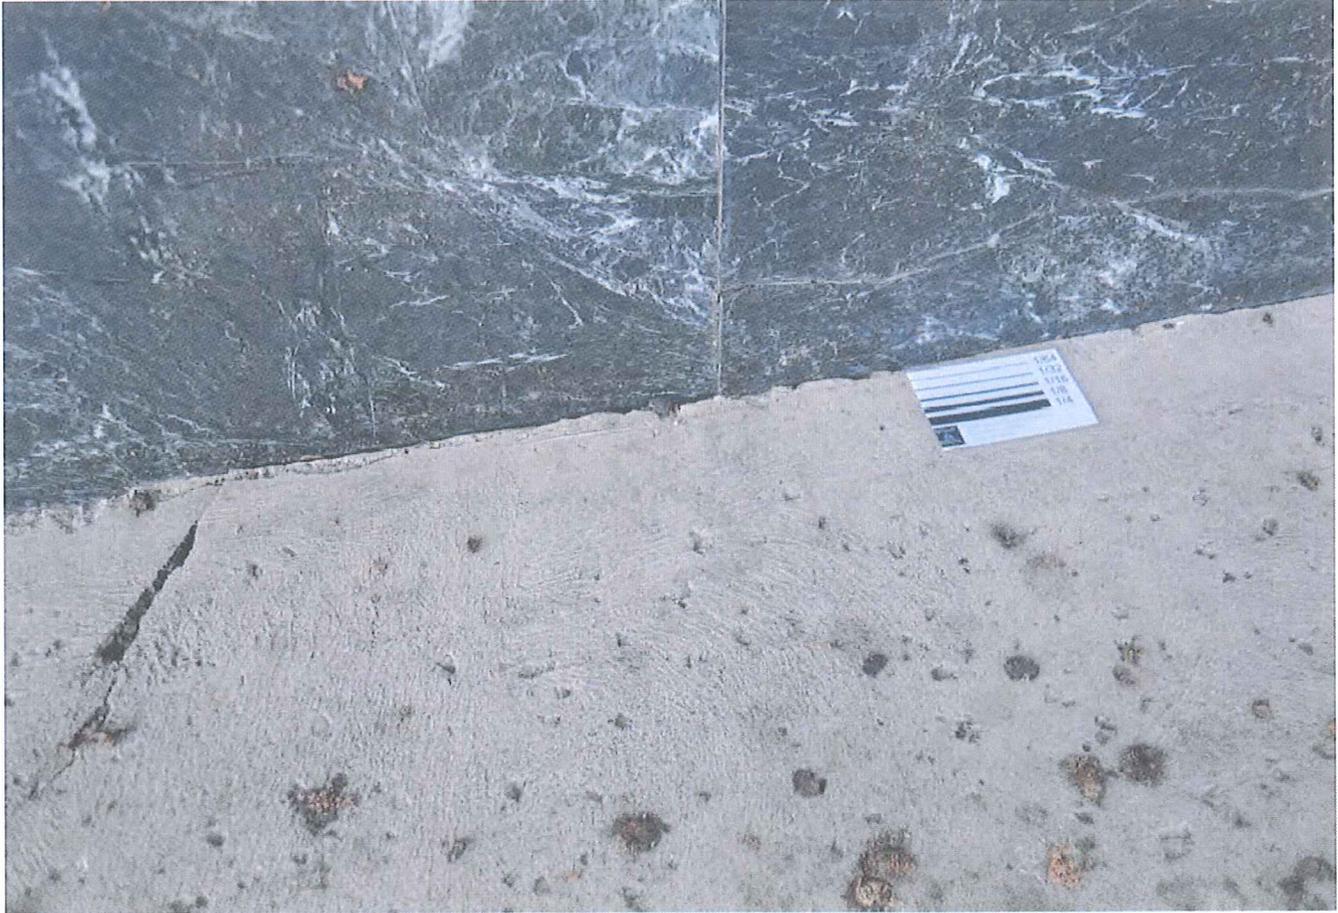
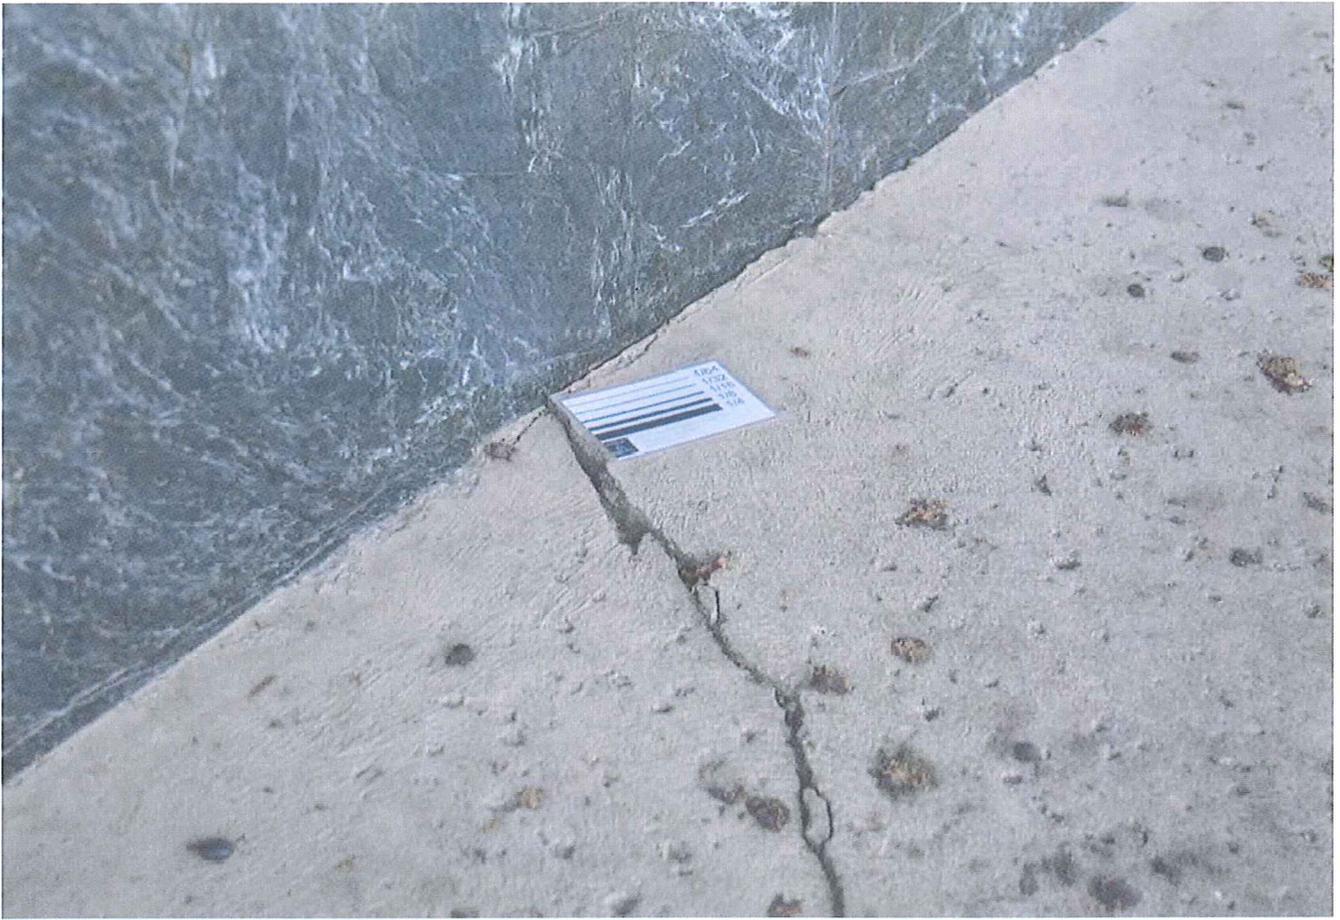
North of the south entrance, the ¾-inch thick serpentine architectural stone finish is cracked (Photos 38 and 39) due to long-term movement of the sidewalk into the roughly 20.5" x 30.5" stone slab, which is most likely due to ongoing tree root growth. An adjacent sidewalk crack near this damage is vertically offset about 1/8-inch to 3/16-inch, with the north side up (Photo 40).
