Re: Application for Tree Removal and/or Permit to Remove Trees at 497-511 South Lake Avenue

Purpose of this Report: To evaluate existing damages to the structure and the extent of damages resulting from three overgrown ficus trees adjacent to the property.

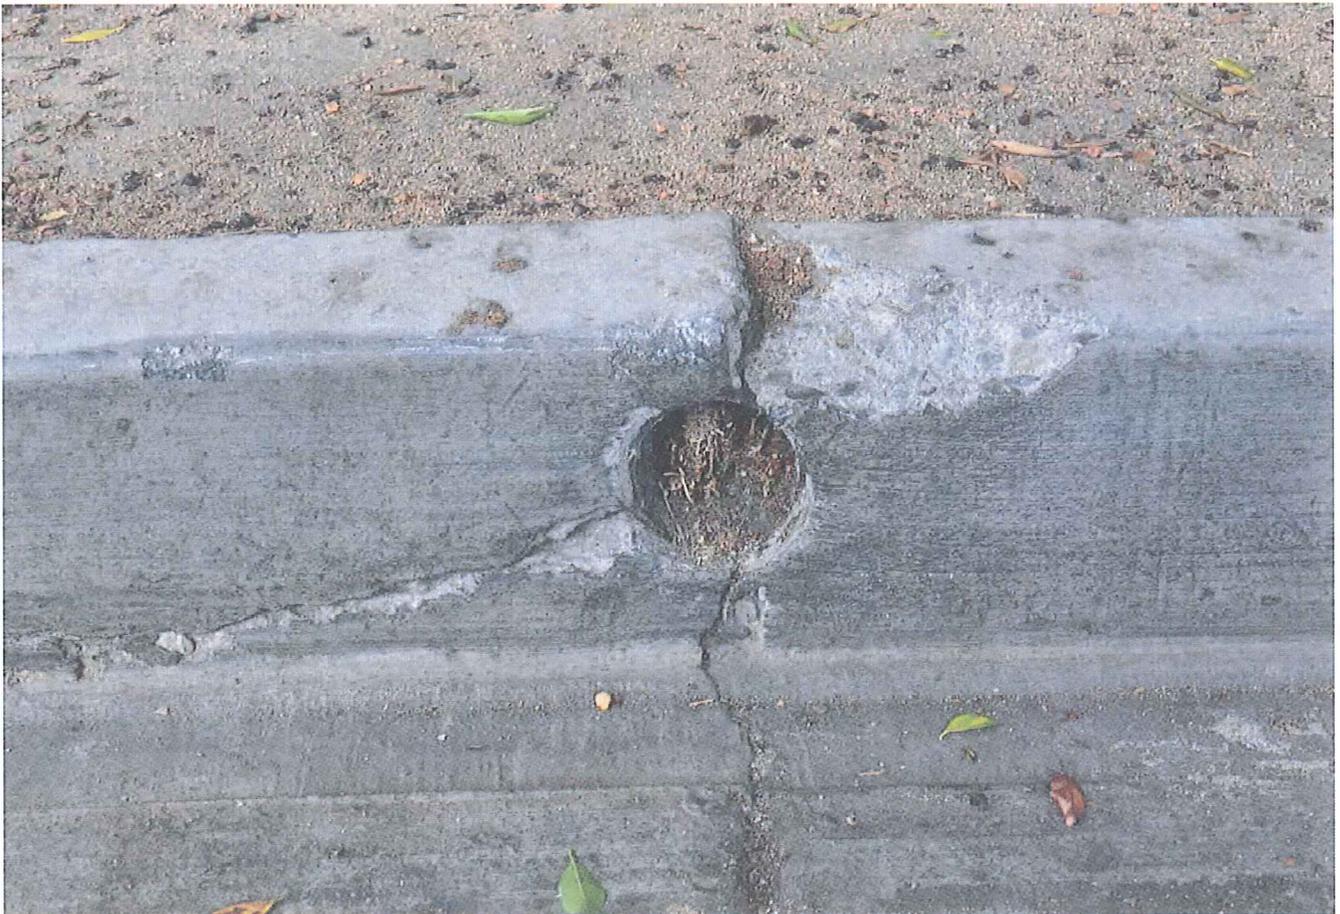
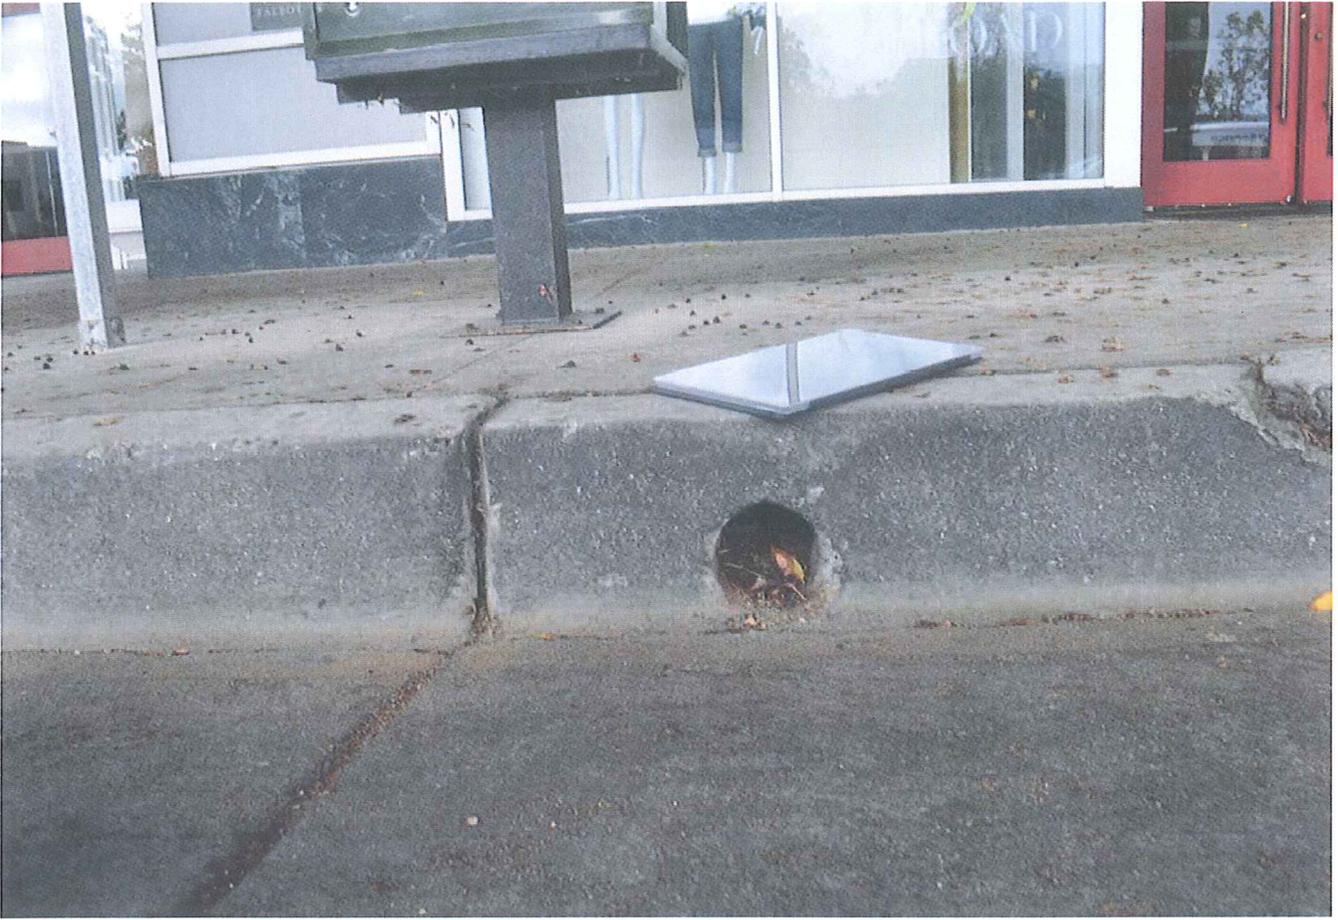
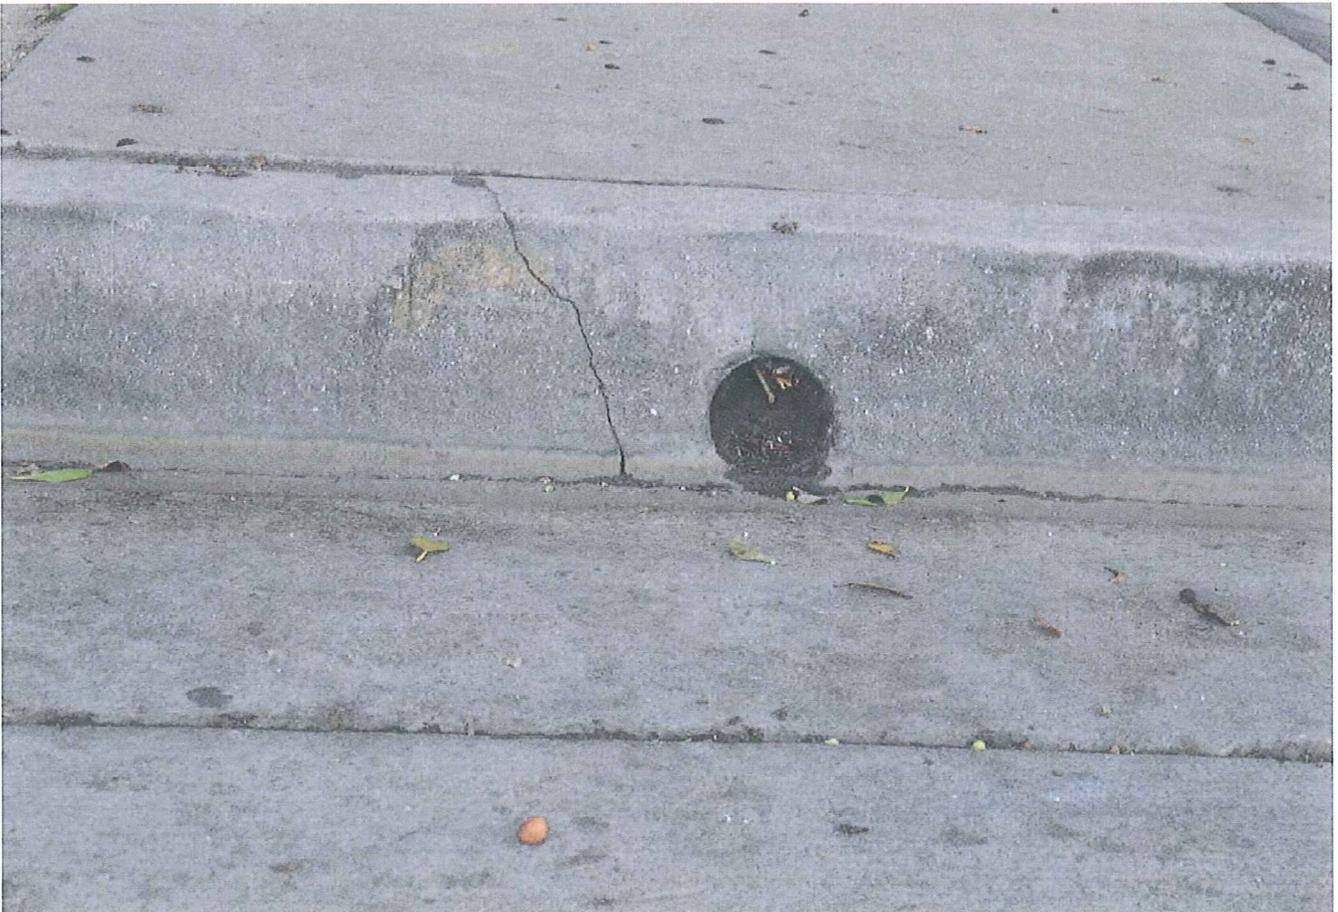
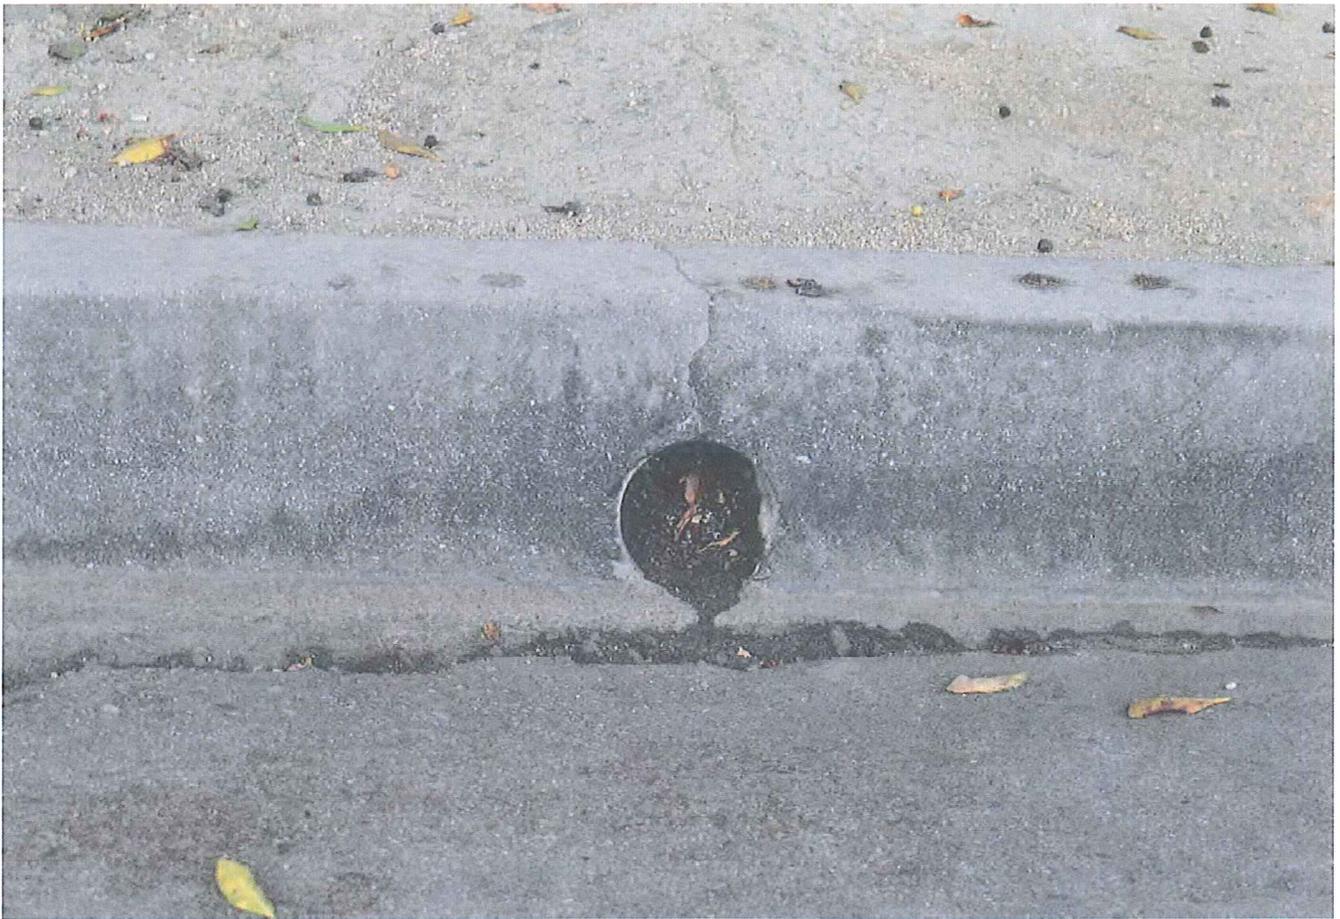
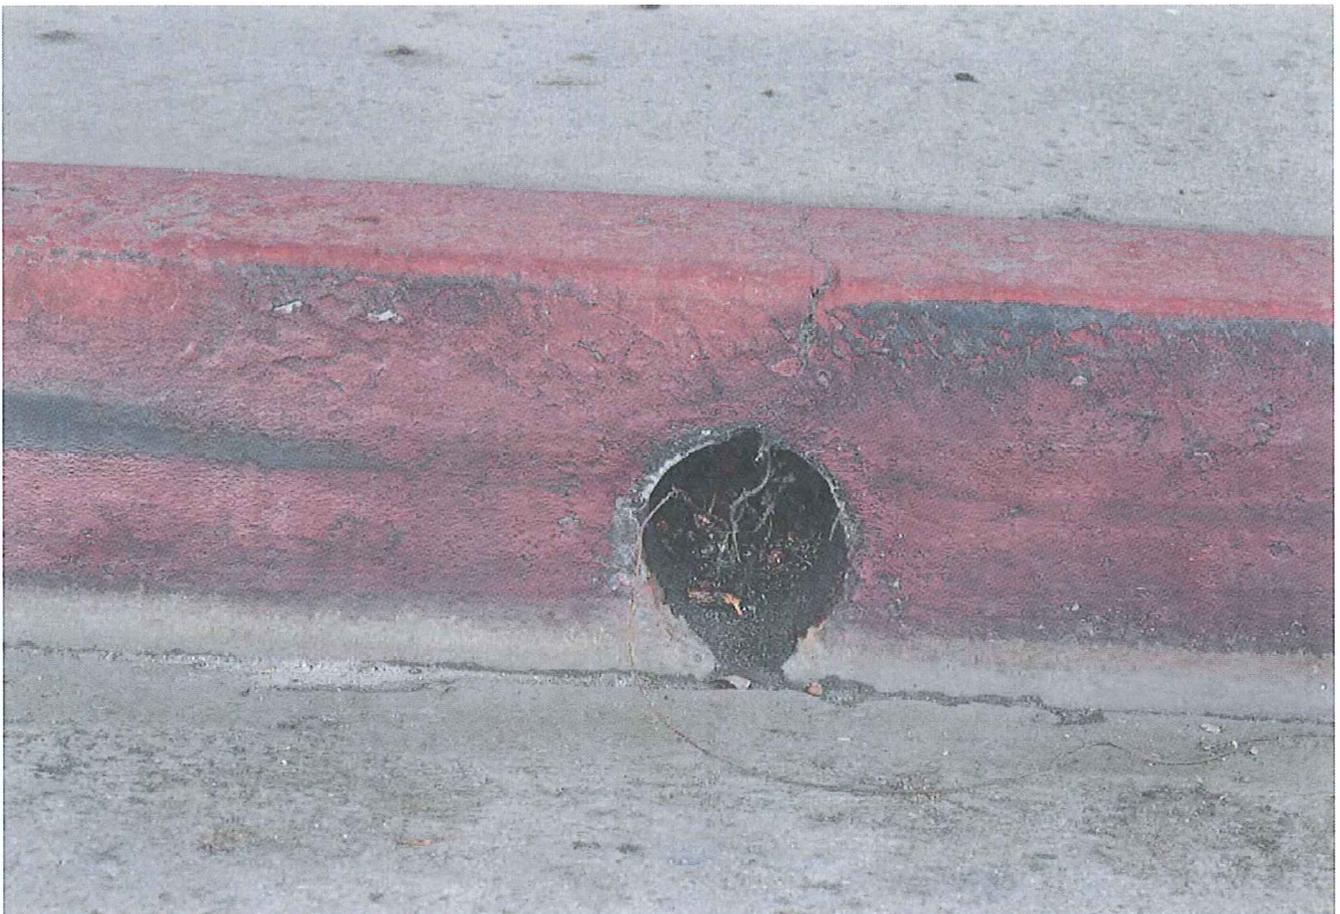
We observed four curb drain outlets in front of the subject building that are between 3.75 to 4.25 inches in diameter (Photos 41, 42, 43, 44). We observed that all of these drains have some degree of infilling with dirt and debris. Another curb drain, just north of the ones discussed above, is the furthest from the ficus trees and has roots that appear to be growing out of the drain (Photo 45).

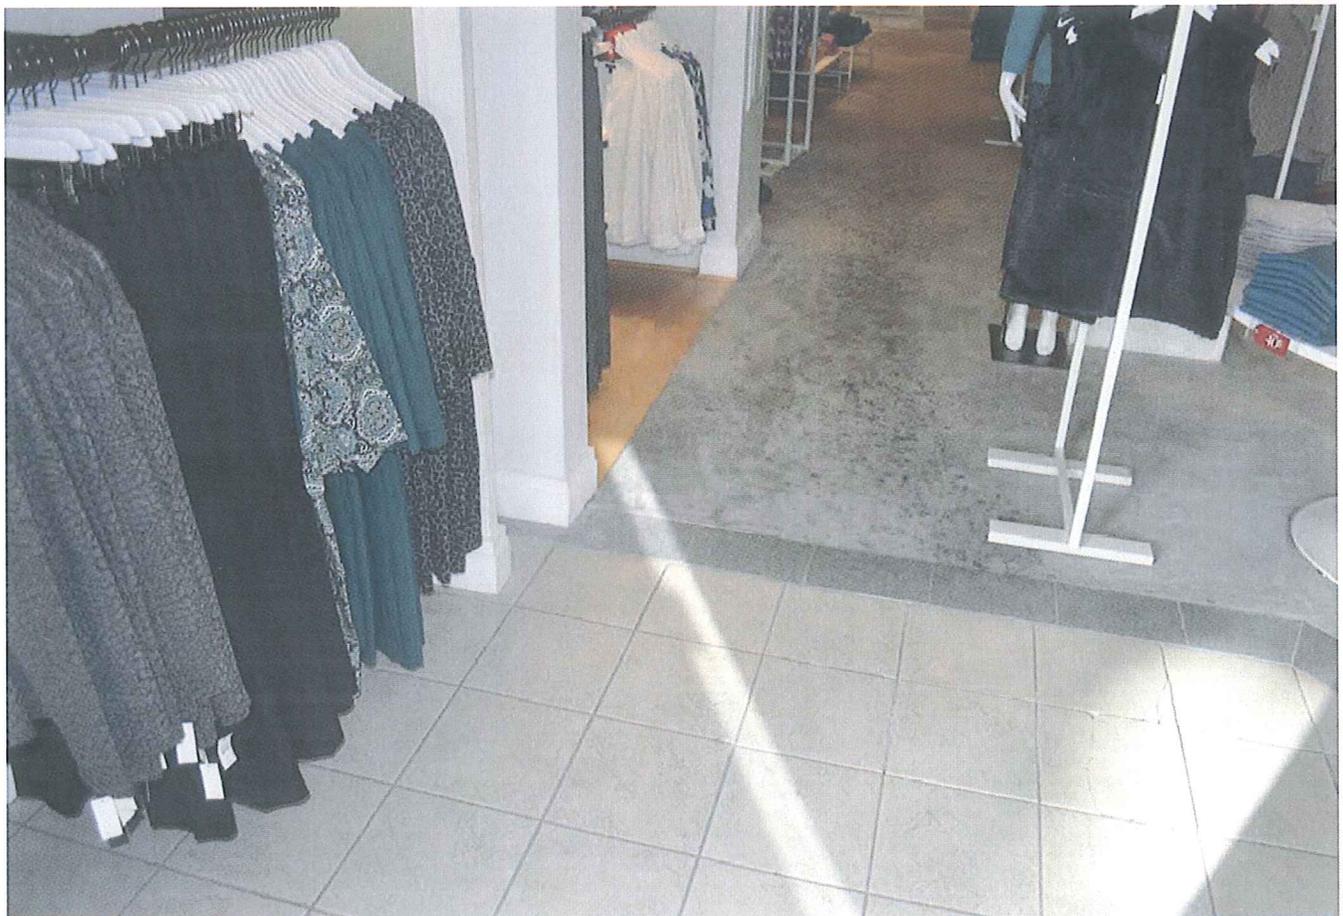
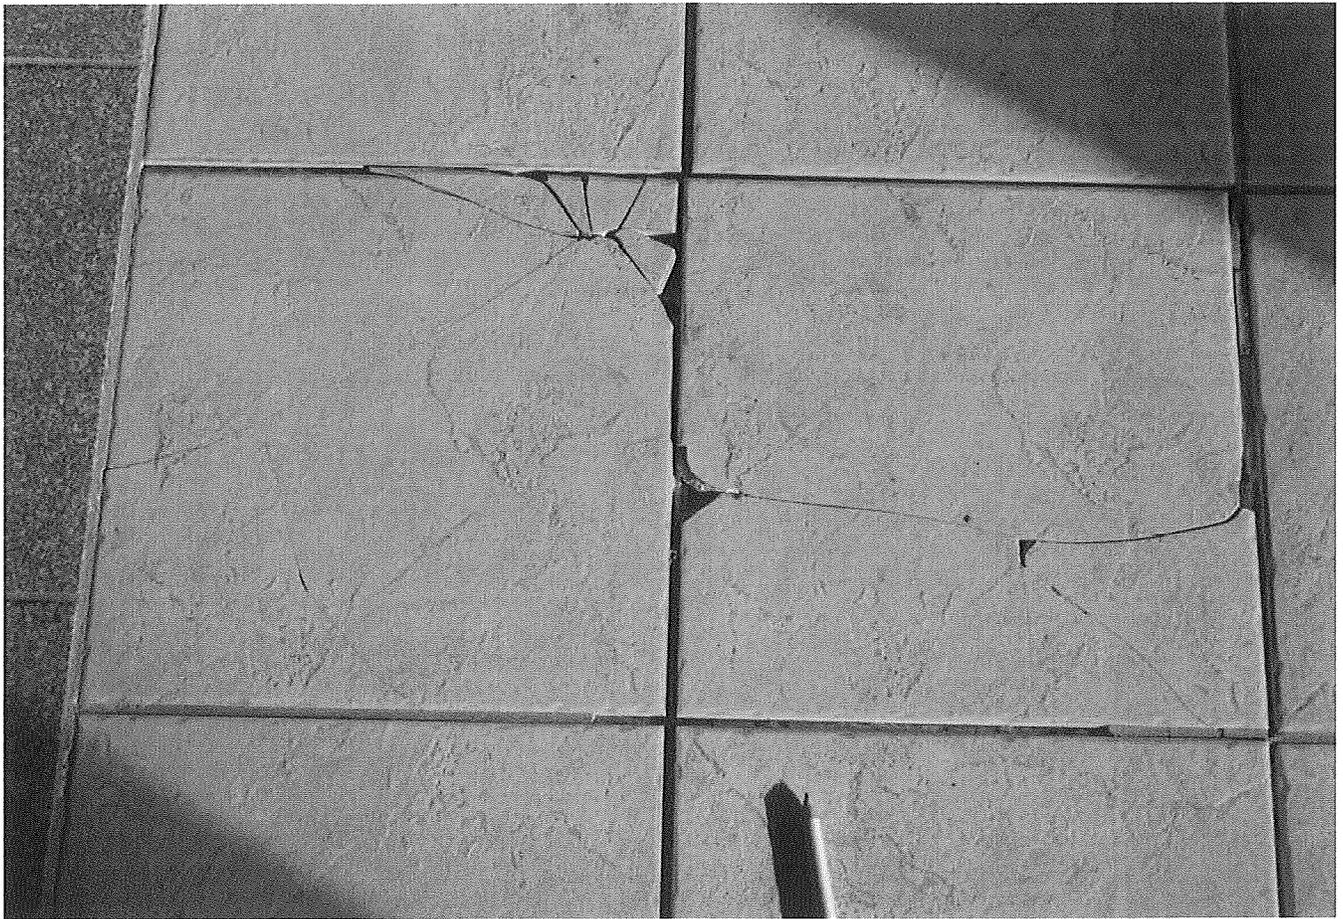
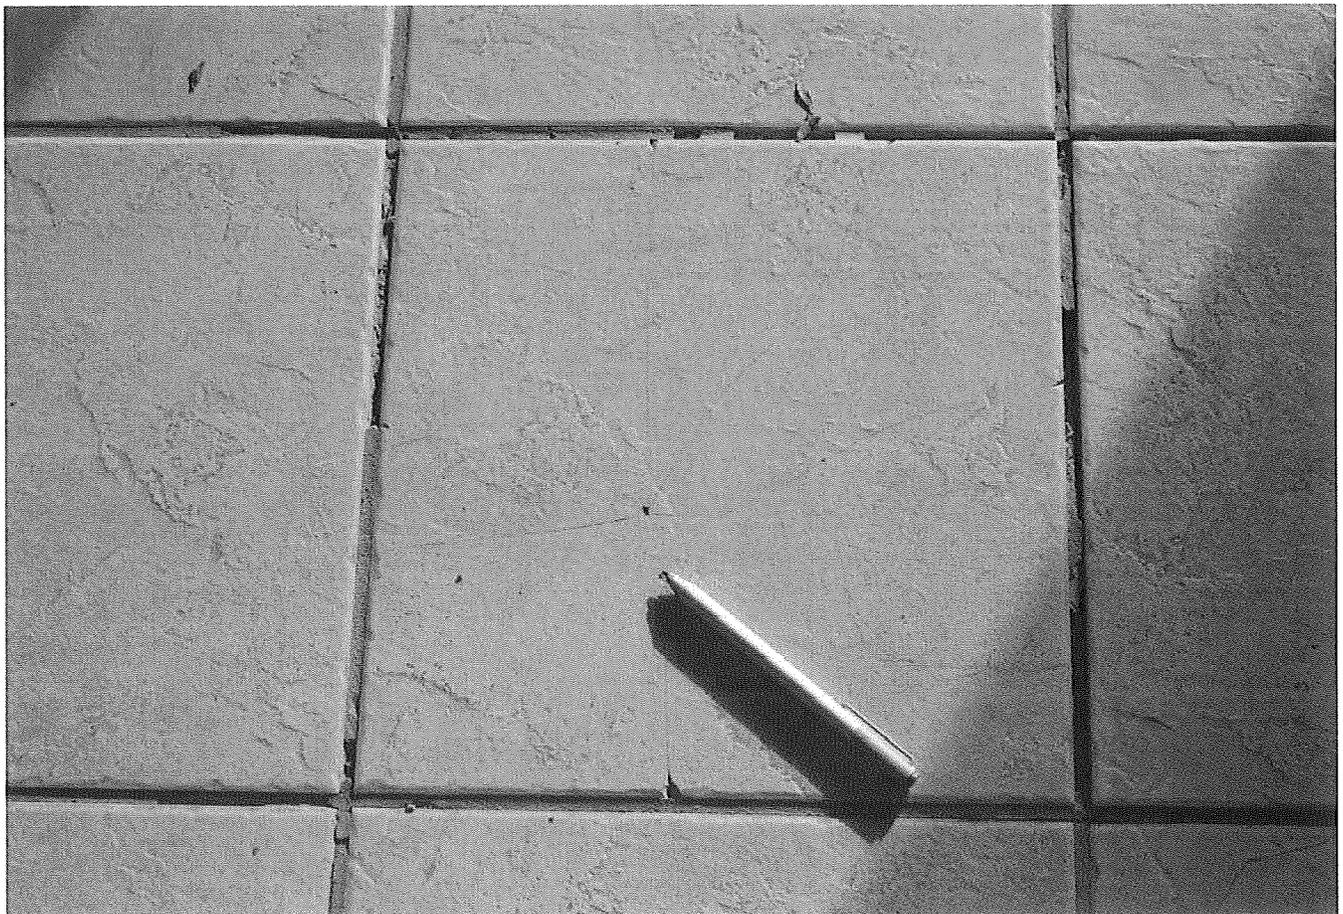
The front entry floor area of the north entrance is covered with 11¾-inch square floor tiles (Photo 46). We observed a few cracked floor tiles and some of these have detached from the underlying slab (Photos 47 through 49). The cracks in these floor tiles are most likely due to impacts of heavy objects onto the tiles. The damaged tiles are covered with a floor mat. The floor perimeters are covered with wood plank flooring and the majority of the store flooring is carpet (Photo 50).

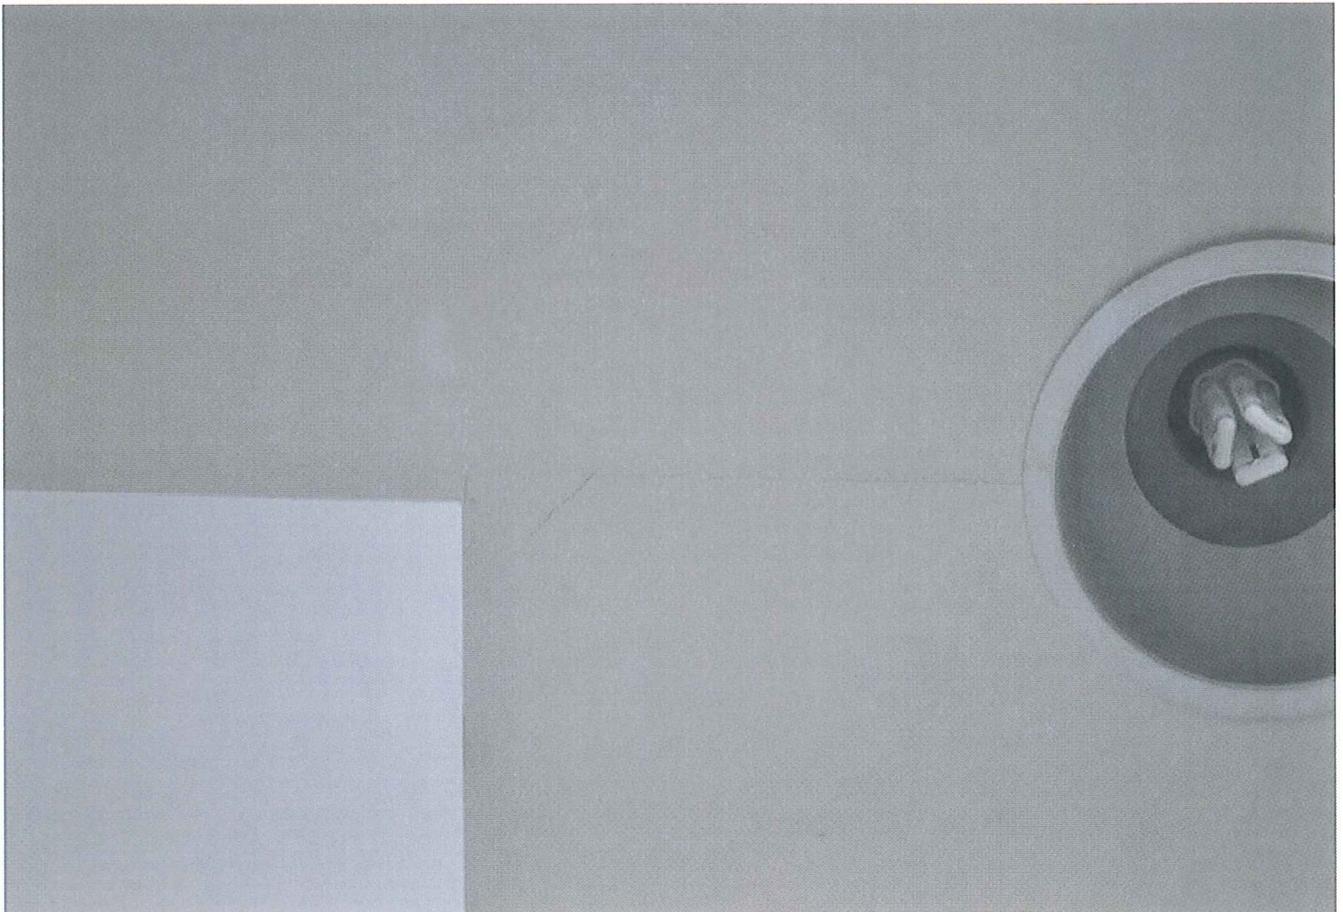
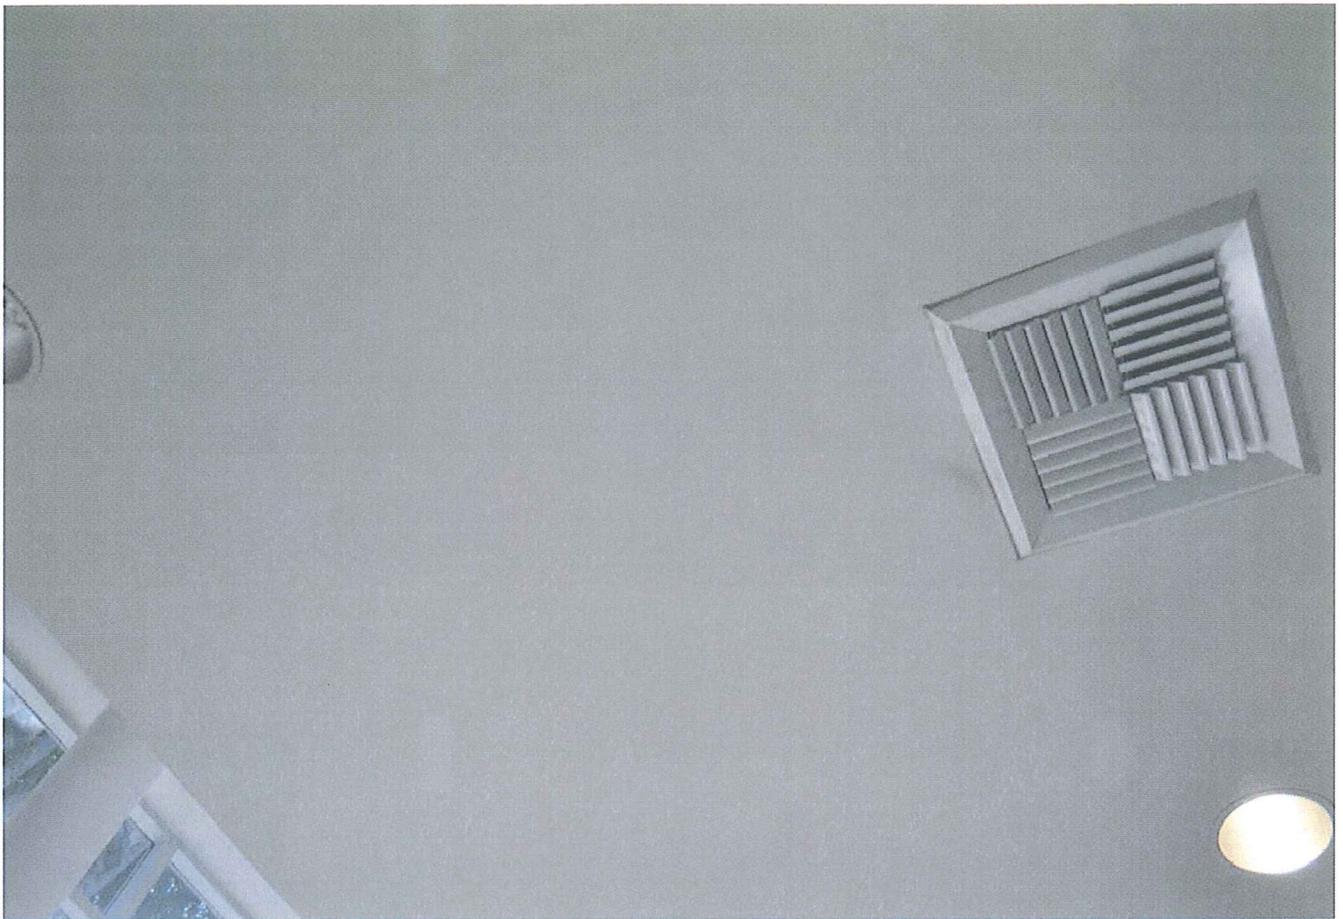
Wall and ceiling panel damages consist of minor cosmetic crack damages. In the front ceiling, a minor hairline width crack is present (Photo 51). A linear east-trending hairline width crack extends east of an air vent (Photo 52). A few patched and unopened linear cracks/separations are in the north portion of the ceiling and appear to be at wall panel junctions (Photo 53). In the northeast portion of the store, at the base of the front window, there are linear hairline to 1/64-inch wide cracks at corner bead and wall junctions in the low wall (Photo 54). Some drywall/plaster damage (possibly due to impact) is also present (Photo 55). A stepped hairline width crack is near the northeast corner junction. The wood floor shoe mold trim at this location has a slight vertical offset with the north mold up relative to the south mold. These cosmetic damages are consistent with normal adjustments from building material dilation and shrinkage in response to environmental changes, including fluctuations in temperature and humidity.
