WEEKLY NEWSLETTER

RE: Department of Public Works – Storm Update

RE: Arroyo Stone Wall Repair

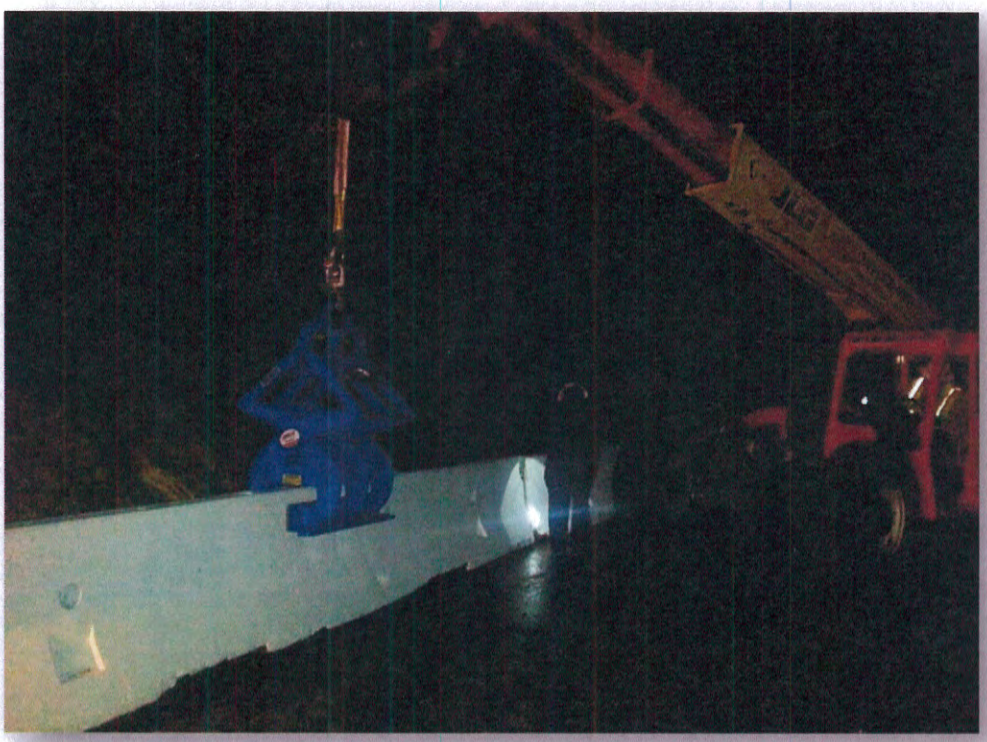
Attachment 2 –
Glen Oaks Photographs

The most significant impact was a slope failure and rock slide near 1562 Glen Oaks Boulevard. The Department of Public Works installed approximately 50' of K-rail to keep the roadway free of debris.

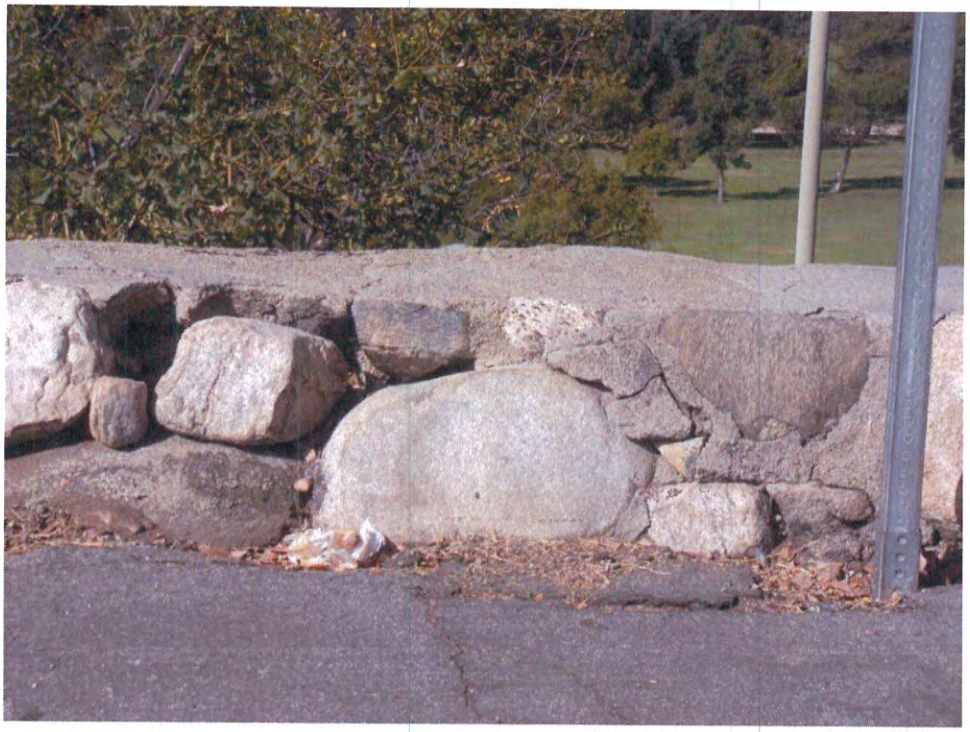
LOCATION #6
East on Rosemont Ave.,
(2'-3' cap repair - across middle of club house)

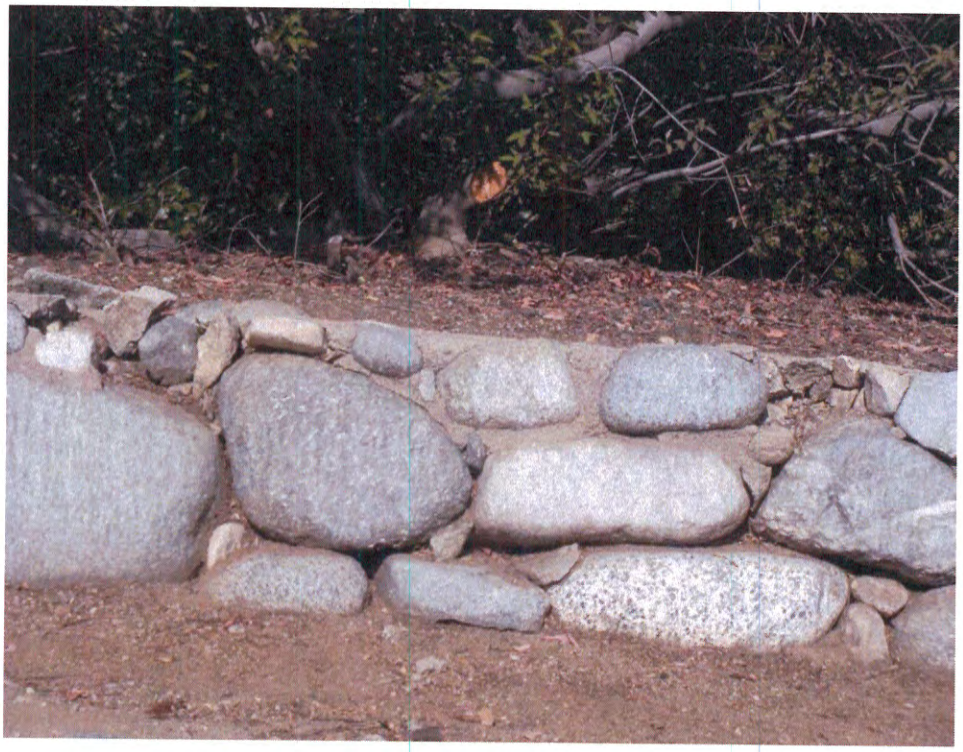
LOCATION #11
On West Drive at end of wall
(8' long cap & large hole/north of Salvia Canyon Road)

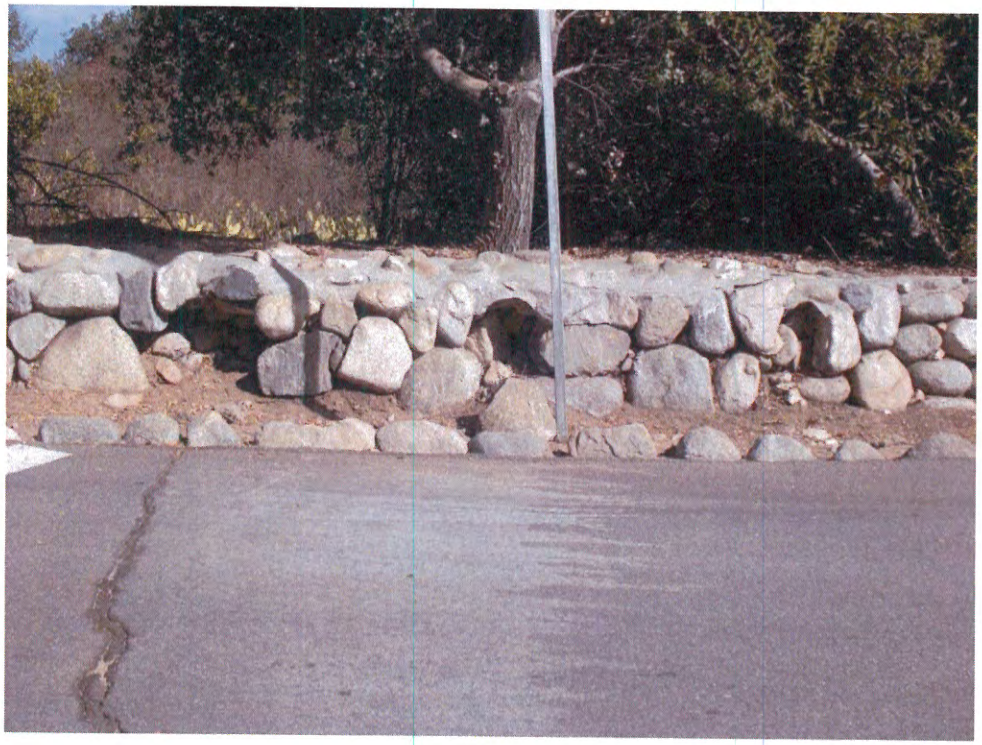
LOCATION #12
West side of Salvia Canyon Road
(At corner; at "FREEWAY" sign/Fill holes; repair cap 3' ea.)

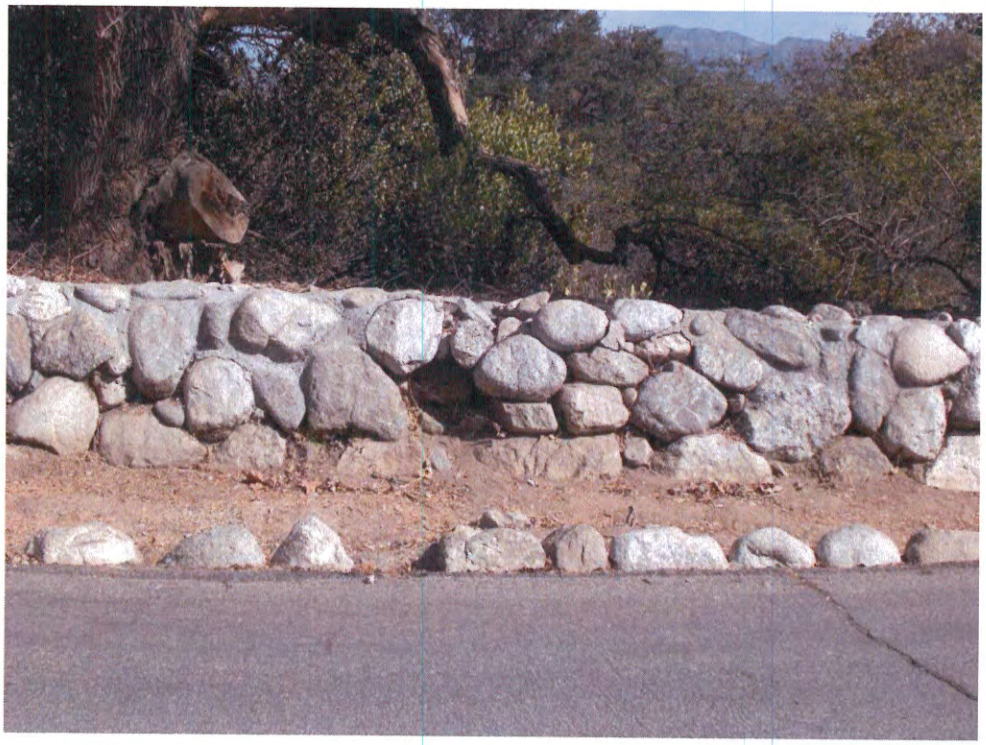
LOCATION #13
Northwest side of Salvia Canyon Road
(At 35 MPH Speed Limit Sign/Fill holes)

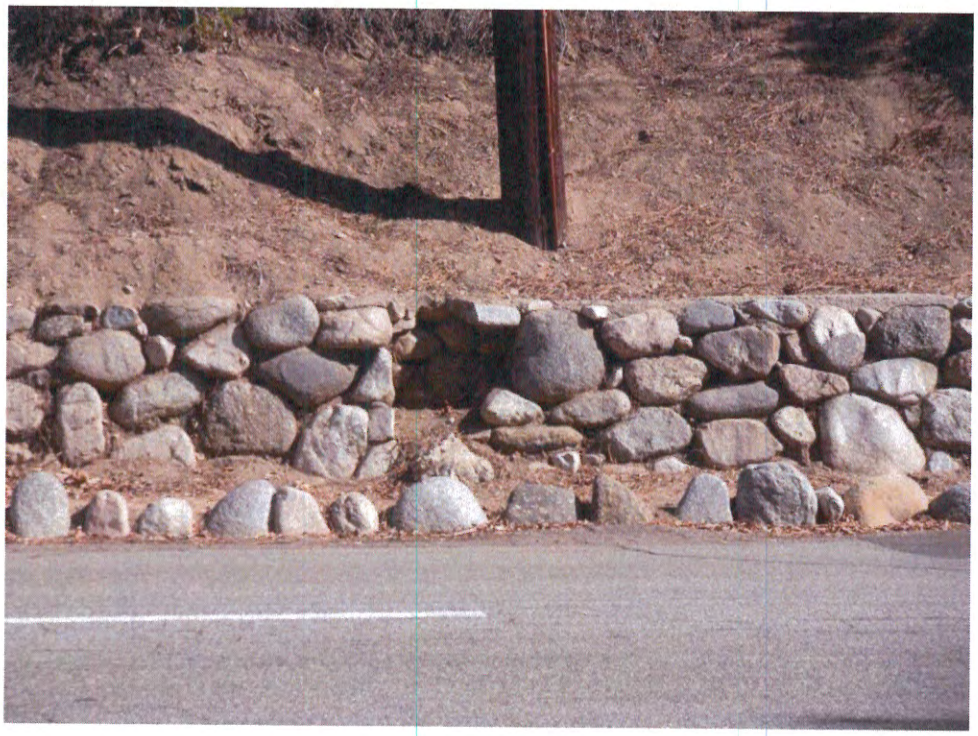
LOCATION #17
Salvia Canyon Road, west side
(At "TOW AWAY No Parking Anytime" sign/Fill hole; repair 6' long cap)
