Re: Application for Tree Removal and/or Permit to Remove Trees at 497-511 South Lake Avenue

Purpose of this Report: To evaluate existing damages to the structure and the extent of damages resulting from three overgrown ficus trees adjacent to the property.

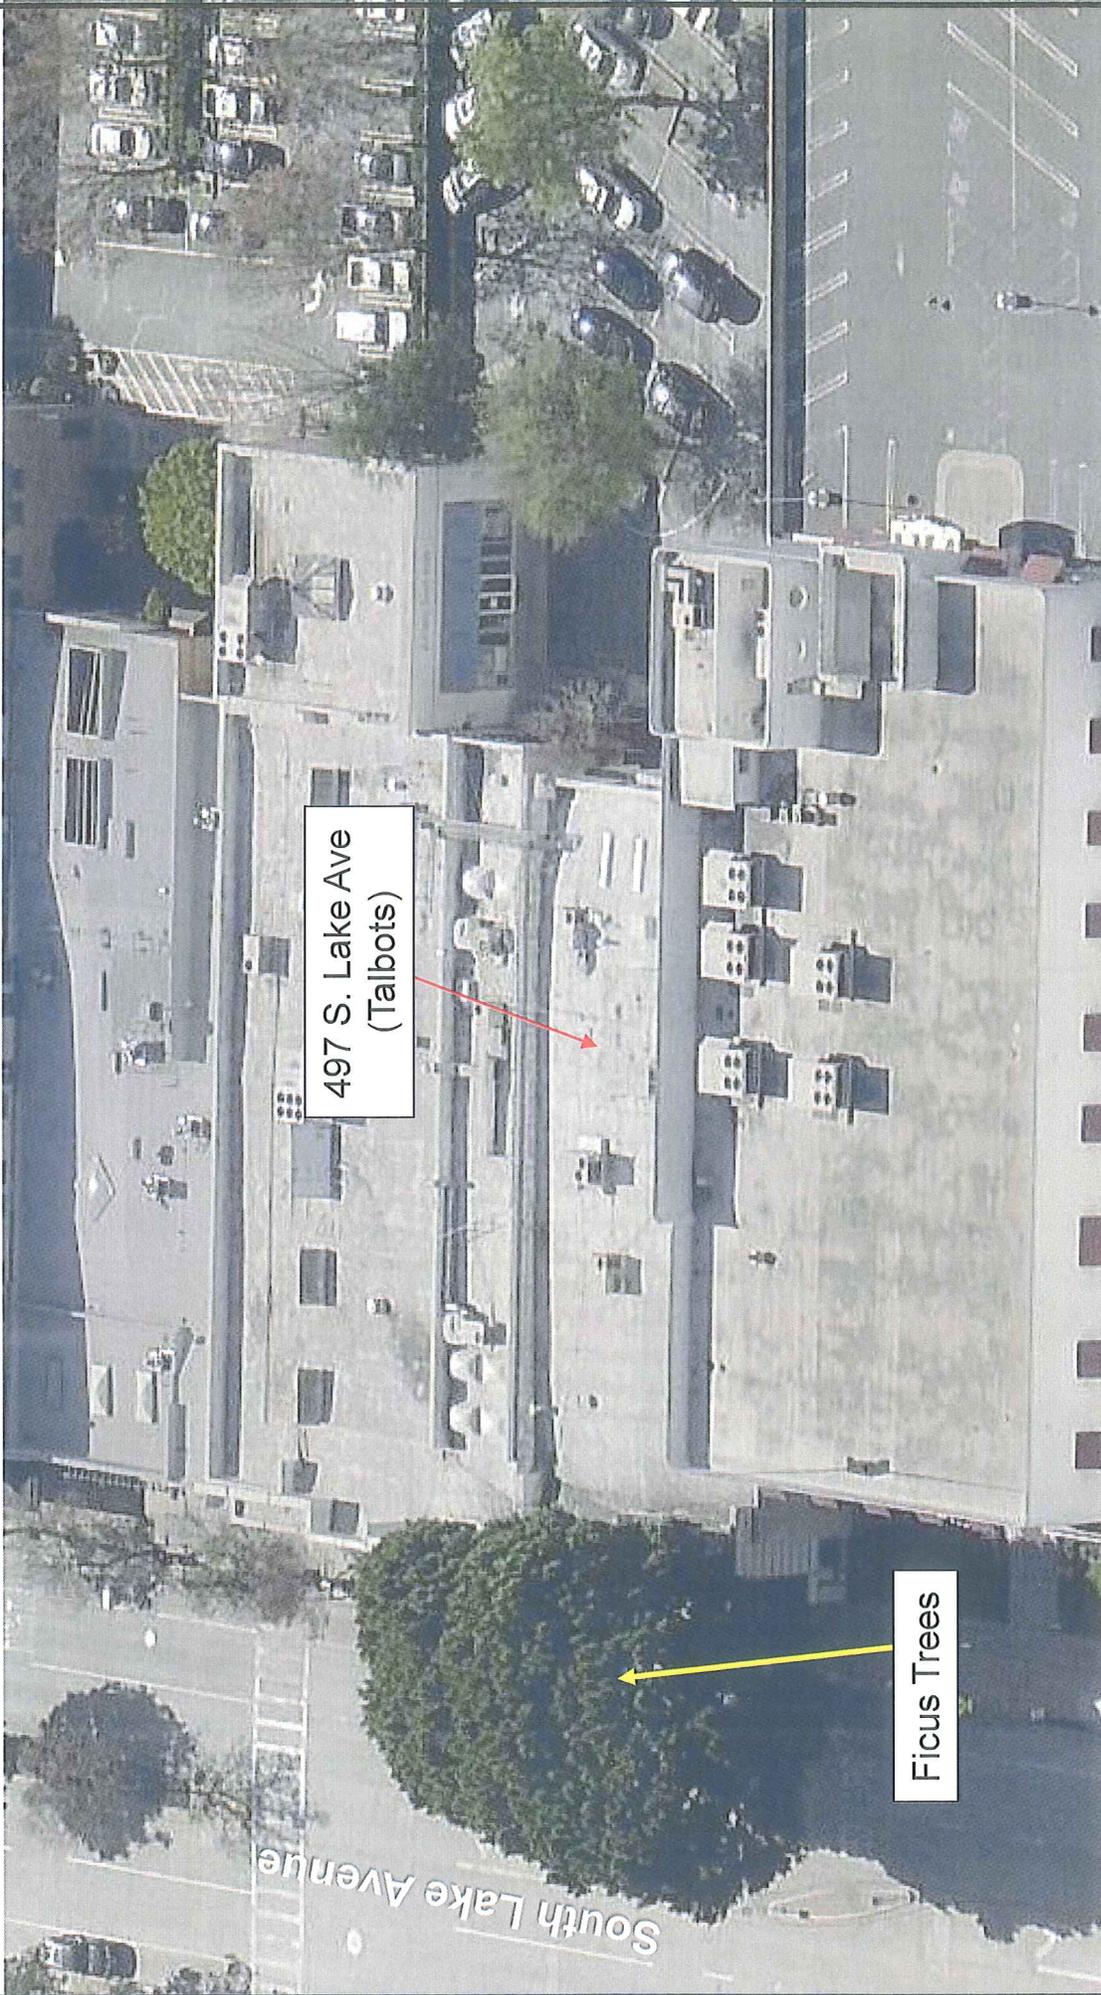
GROUP DELTA CONSULTANTS, INC. ENGINEERS AND GEOLOGISTS	FIGURE NUMBER 4
	PROJECT NAME: 497 S. Lake Ave., Pasadena, CA	PROJECT NUMBER GF-2078
CASE NUMBER: BC542643		Date: October, 2015

For more than several years, three very large ficus trees have been overhanging the front portions of the subject building roof (Figures 2 to 5 and 9 to 11). Leaves and other tree debris continuously fall upon the roof causing roof drain blockages. During rains this can result in water ponding upon the roof front two corners to a depth of at least 1'-6". At the surface level, large tree roots are heaving up and fracturing the front public sidewalk, causing damages to the concrete sidewalk as well as raised edges and out of level concrete surfaces, resulting in a pedestrian trip hazard. Leaves, berries and other debris from the trees cover portions of the subject roof and the front sidewalk access to the building.

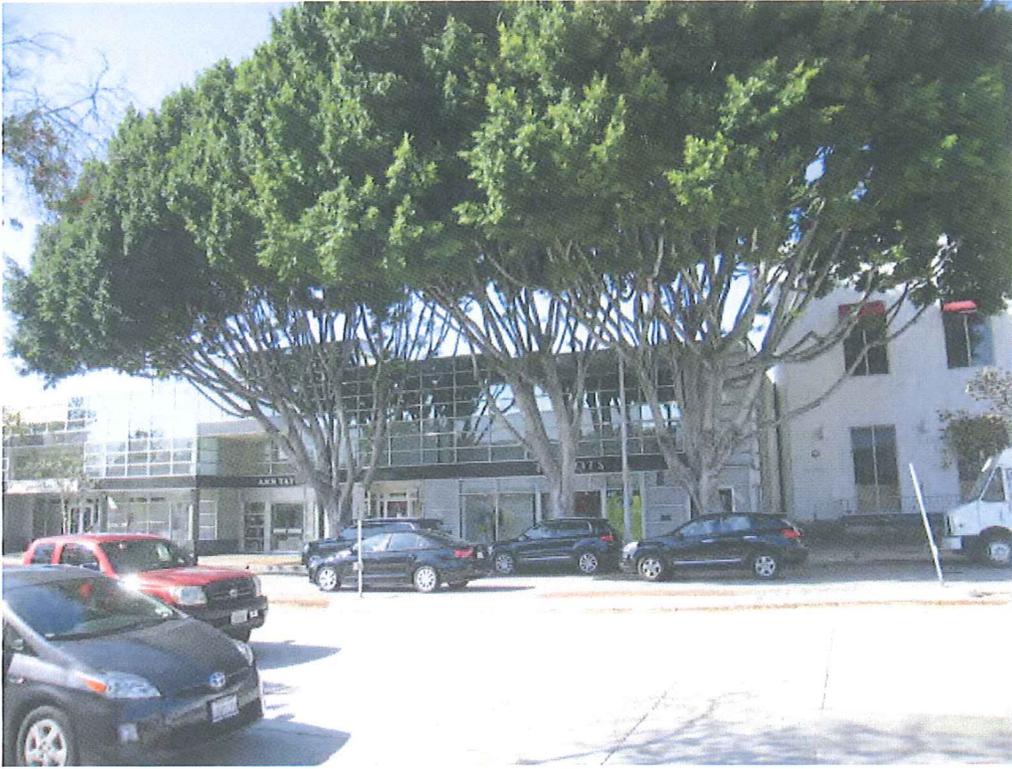
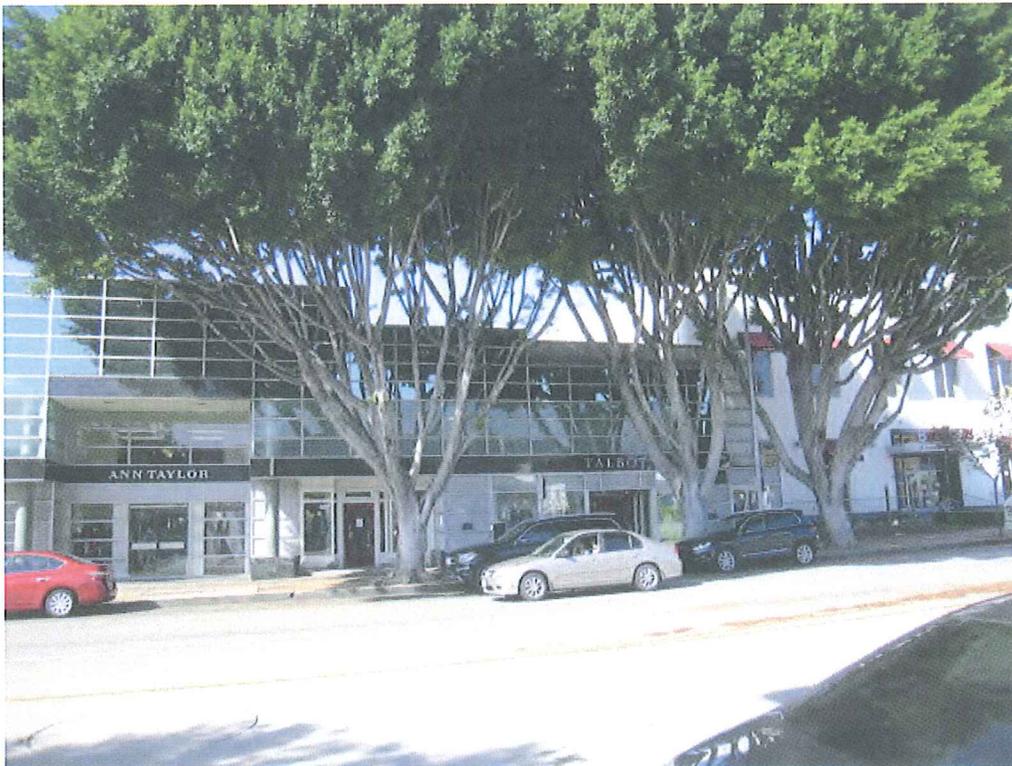
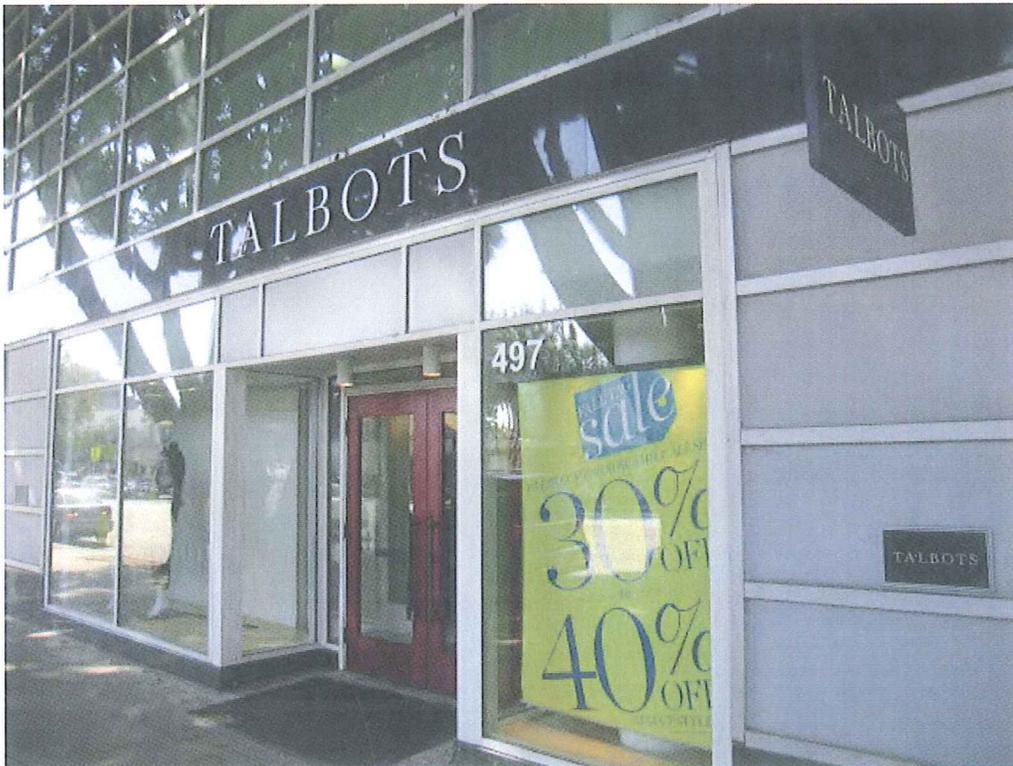
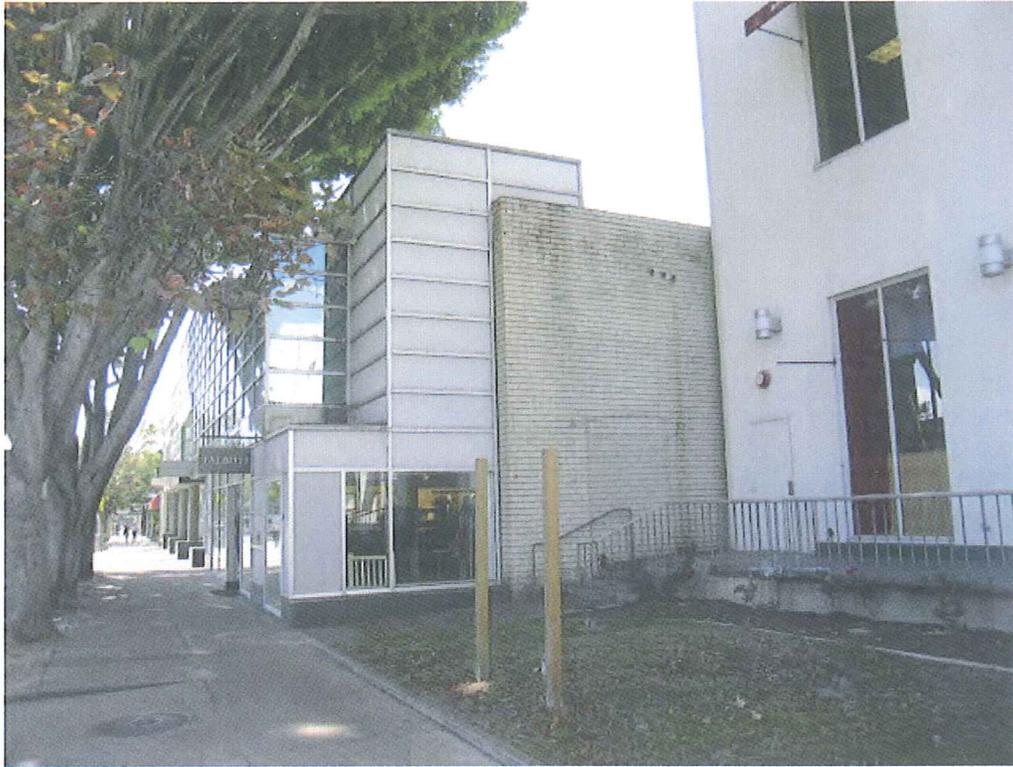
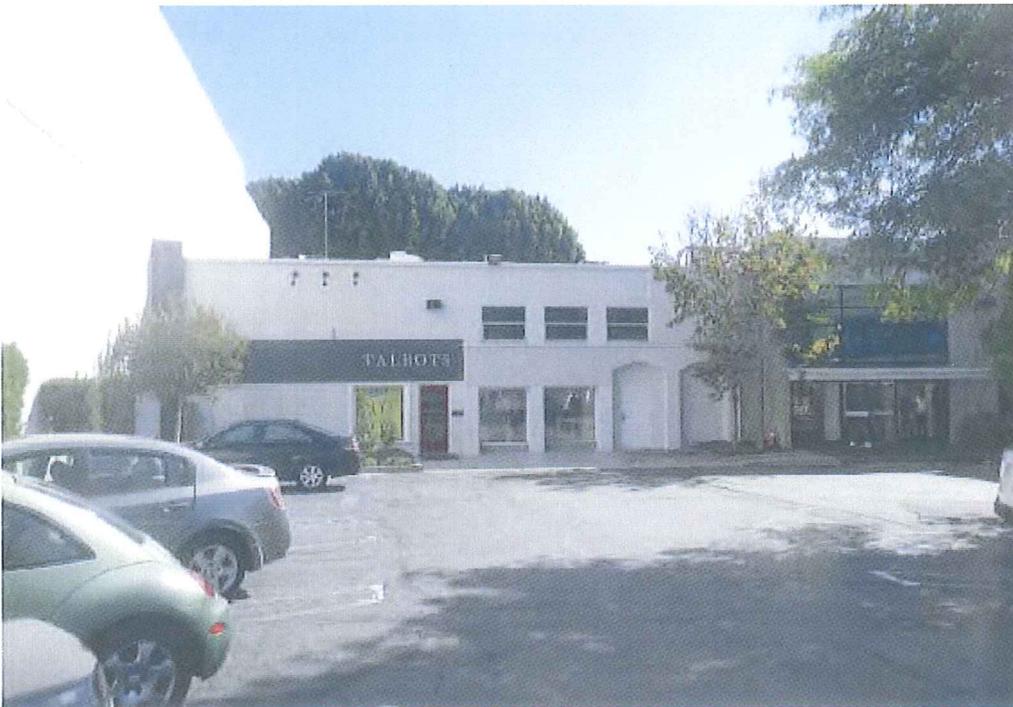
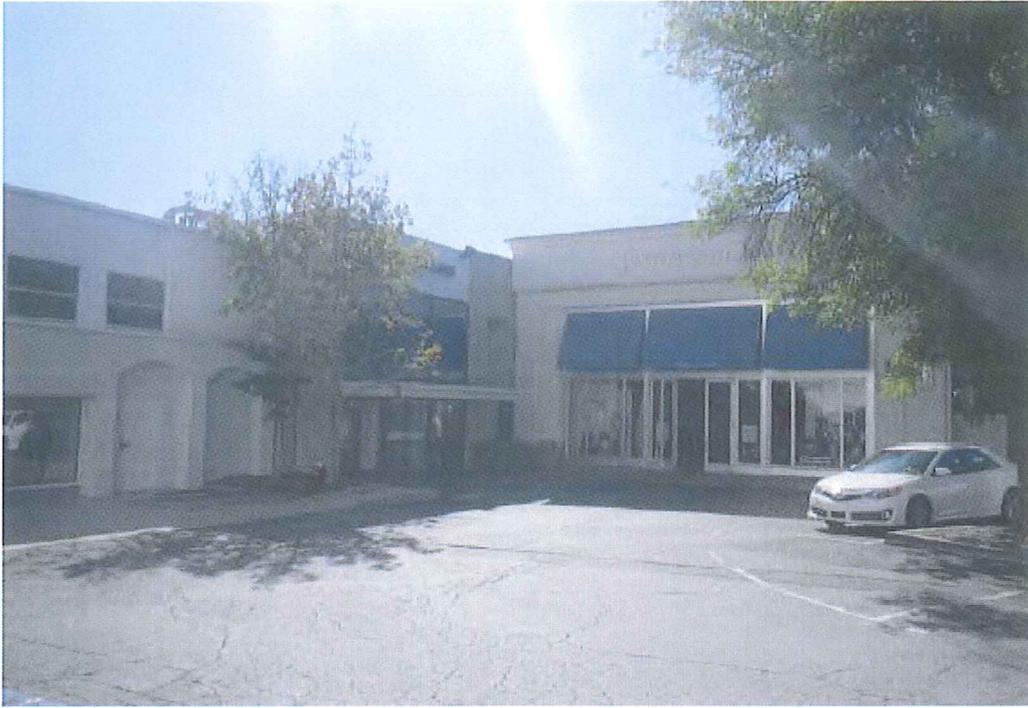
The subject property is situated west of S. Lake Ave and north of California Blvd, within the City of Pasadena, California (Figures 1 to 5). The structure at 497 S. Lake Ave is currently occupied by Talbots, a clothing retail store. The generally east facing Talbots commercial building (Photos 1 to 7) consists of an approximately 8,200 square foot, single story structure. According to public records, the building was built in 1954.

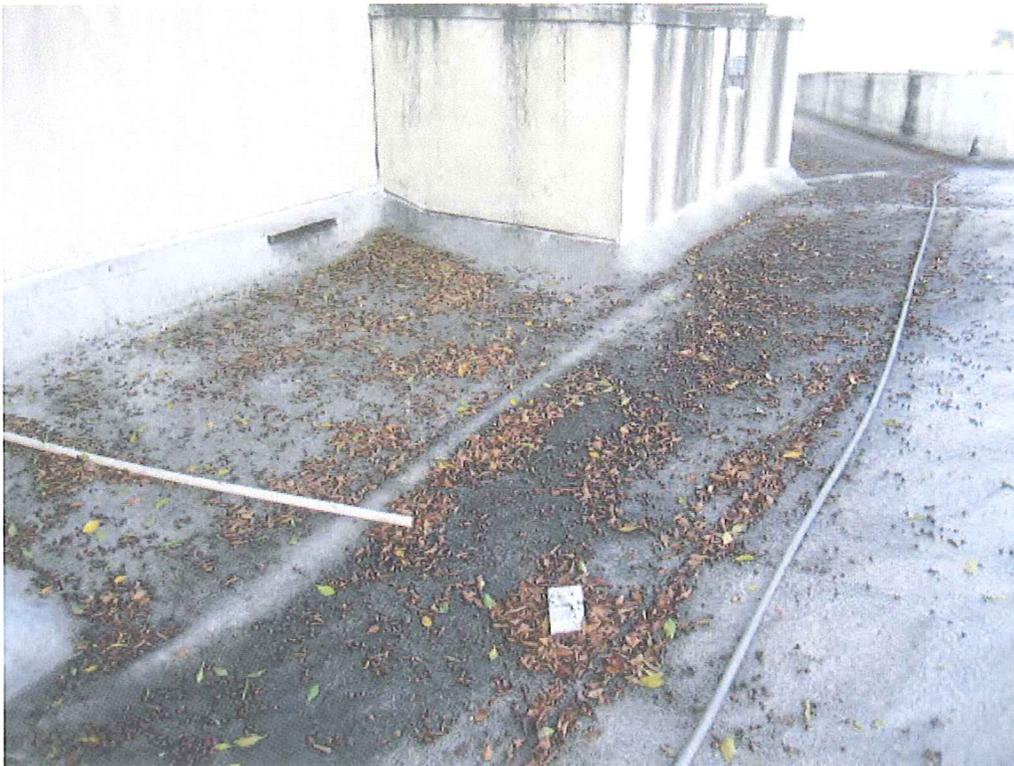
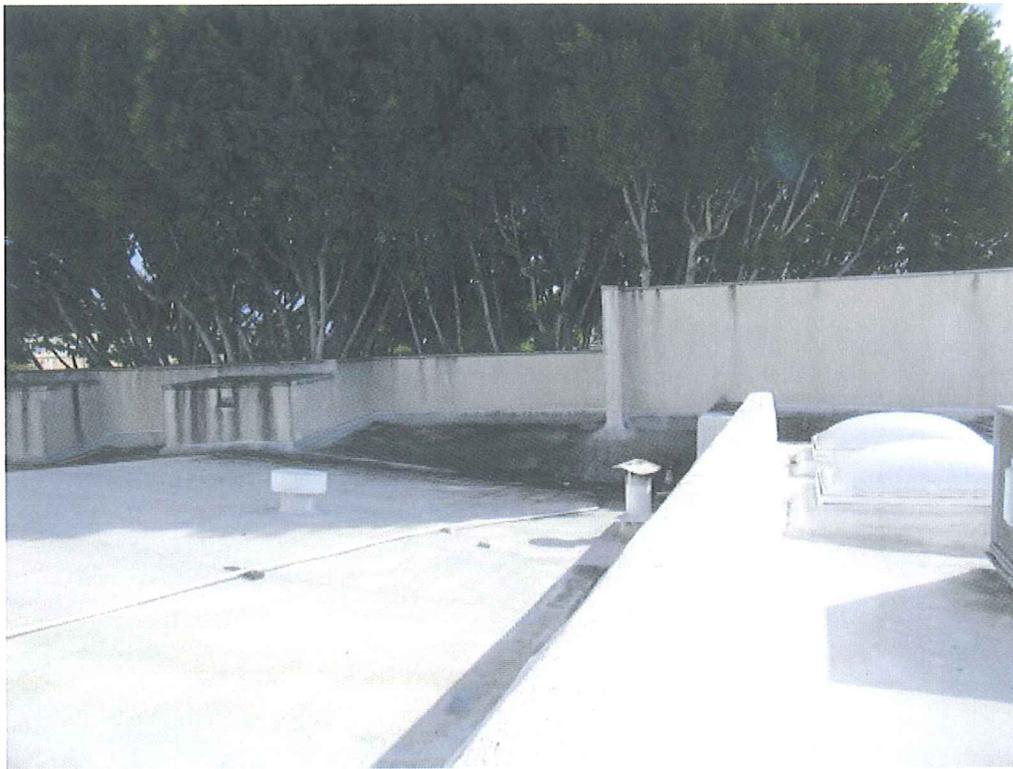
The roof of the structure is surrounded by parapet² walls at all 4 of its sides (Photos 12, 13, 14, 15 & 16). At the front of the building are large trees which overhang the roof and continuously drop leaves, berries and other debris onto the roof causing the blockage of roof drains (Photos 12, 14, 17, 18, 19 & 20). At the time of our inspection, ponded water approximately 6 inches deep remained from a recent rain at the northeasterly front corner of the building where a pump had been installed to drain the area (Photos 21, 22 & 23).

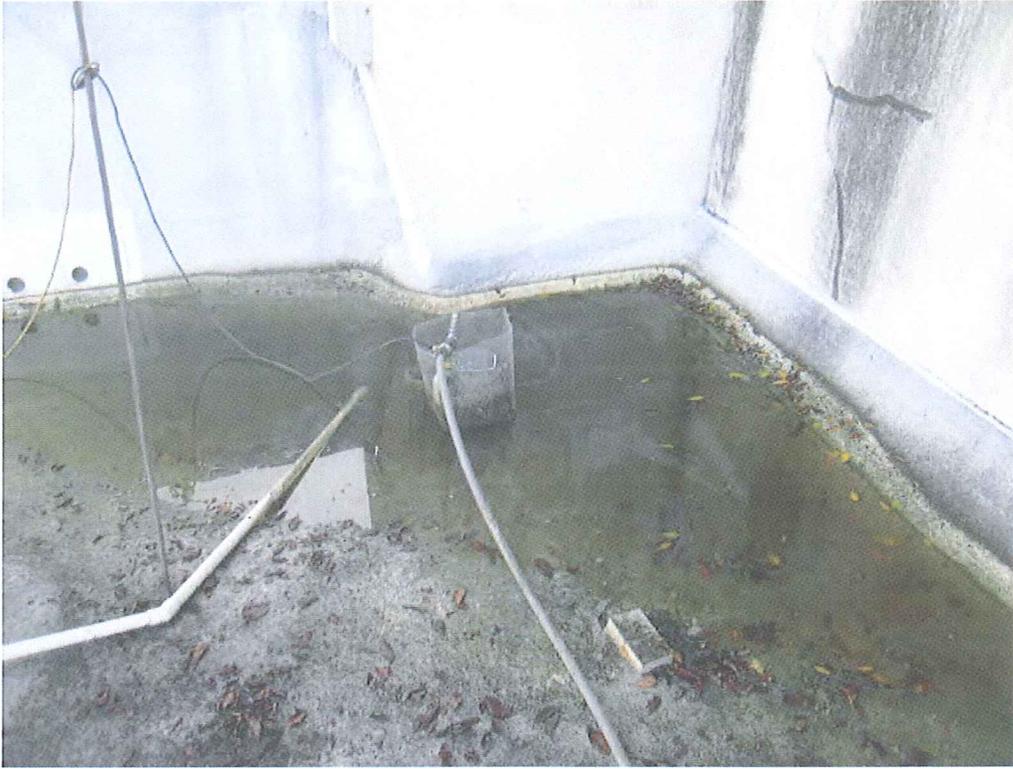
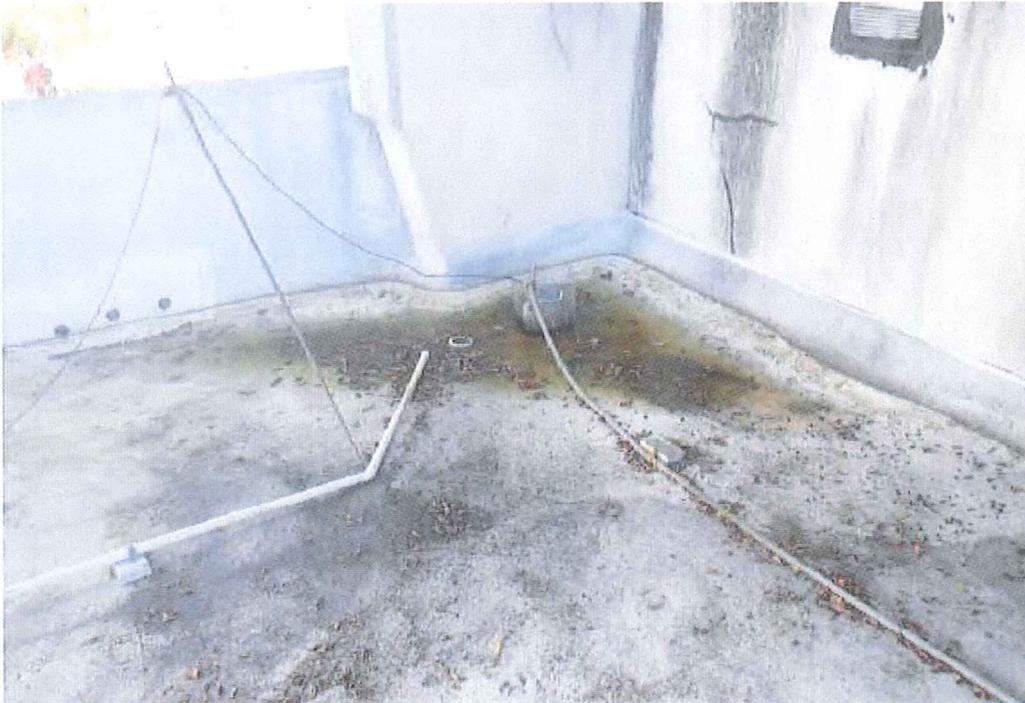
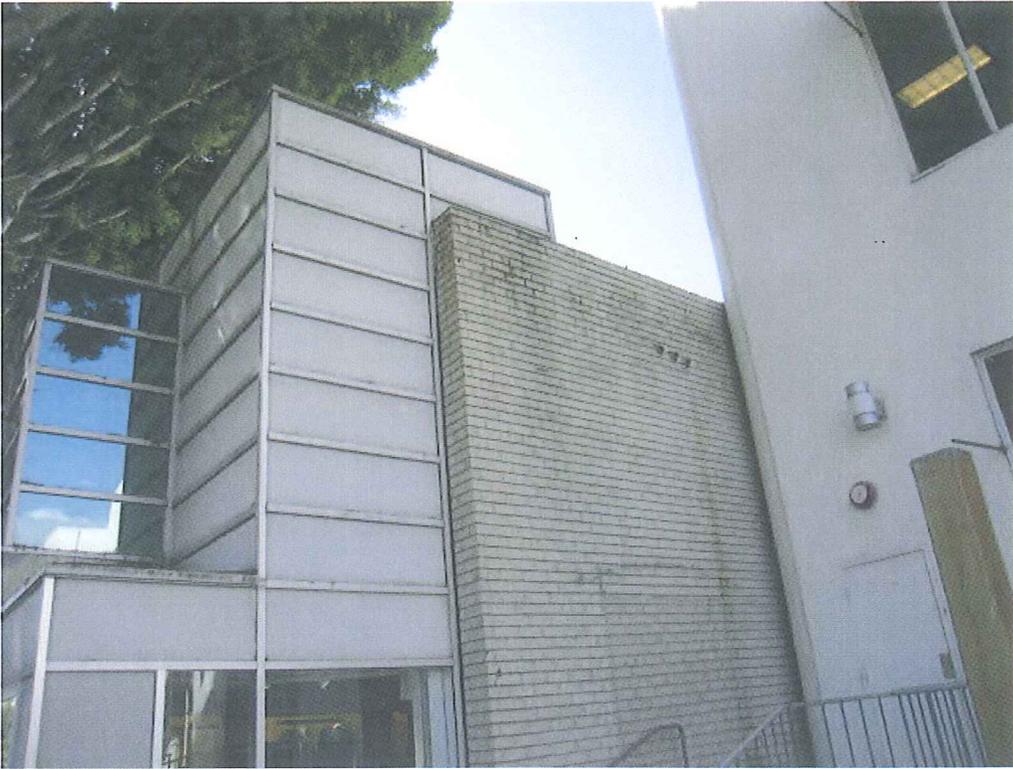
Roof scupper holes have been bored through the northerly masonry wall for emergency drainage of the northeasterly roof corner when roof drains are blocked (Photos 21, 28 & 29). These are too small and will become clogged with tree debris during deep water ponding events.

corners of the roof located at the deepest point of ponding. Those scuppers currently existing at the front, northerly corner of the building are too small and also subject to blockages (Photos 21, 28 & 29).

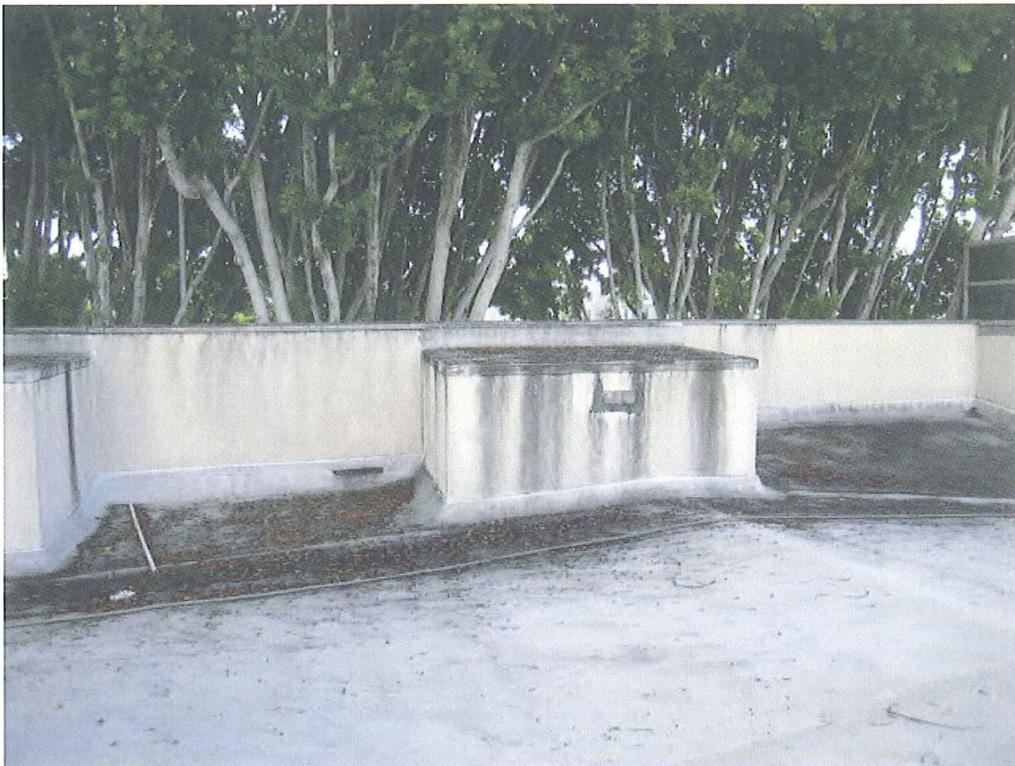
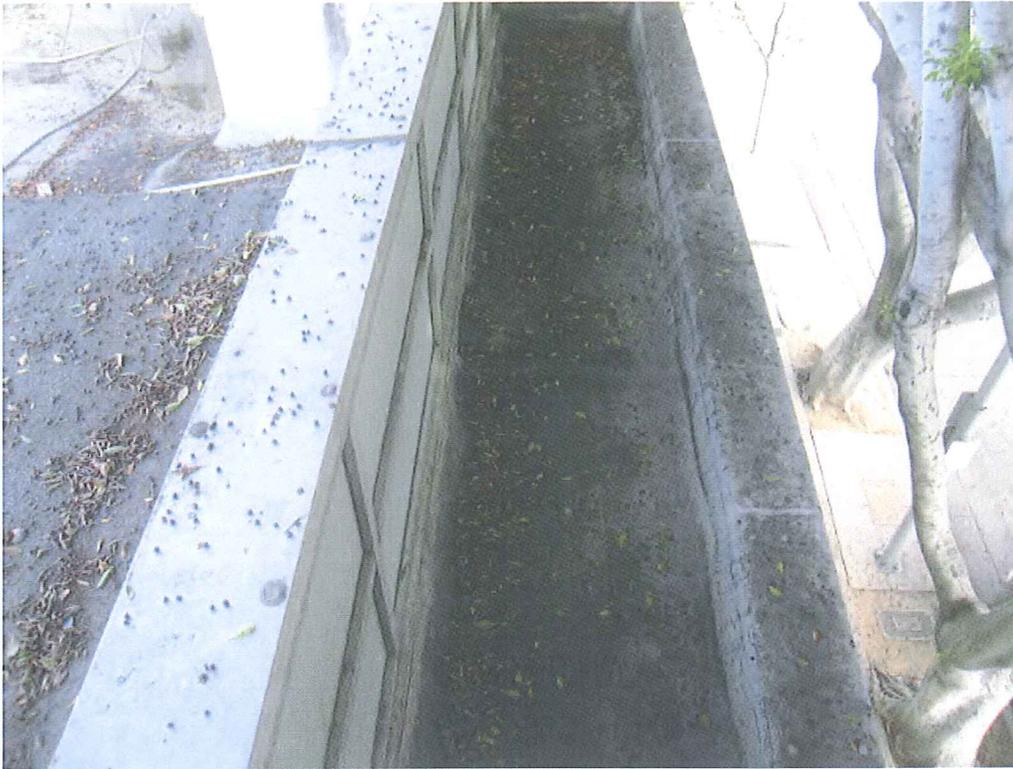
At the front entry area of the building are two small, lower roofs above the storefront aluminum and glass structure (Photos 3, 24 & 25). These have their own parapets and become filled with tree debris. The upper small roof drains back onto the main roof through a scupper (Photos 26 & 27), which when clogged by the debris will cause it to reservoir approximately a foot of water.
