GDC Project No. GF-2078

Subject: Summary of Observations
Sidewalk Removal by City of Pasadena
497 S. Lake Avenue, Pasadena, California 91101

GF-2078
Summary of Observations
497 S. Lake Avenue, Pasadena, California

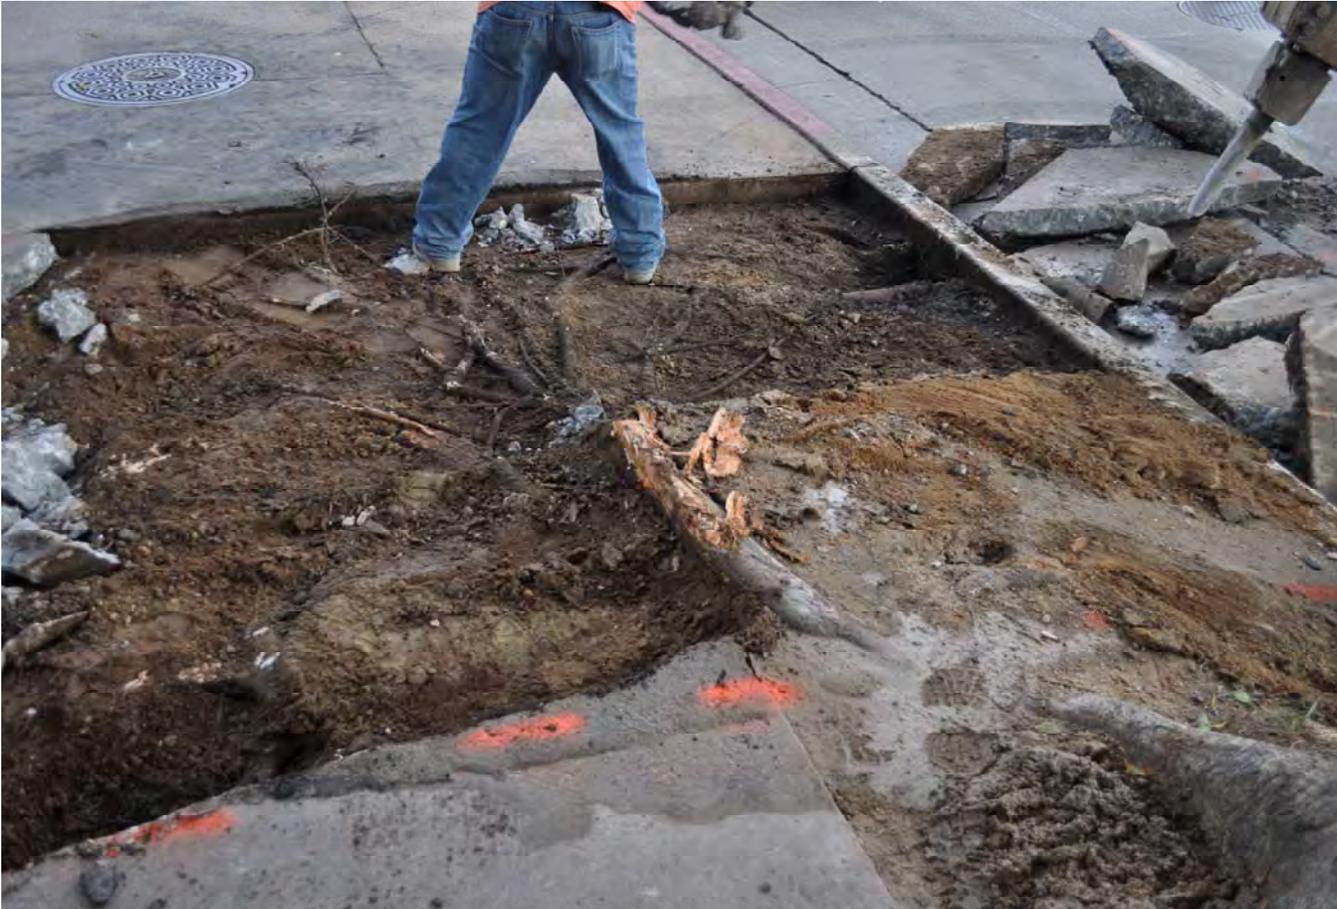
Photo 2

The sidewalk was demolished with a Bobcat jackhammer and the removal exposed numerous roots beneath the sidewalk adjacent to the subject building (Photos 1 - 6). Some roots are over 6 inches in diameter. A section of the sidewalk adjacent to the northeast corner of building was not demolished because there is a survey point that is likely for the property line (Photo 7).

Sidewalk removal began about 9.5 feet north of the subject building (Photos 1 - 3) and extended to the south (Photos 4, 6) a total distance of about 82 feet, 8 feet south of the south end of the building (Photo 5). The 9 feet 10-inch wide sidewalk sections were removed, with two wider sections of sidewalk removed south of the north tree planter and south of the southernmost tree planter. The sidewalk varied in thickness, but typically about 4 to 5 inches and there was no apparent steel reinforcement.

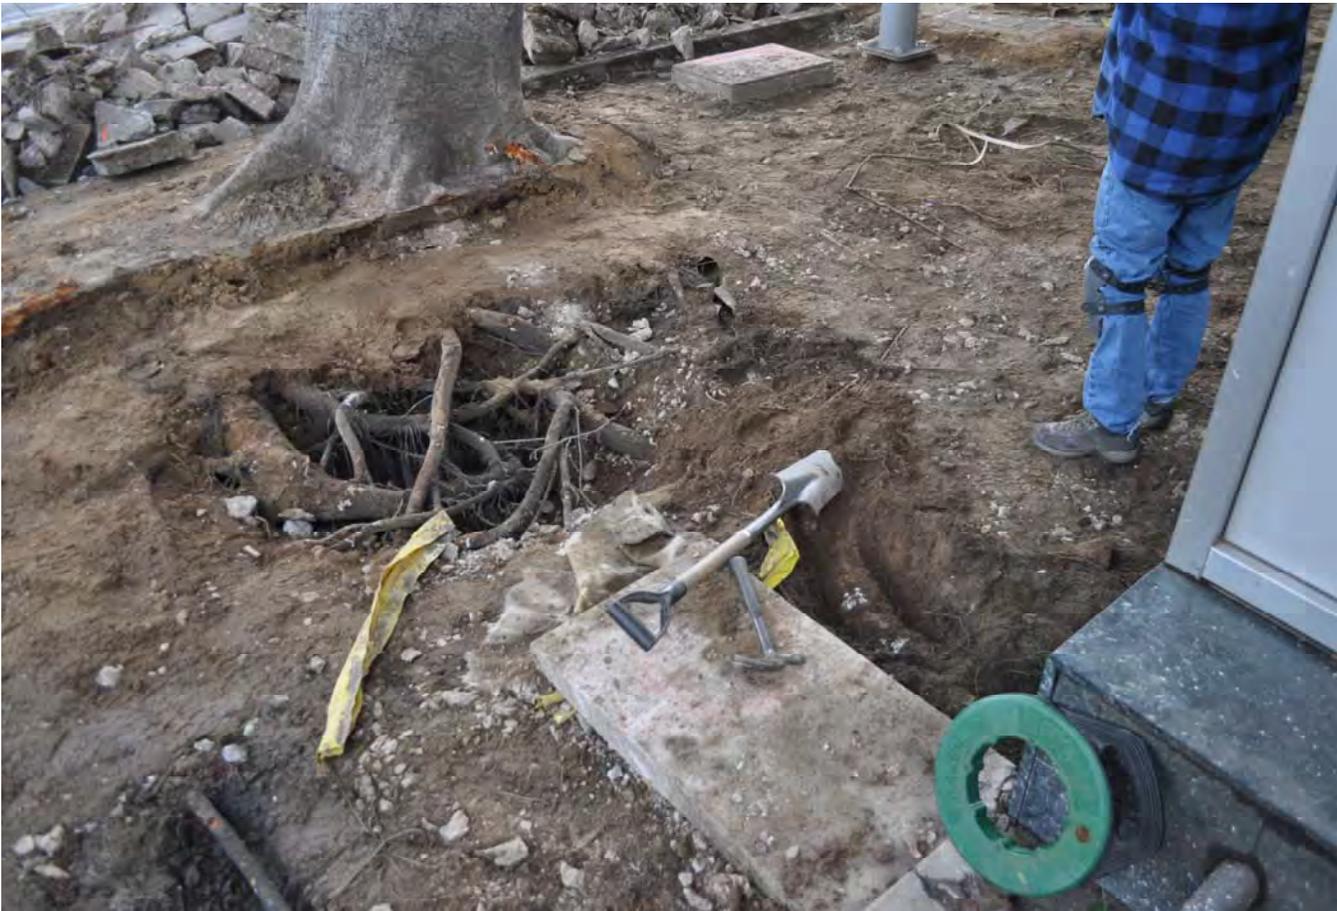
Photo 12

At the northeast building corner, just below the sidewalk, is 4-inch cast iron drain line that extended out of the building (Photos 12 – 14). The line had a cast iron elbow directing the pipe to the southeast toward the street. The pipe extended out several feet where it connected with a 4-inch plastic pipe (Photo 15). There was a roughly 2-foot section of the plastic pipe that was broken adjacent to the depression (Photos 16, 17). Roots were observed growing inside this portion of the drain line. The cast iron pipe was opened up at the elbow and was found to be completely filled with roots (Photos 18 - 26). We observed a ½-inch wide root (Photos 27 – 29) and numerous smaller roots that completely filled the pipe and continue into the cast iron pipe and into the building.

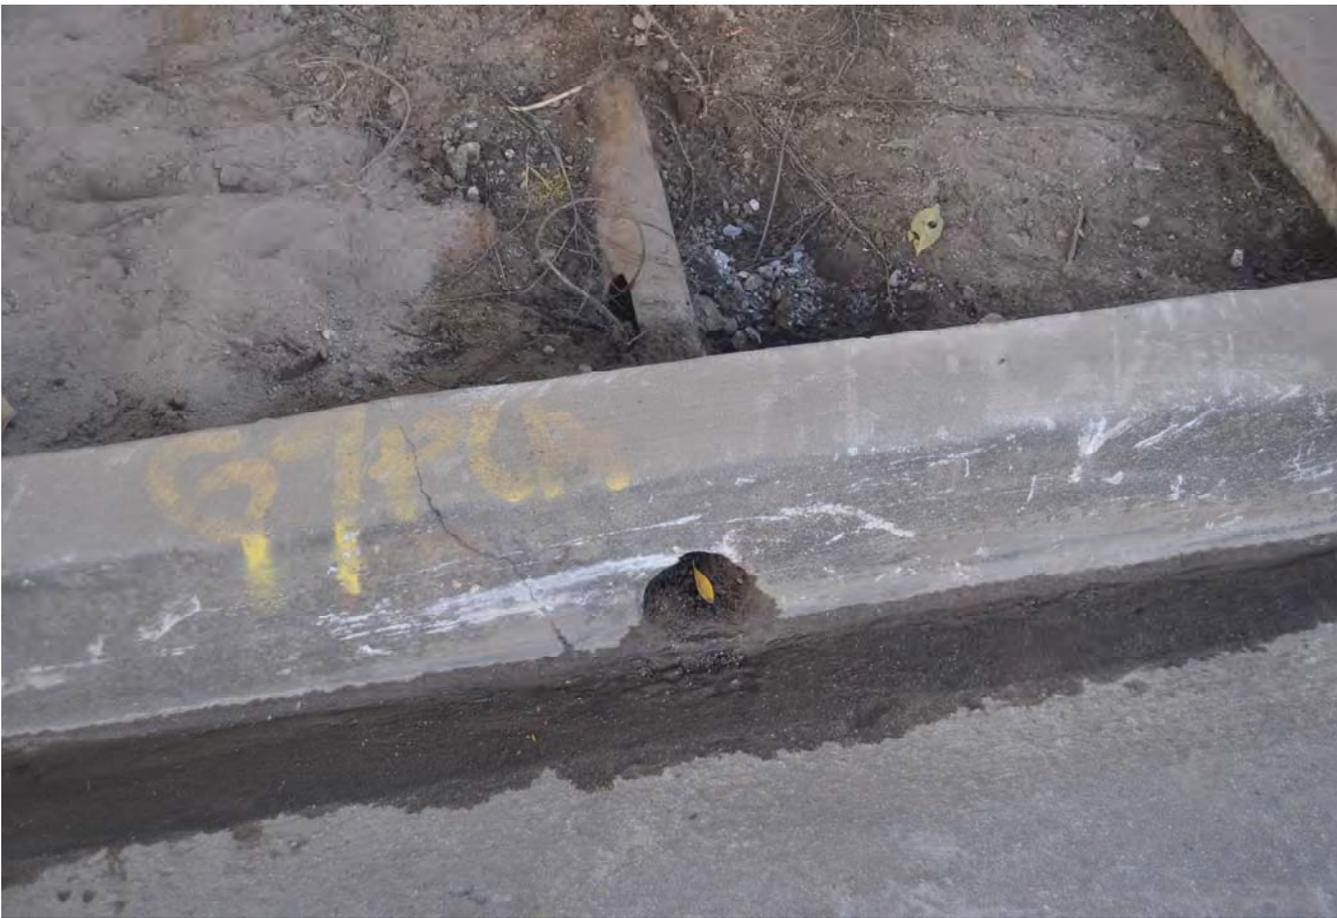
Photo 33

North of the depression are two easterly trending drain lines that appear to be for the vacated neighboring building to the north (Photo 30). About 7 feet north of the subject building is a cast iron line that was observed to be broken near the street and with roots growing in the pipe (Photos 31, 32). The outlet at the street is completely blocked (Photo 33). At about 4.5 feet north of the subject building is a plastic drain line that is damaged at one location where we observed standing water (Photos 34, 35). The curb outlet for this pipe is completely blocked (Photo 36). There are two roots about 1 to over 1.5-inches in diameter that trend along this pipe and go to the west under a landscaping curb (Photo 37).

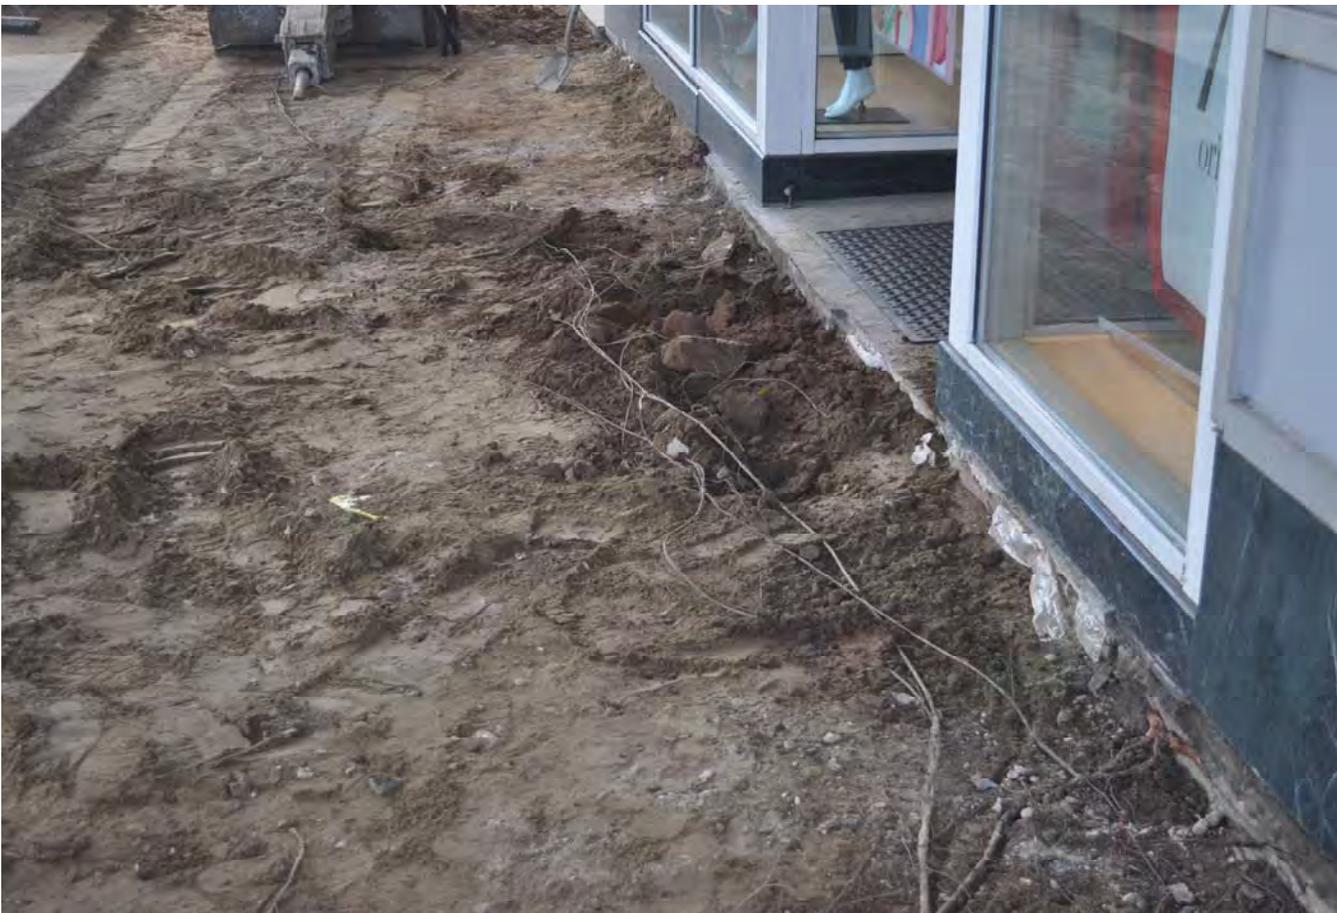
Photo 40

The general contractor had the Bobcat Jackhammer operator disturb the ground surface adjacent to the north front entrance a total depth of about 1 foot and a linear distance of about 7 feet (Photos 40, 41). We hand excavated deeper and along the disturbed ground to expose the slab edge and open up the disturbed ground (Photo 42). This work exposed a ¾-inch root and smaller roots going under the adjacent slab (Photos 43, 44). This slab appeared to be about 3½ inches thick and our metal detector did not indicate the presence of metal reinforcement (Photo 45). The general contractor did not want to excavate any further because he said that there is a gas line in the vicinity of this portion of the building.

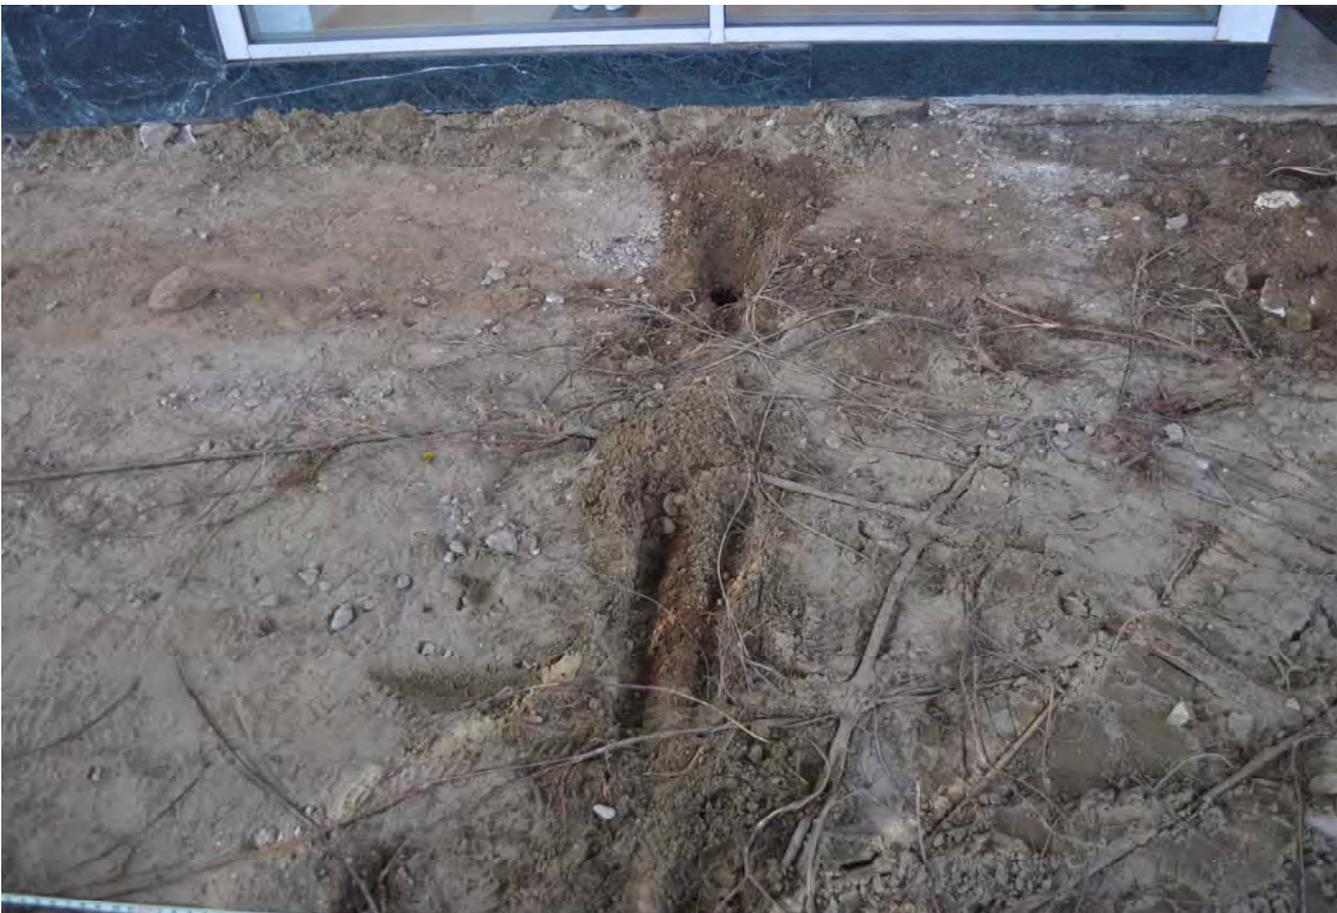
Photo 46

A significant number of surface roots were directly beneath the sidewalk between the middle and south trees (Photo 46). Removal of the sidewalk in between the south and middle trees resulted in detachment of a section of the marble facing (Photos 47, 48). Removal of the sidewalk showed that the sidewalk butted up against the cracked wall facing (Photos 49, 50) that was observed during our original site visit (Photos 51, 52). This confirmed that the growth of the south tree root mass most likely caused the compression damage to the sidewalk and likely pushed the

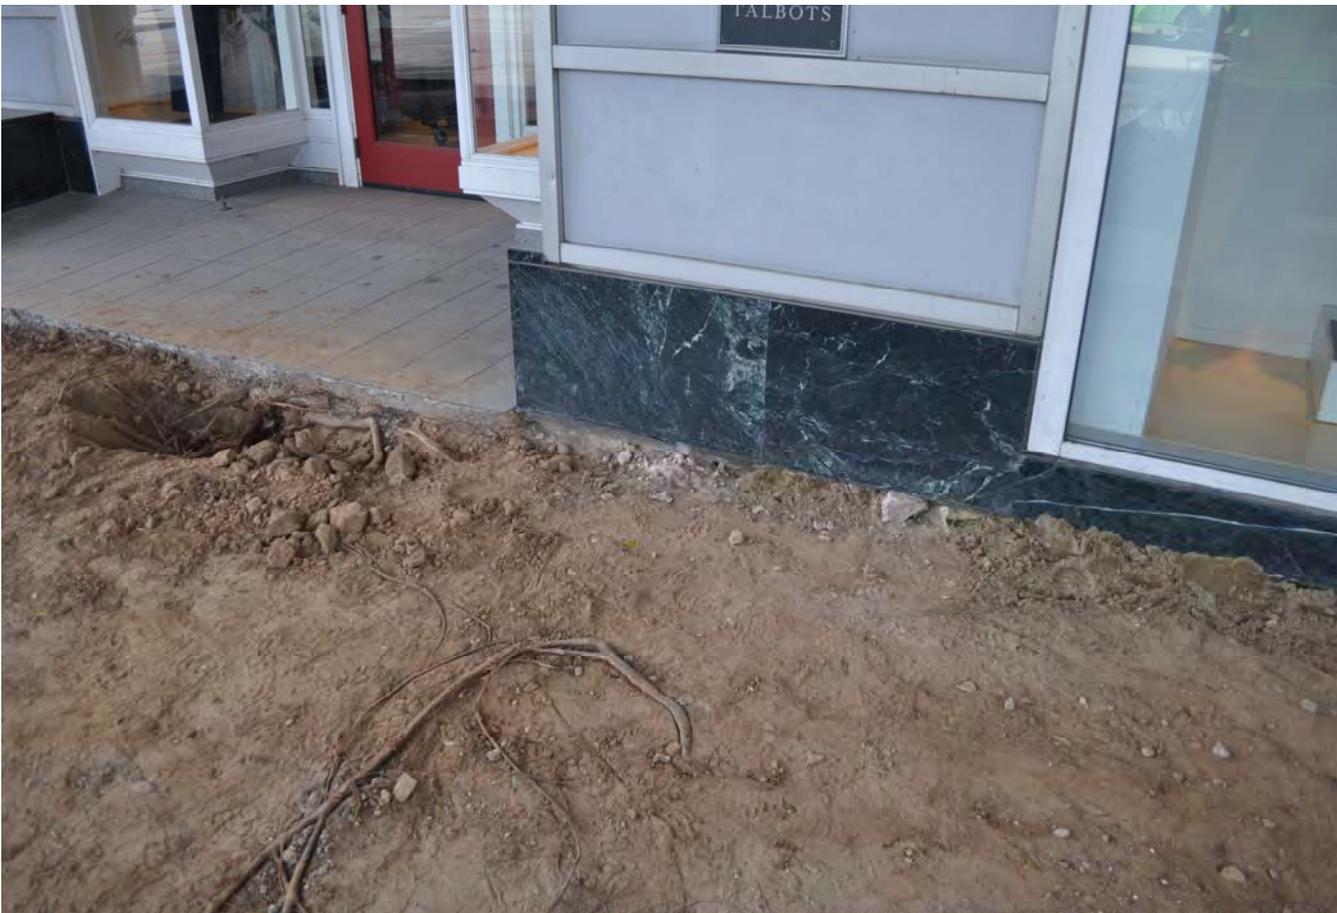
Photo 54

sidewalk northwestward and into the building facing (Photo 53). This may have been exacerbated by the growth of roots directly beneath this portion of the sidewalk (Photo 54).

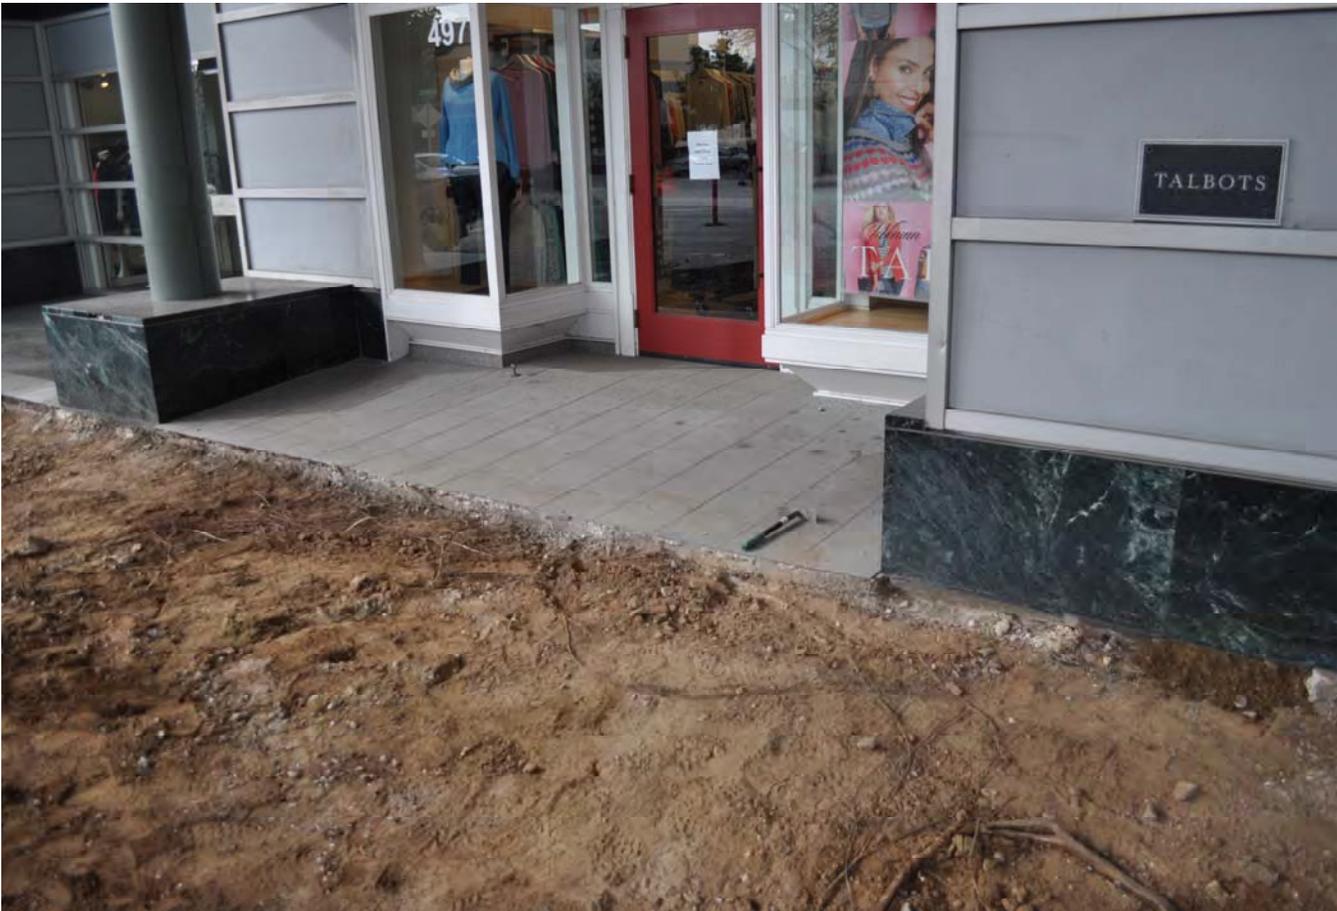
Photo 58

The general contractor disturbed the ground surface adjacent to the front entrance slab of the south building entrance (Photos 58, 59). The disturbance was about 0.5 to 1 foot deep and about 12 feet long. We hand excavated deeper and exposed a root about 5 to 6 inches in diameter about 4 feet south of the north end of the entrance slab (Photos 60 - 65). Several smaller roots splayed off the larger root (Photo 66). Mr. Kenny Graham, City of Pasadena Forestry Supervisor, had a couple of City personnel excavate around these roots and dig slightly deeper (Photos 67 - 69). It was discovered that the 5 to 6-inch thick root turns down into the ground and it is not known where it goes (Photo 70). The small roots were observed to have grown into the slab/footing edge of the entrance slab and then turned away. It was discovered that the entrance slab edge/footing is at least 14 inches deep at this location (Photo 71), with an apparent separate pour of 5-inch thick slab/tile installation on top. Our metal detector indicated the presence of metal reinforcement in this slab, possibly rebar.

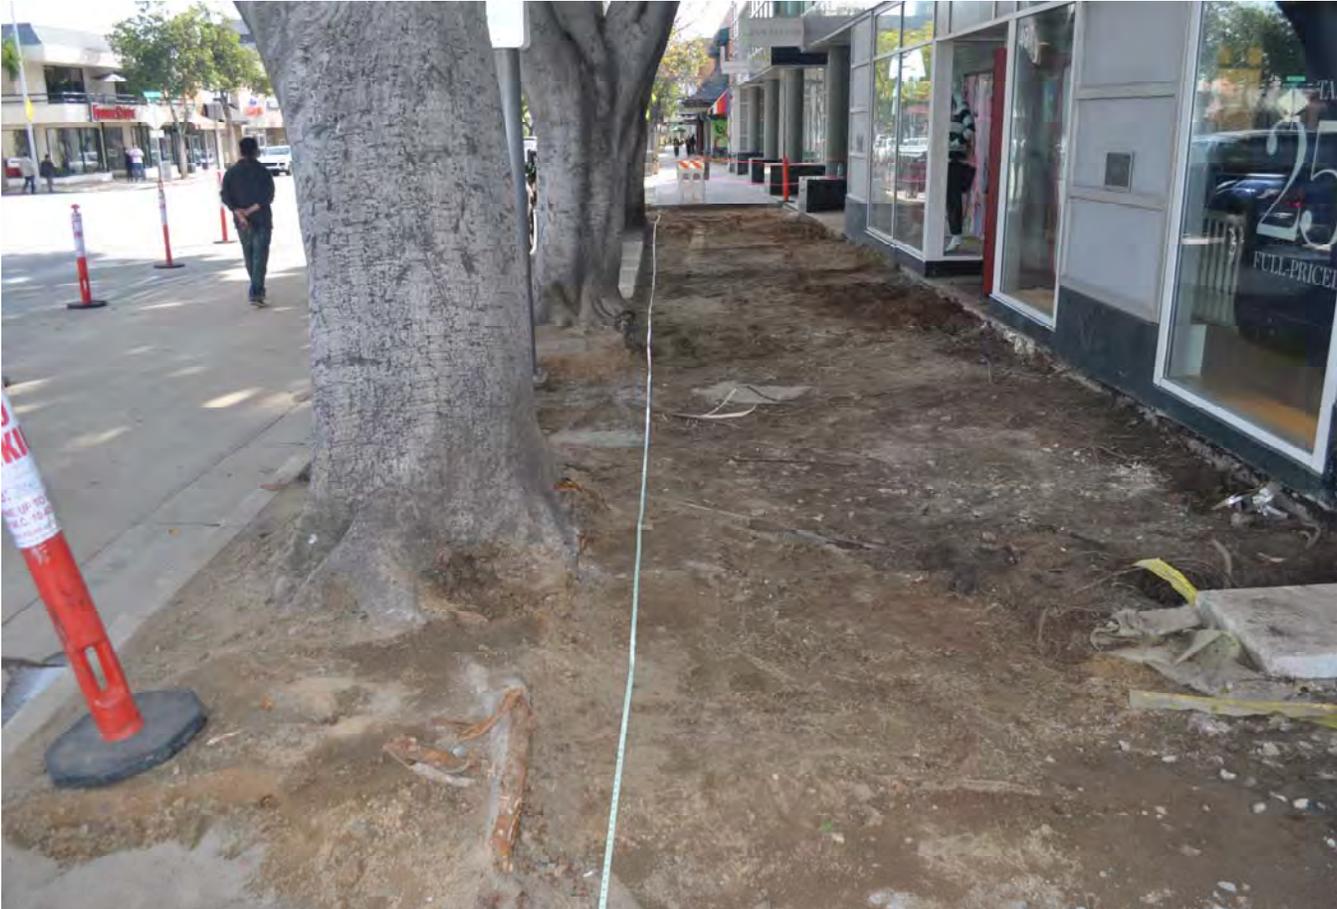
Photo 79

Beneath the south end of the sidewalk removal (Photo 75), large root(s), typically 4 to 4.5 inches in diameter extended to the south from an area between the south building entrance slab and the south tree (Photos 76 – 78). This tree root system extends at least 21 feet from the tree and continues beneath the remaining sidewalk with a root diameter of about 3 inches (Photo 79).

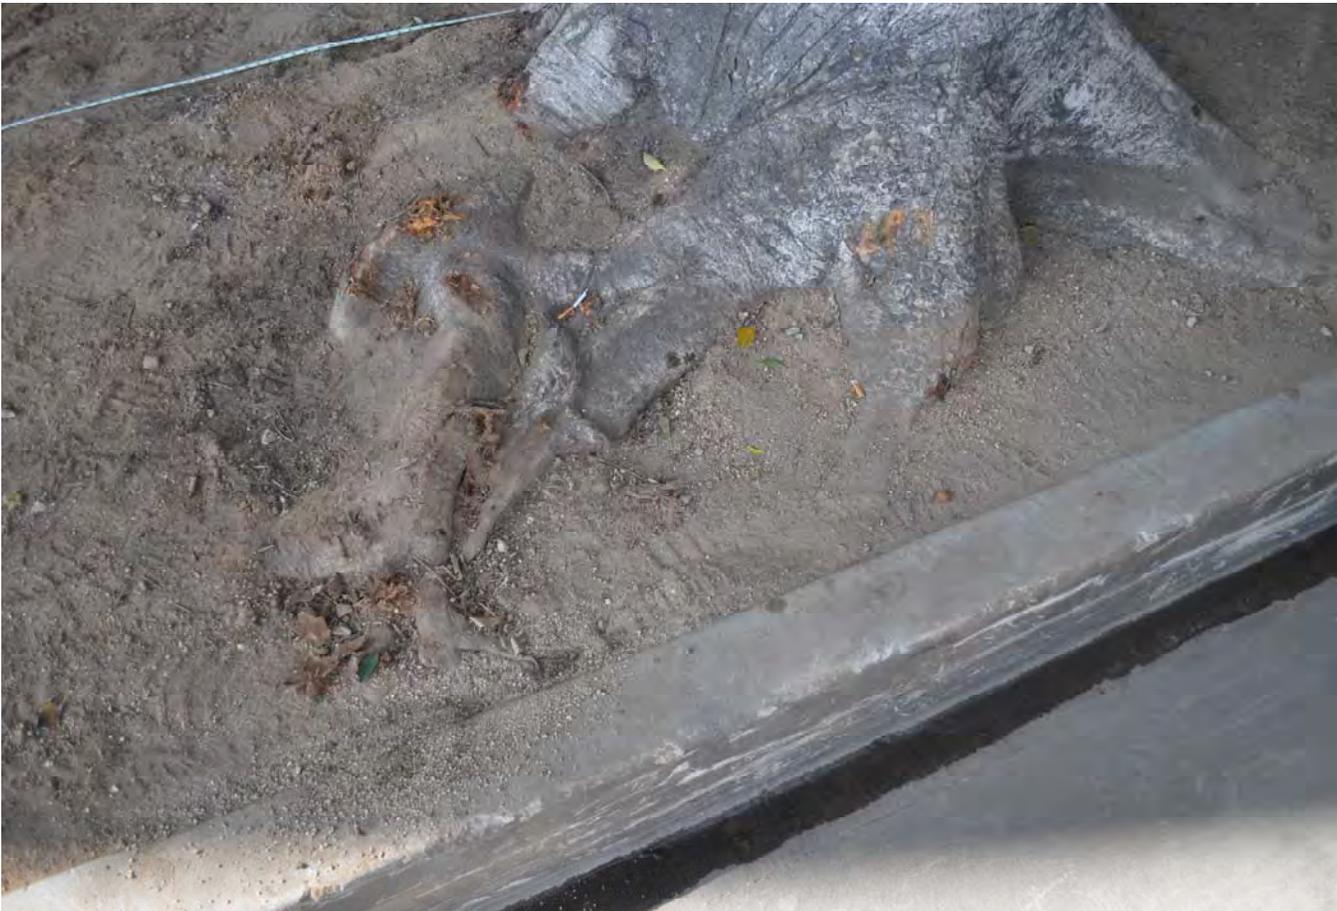
Photo 81

The trees and roots adjacent to the curb and street are massive (Photos 80 - 83) and the curbs have apparent long-term heave from continued growth of the three ficus trees (Photos 84 and 85).
